**PADinspections**

**Inspection Address**

Report/Agreement # 18032214293223

### Building And Pest Inspection

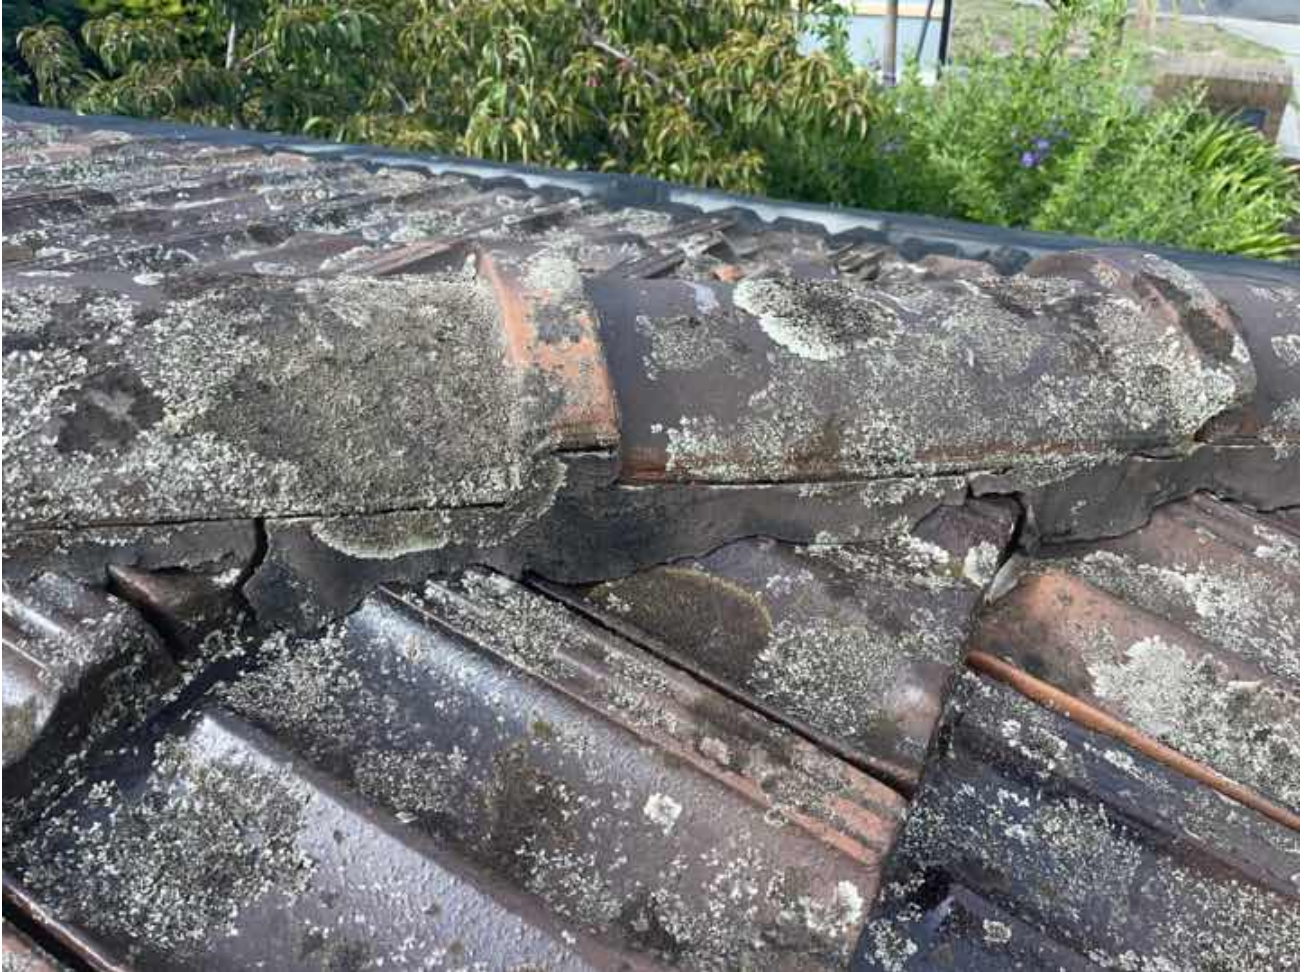
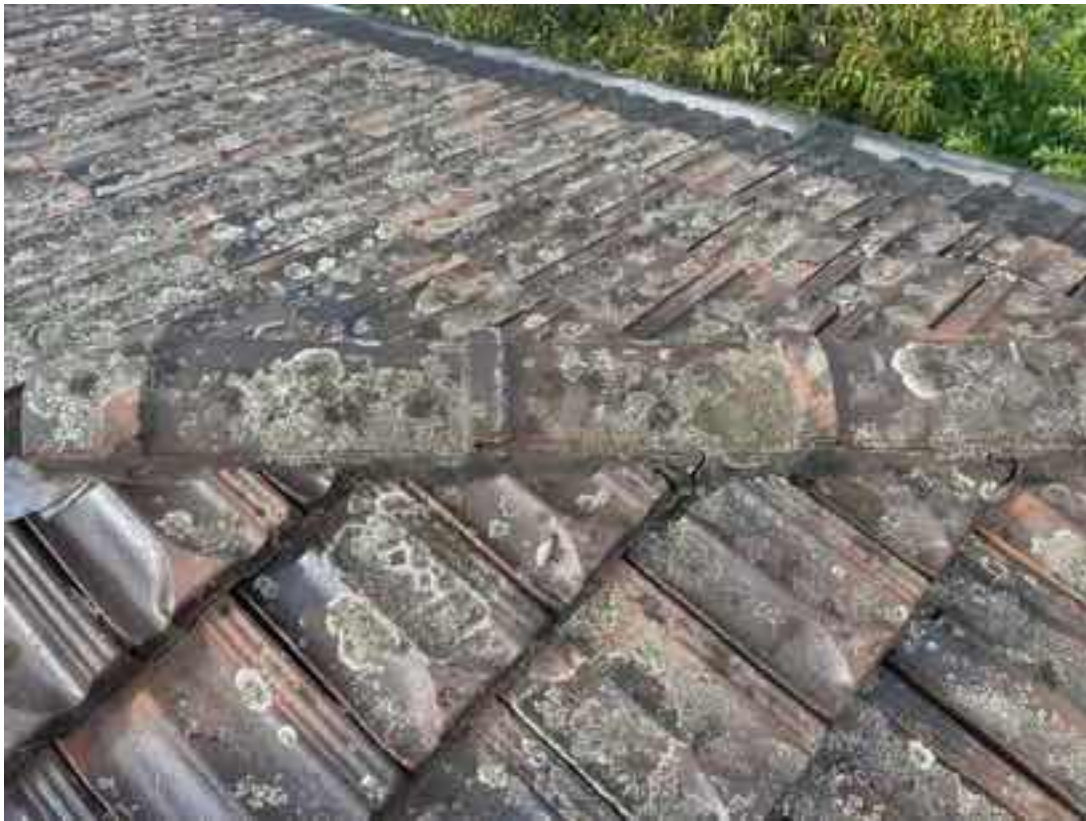
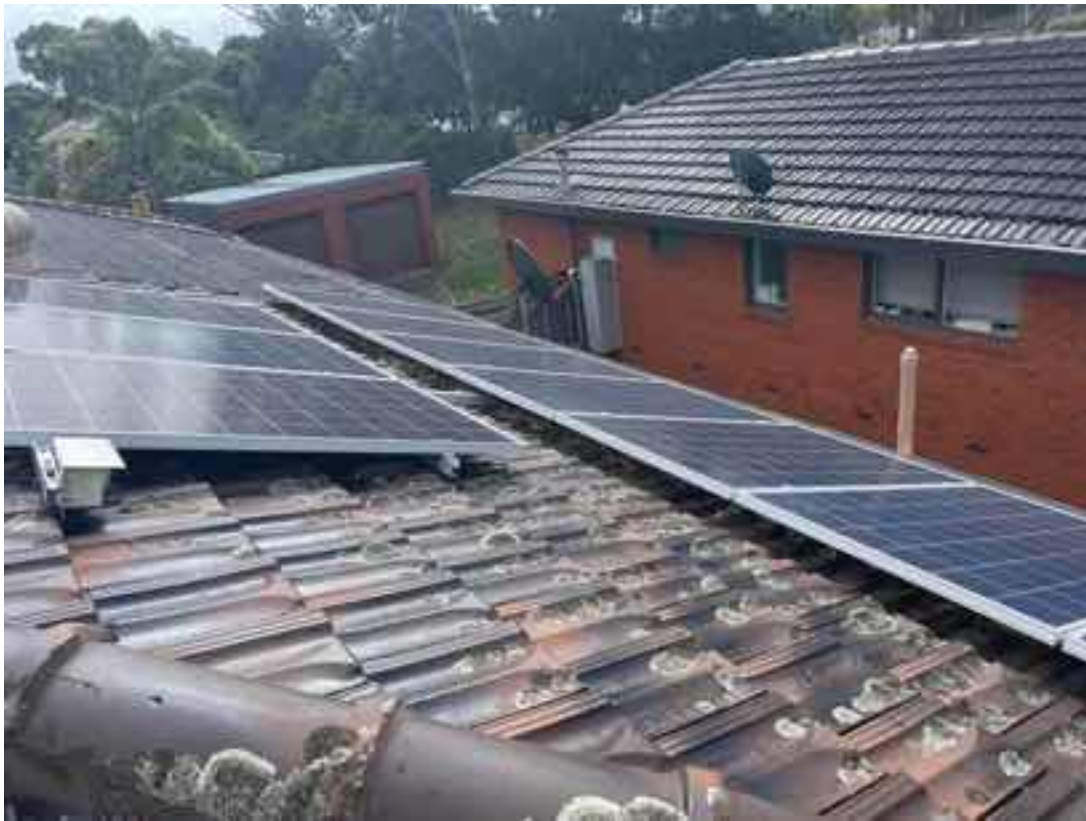
On inspection, defects were noted that may require further assessment and recommendations by licensed roofer.

Mortar cracks visible. We recommend having these repaired by a licensed roofer as they contribute to water ingress. Whilst common on properties of this age we recommend repair it may result in water ingress into the roof cavity

Moss has built up on the tiles over time. It is preferable to have the moss and debris from the surrounding trees removed / cleaned to prevent deterioration. Recommendations: A qualified roof restoration contractor should be engaged for advice and recommendations.

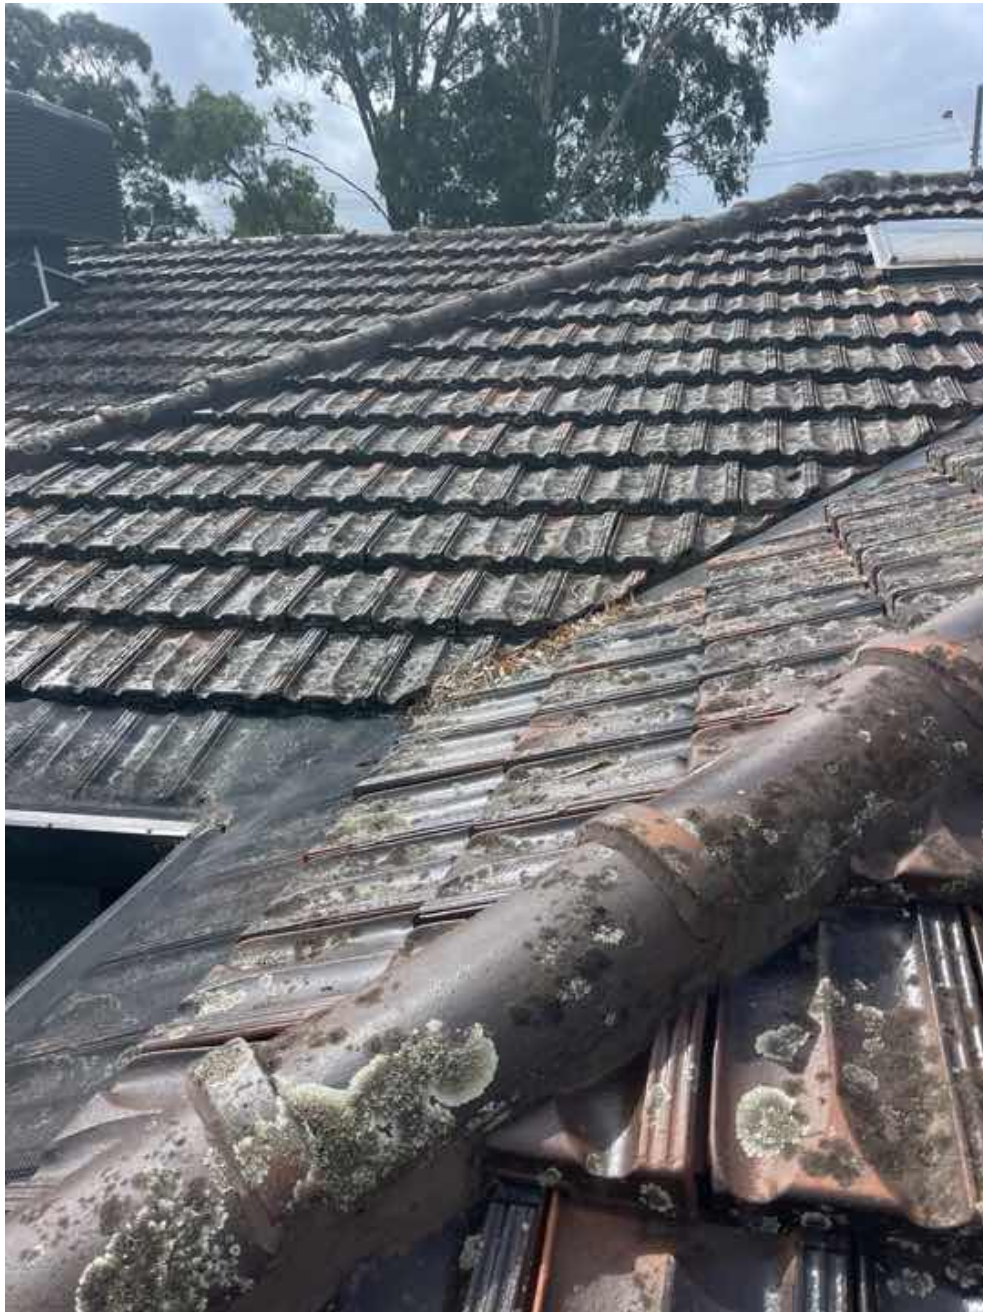
Debris in guttering areas- this requires cleaning out to prevent blocking of down pipes and leaking into eaves and fascia. Recommendations: Have gutters regularly cleaned to prevent ponding. Ponding water will contribute to rust.

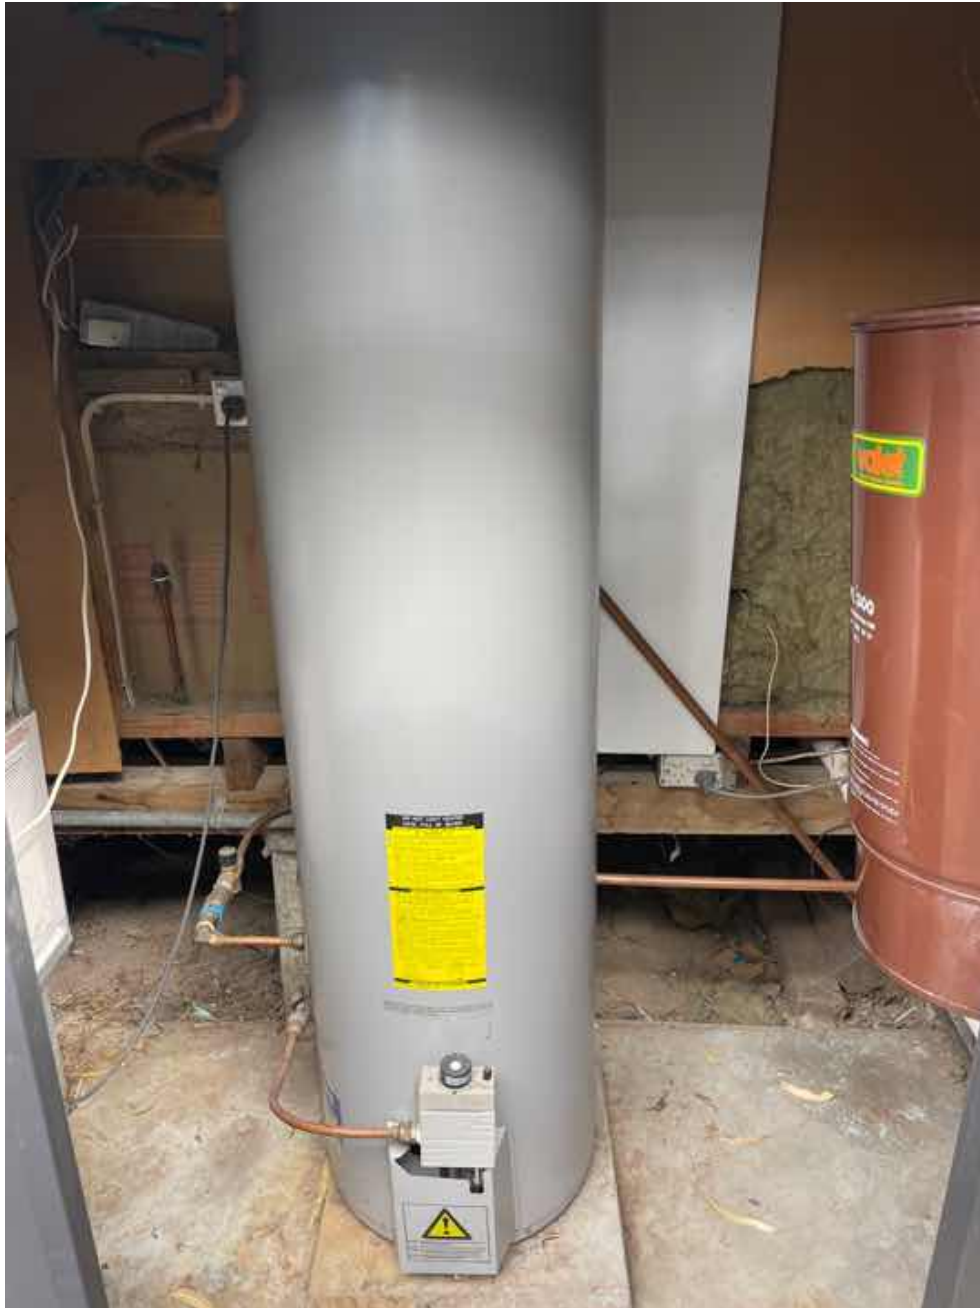
A partition wall has been constructed around the hot water unit restricting assessment.

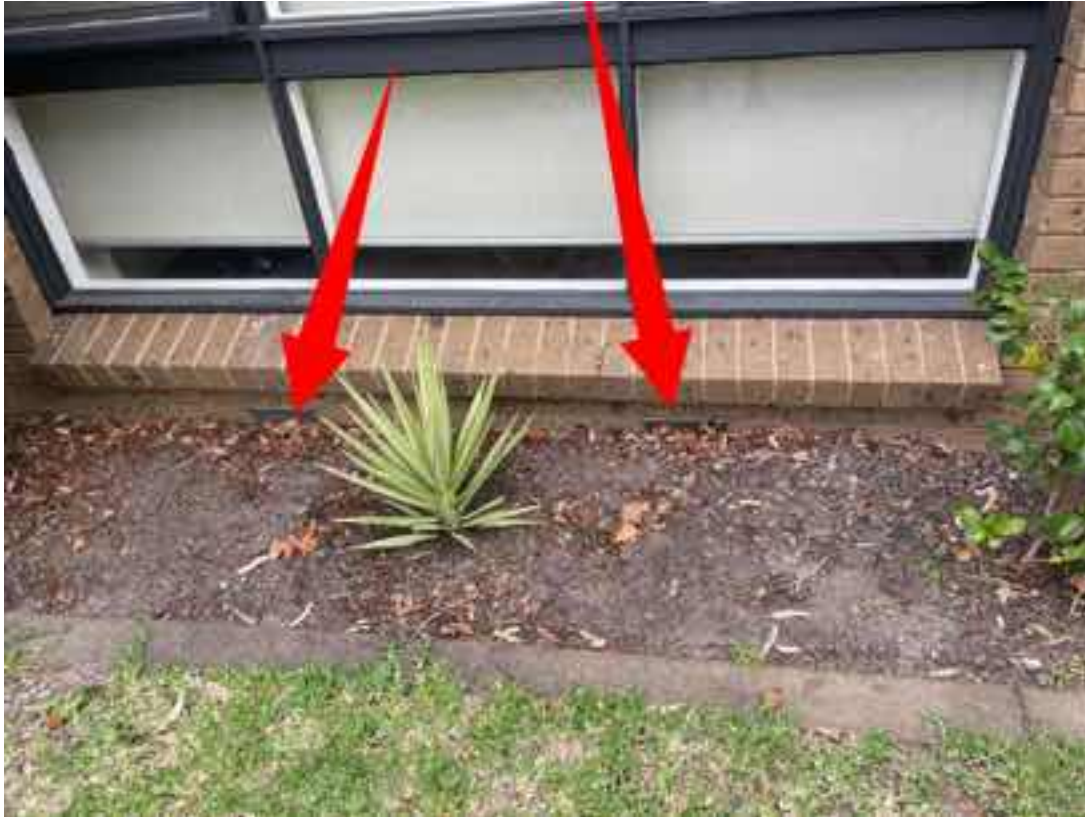
Vents are covered by soil/vegetation or have debris restricting ventilation to the sub floor Recommendations:  
Remove vegetation and or lower soil levels so that sub floor vents are unobstructed and allowing free flowing air.

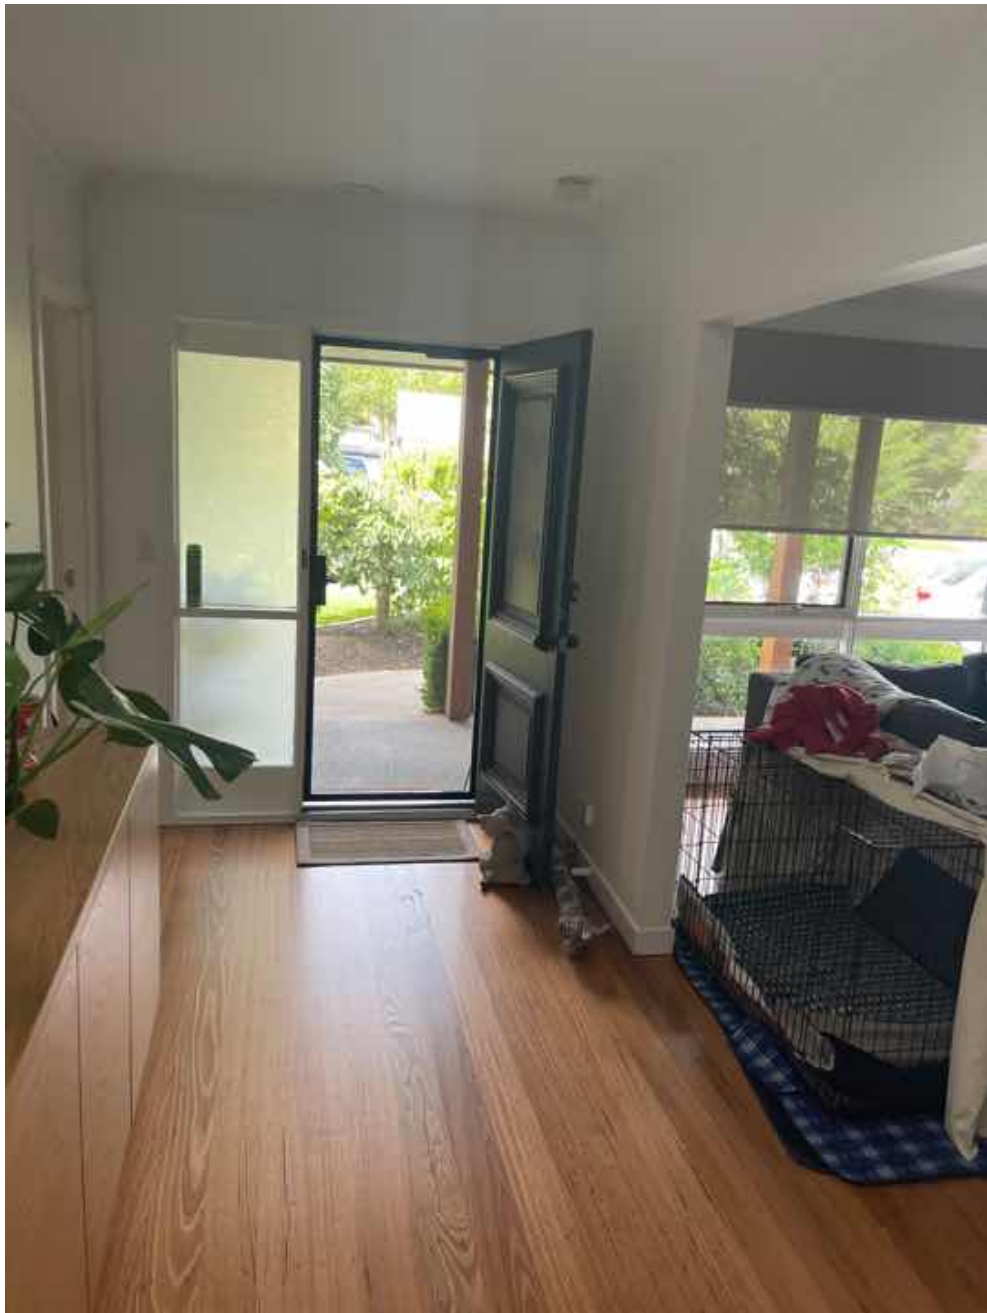
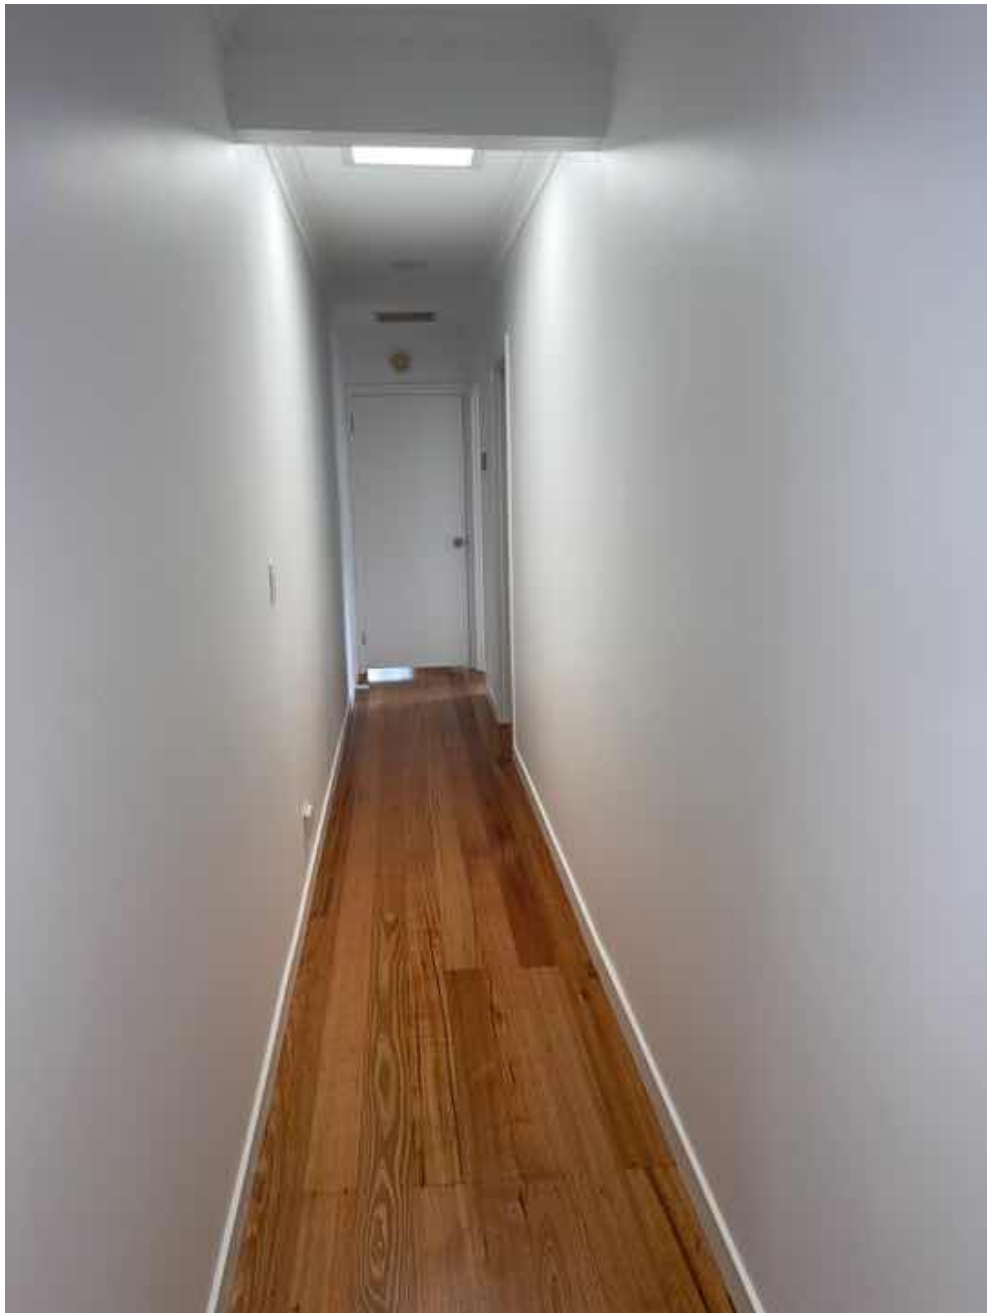
Settlement Cracks Noted . These are typical and generally patch and paint will suffice, however monitoring these cracks advised.

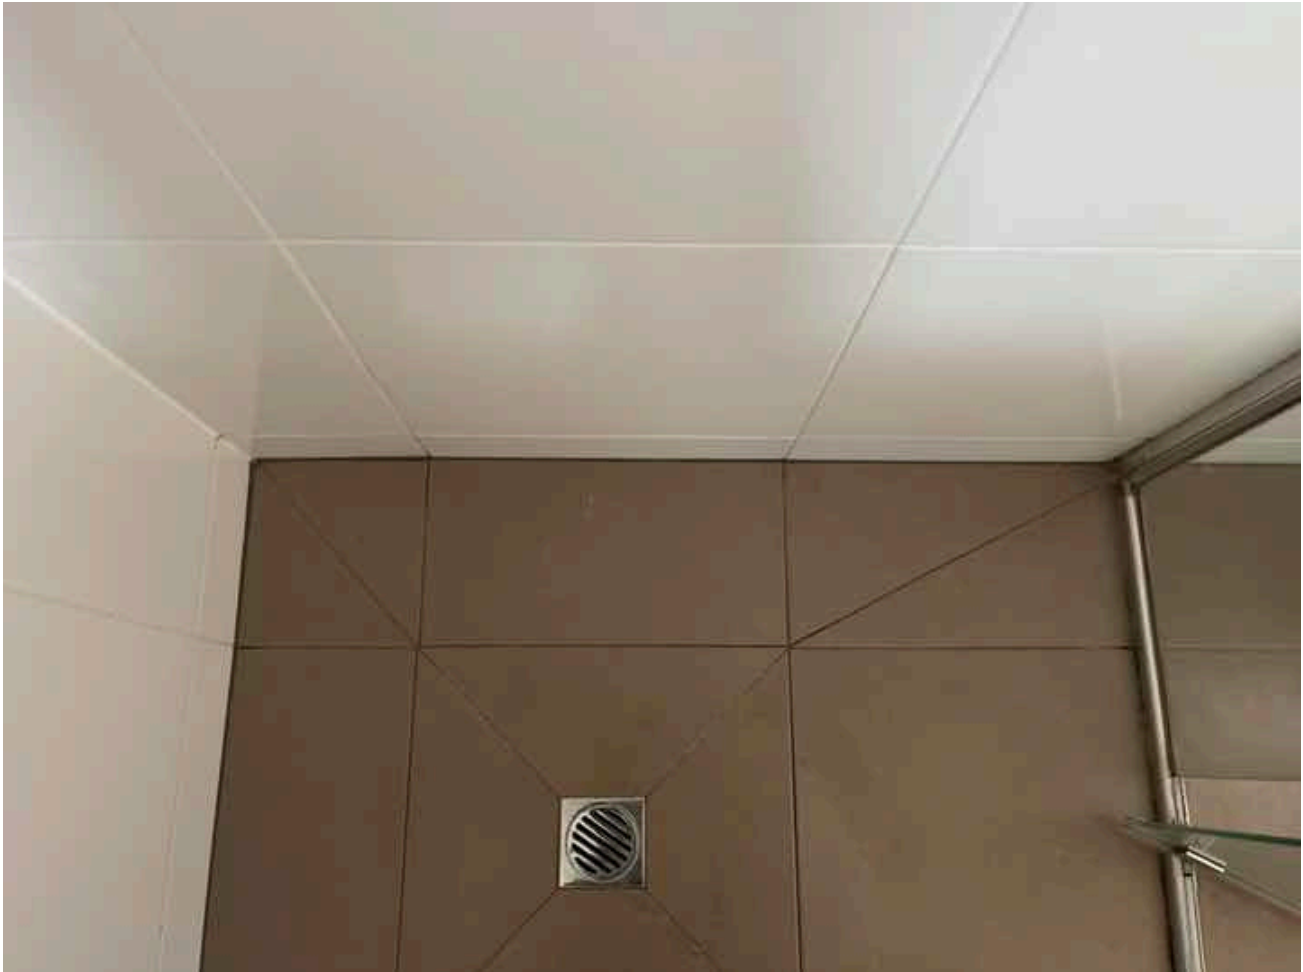
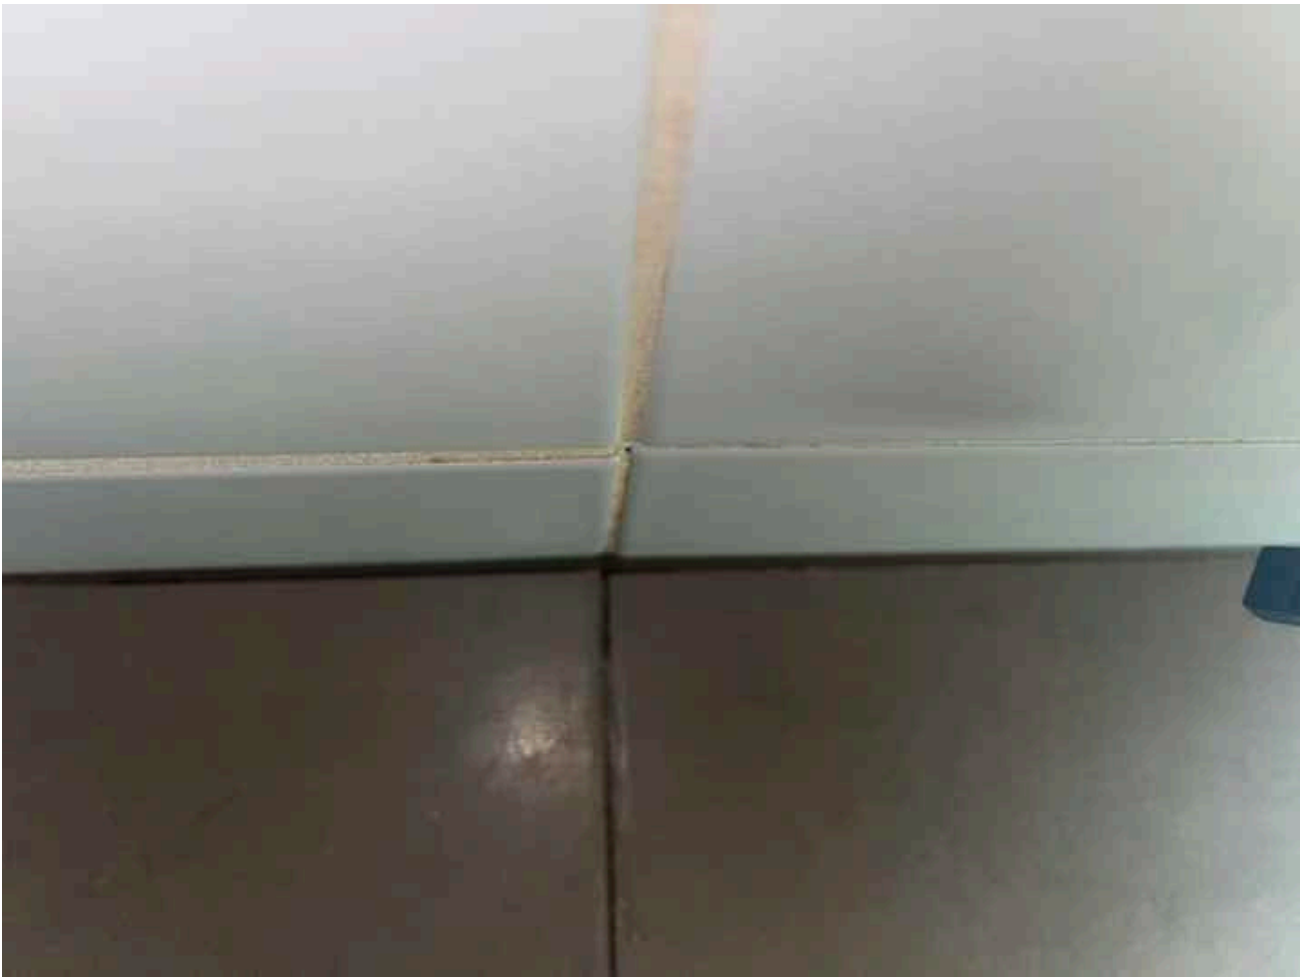
The silicone sealant applied at the junctions of this shower base have gaps that will allow moisture to penetrate over time. Removing the silicone and resealing it is recommended.

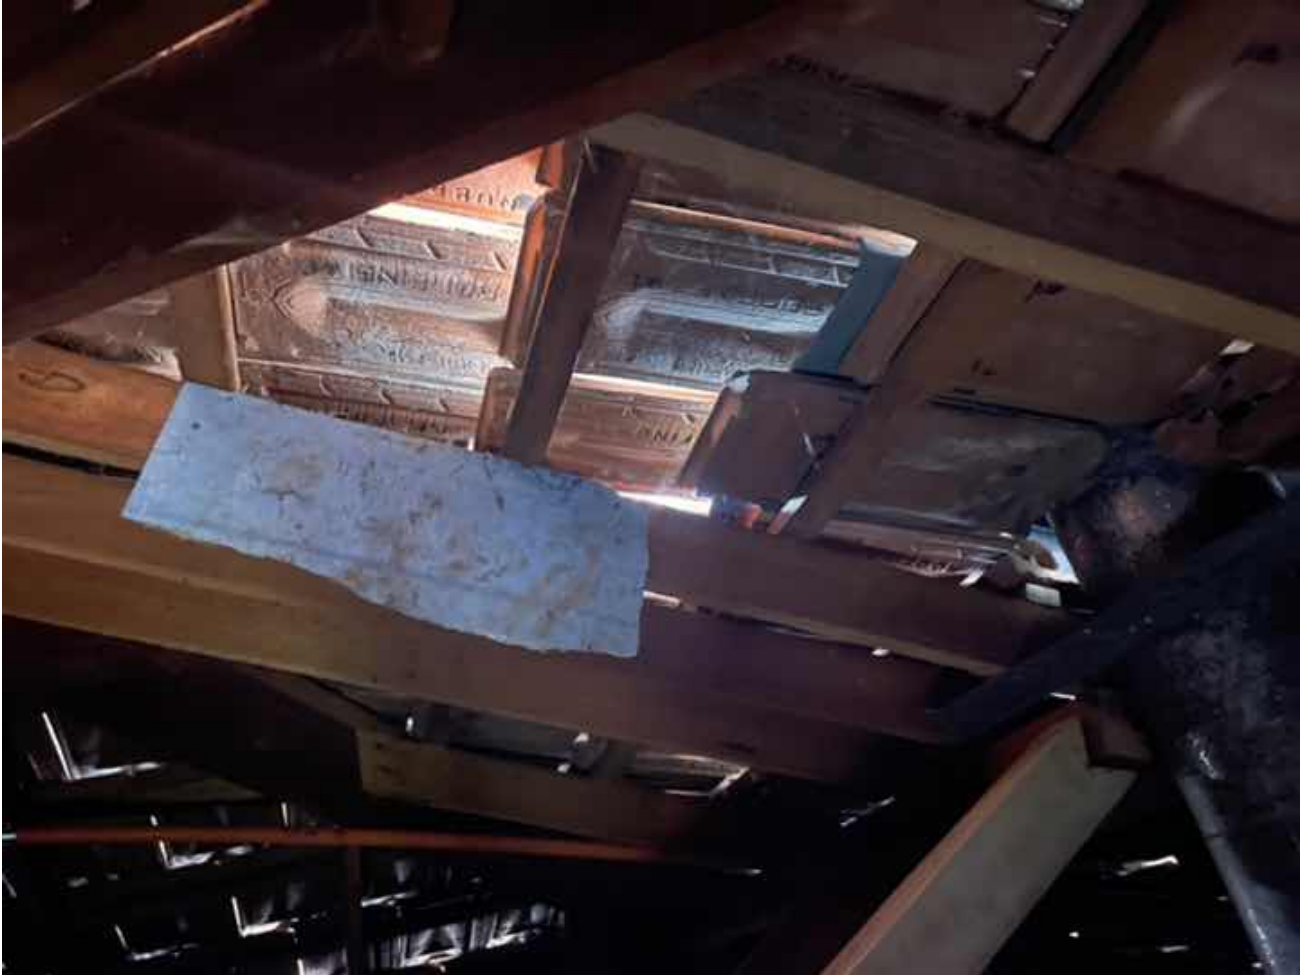
Dislodged/gaps in tile visible around the chimney area. Recommendations: A qualified roof tiler should be engaged for advice and recommendations.

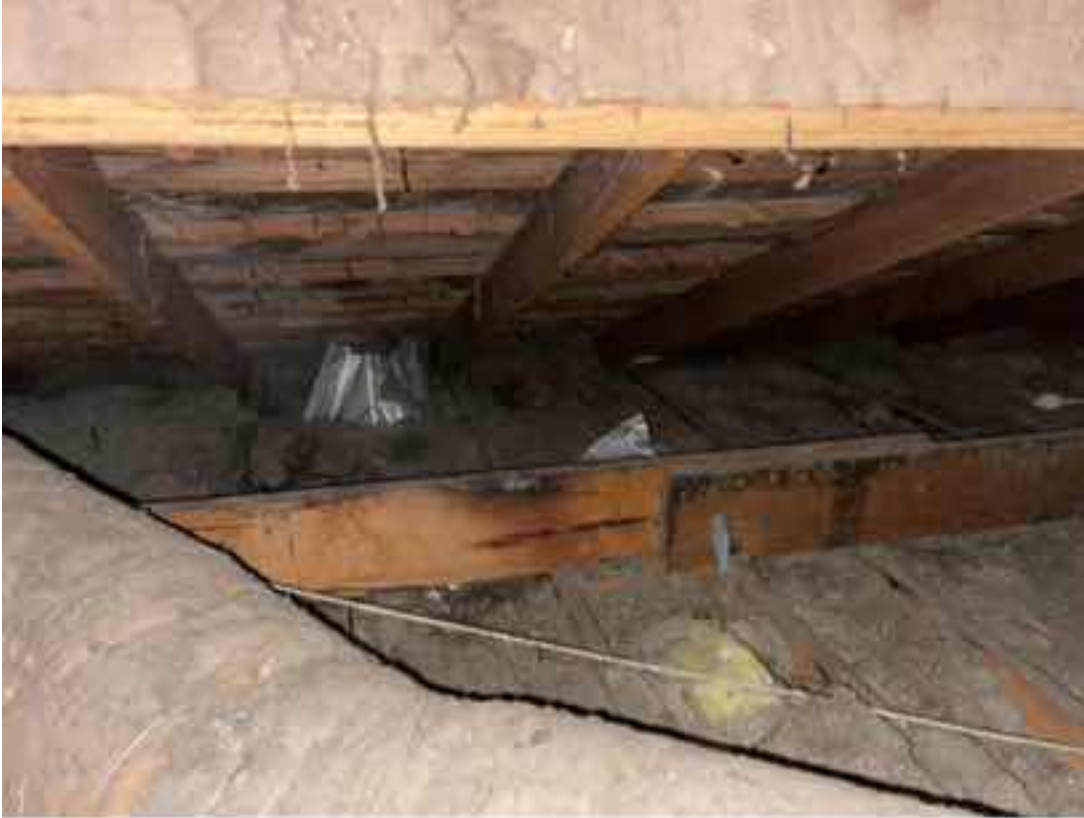
Please note that the insulation under the north side of the home where the debris is building up in and around the solar hot water and solar panels, appears to have old moisture staining. Regular cleaning is required.

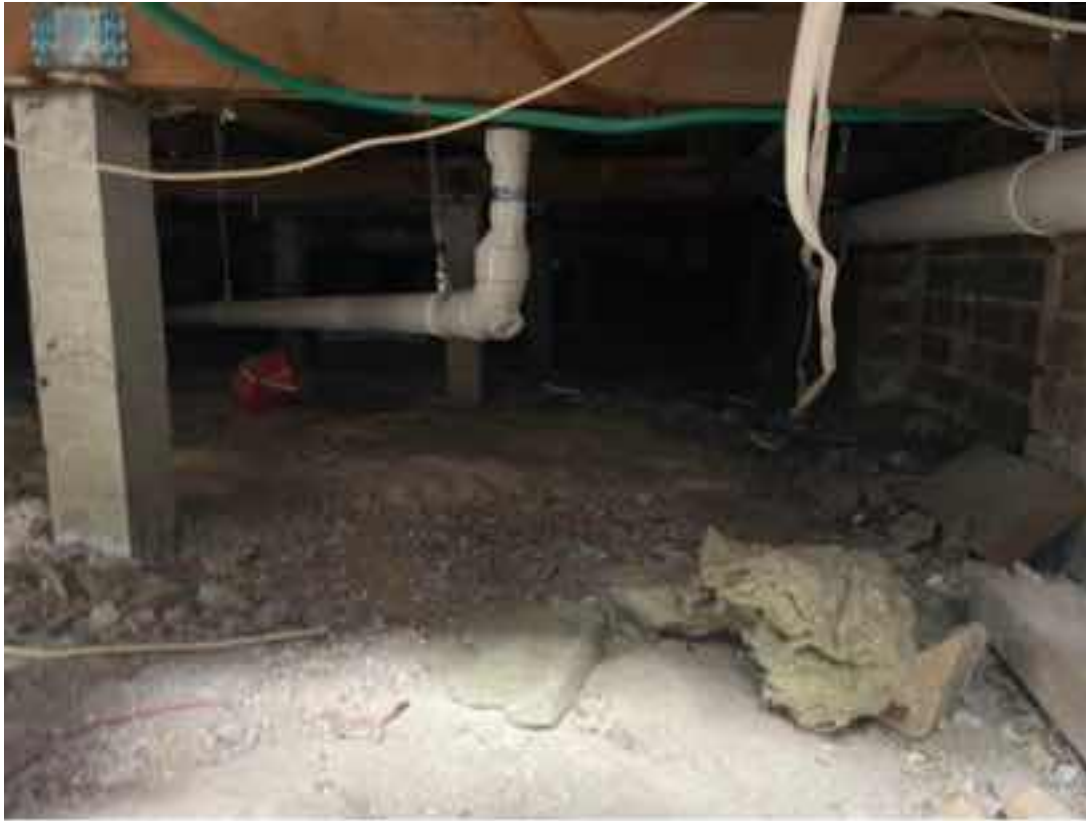
Access was too low to safely enter the area under the master bedroom of the subfloor. Viewed from a distance.

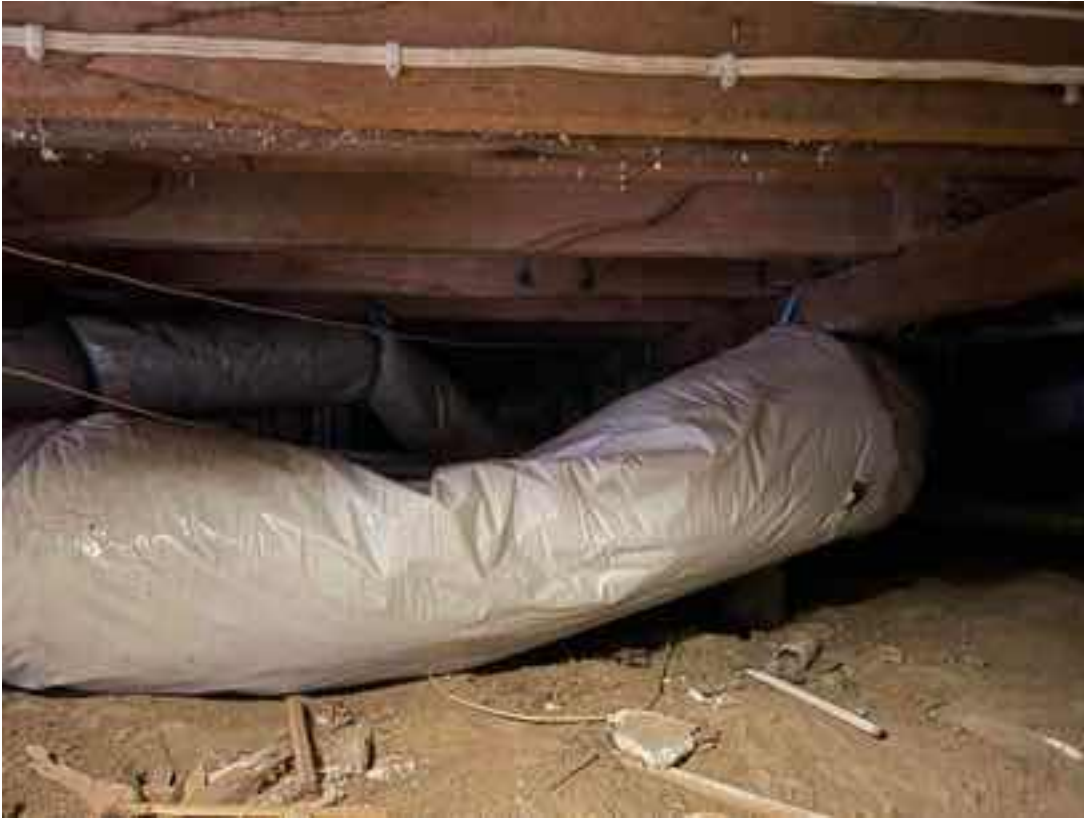
A section of the heated ducting system was flattened by a previous trade. Replacement recommended to ensure that the system runs efficiently.

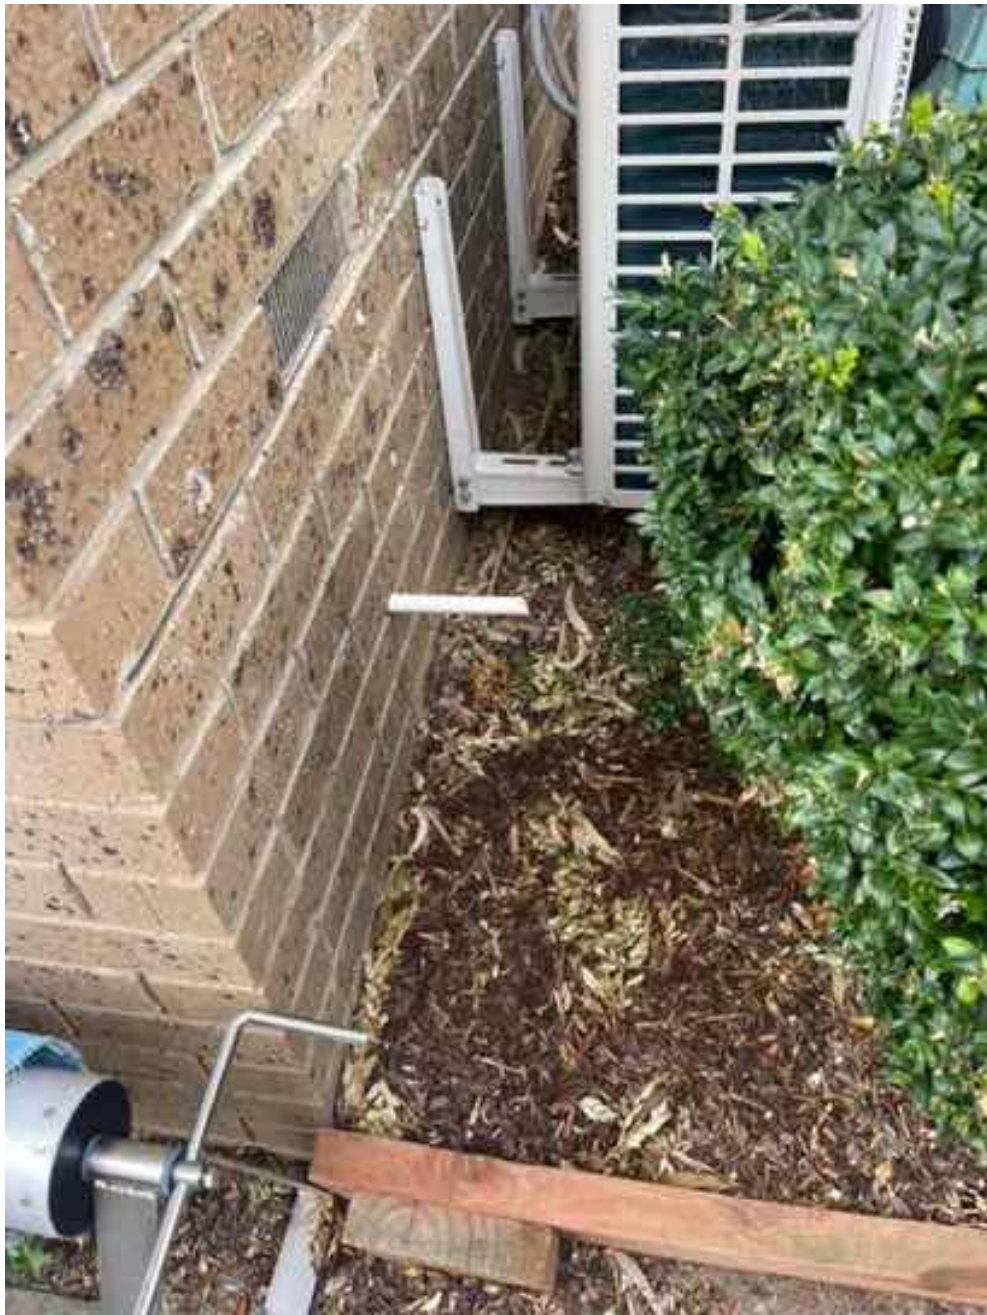
No - Divert A/C overflow away from the building perimeter

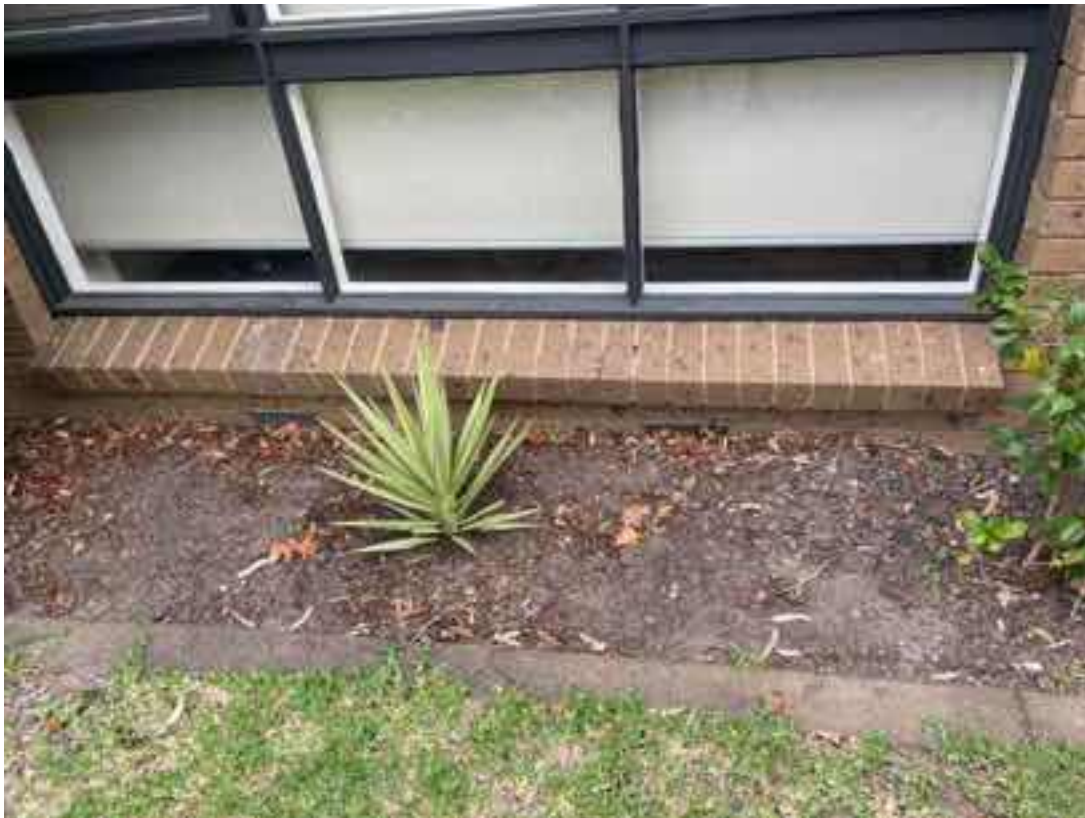
No the subfloor vents were obstructed
