**padinspections**

**Marcia street, Sunshine West, VIC, Australia**

Report/Agreement #       0307151640104  
 Inspection Date           03 Jul 2015  
 Inspection Time           02:00 PM

### Building Inspection

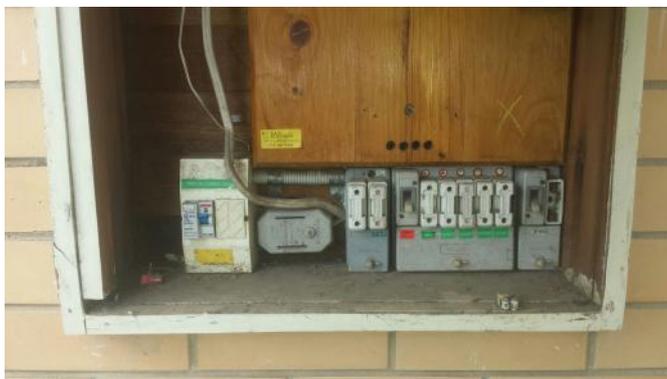
An RCD should be installed for safety reasons

Recommend upgrading switchboard

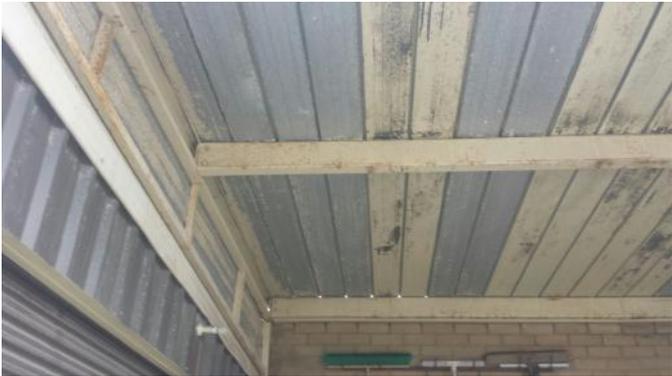
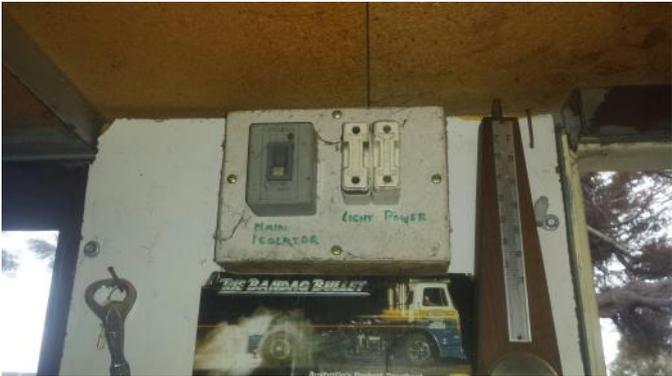
### **Shed Condition**

Rust development on cladding noted. Recommend treating with rust inhibitor

Recommend upgrading switchboard

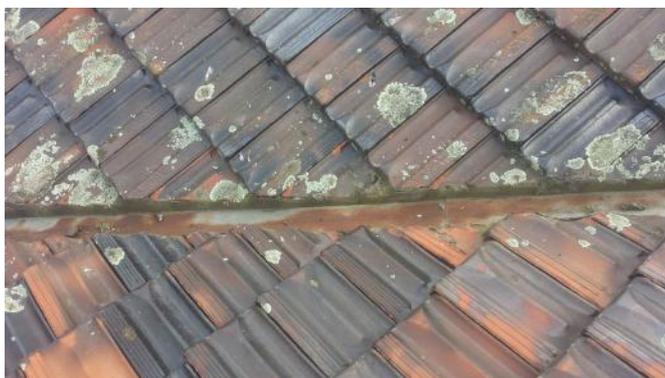
### Roof Clad Condition

Moss has built up on the tiles over time. It is preferable to have removed / cleaned to prevent deterioration.

Rust developing in valley. Recommend treating with rust inhibitor.

Dislodged mortar in places.

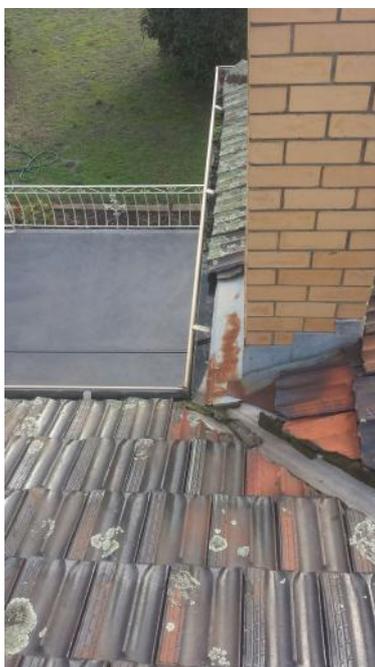
### Flashing Conditions

Minor flashing rust sections.

Recommend treating with rust inhibitor.

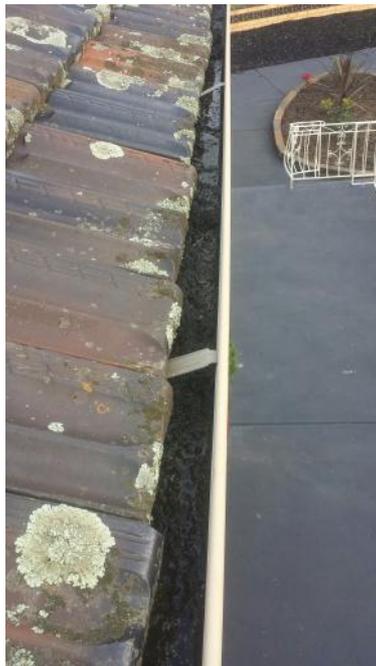
Debris in guttering areas- this requires cleaning out to prevent blocking of down pipes and leaking into eaves and fascia. Recommendations: Have gutters cleaned and assessed by a plumber for adequate fall. Also regularly clean to prevent ponding. Ponding water will contribute to rust.

Gutter ponding - This can relate to poor fall, inadequate down pipes, gutter or debris build up. If debris presence has been noted above clean same out and re-assess for any ponding. If clean guttering is ponding it can be a blocked down pipe or the guttering fall is inadequate.

Recommendations: A qualified plumber should be engaged for advice and recommendations.

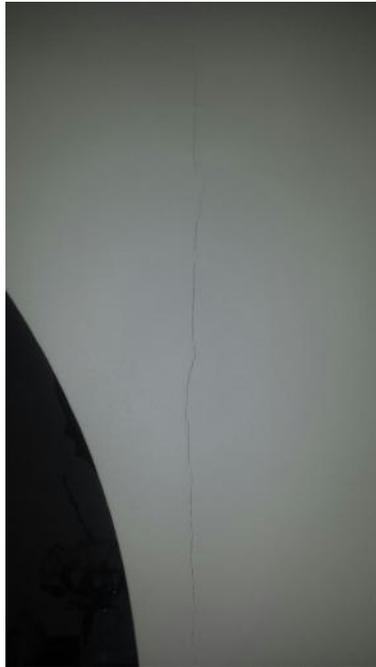
## **Walls**

Settlement Cracks Noted . These are typical and generally patch and paint will suffice, however Monitoring these cracks advised for 12 months and if become wider or longer, you will need to contact a structural engineers to assess.

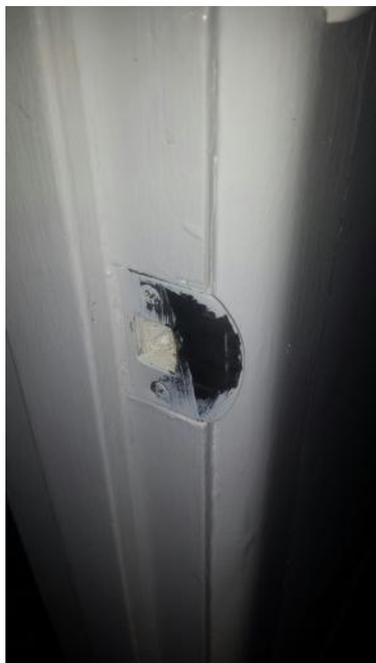
### **Door**

Striker plate needs adjusting.

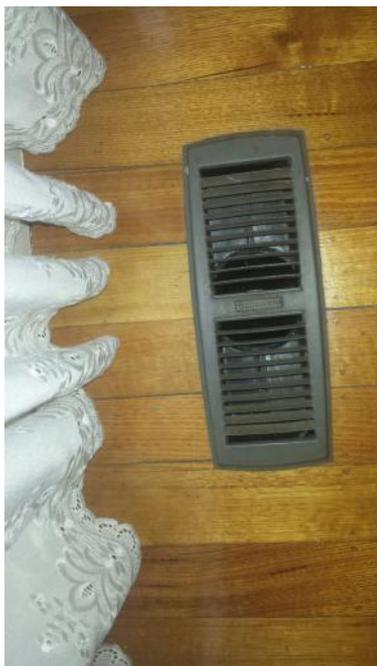
## Flooring

Supporting timber not installed under floorboard alongside heating vent. Recommend having one installed to prevent any damage.

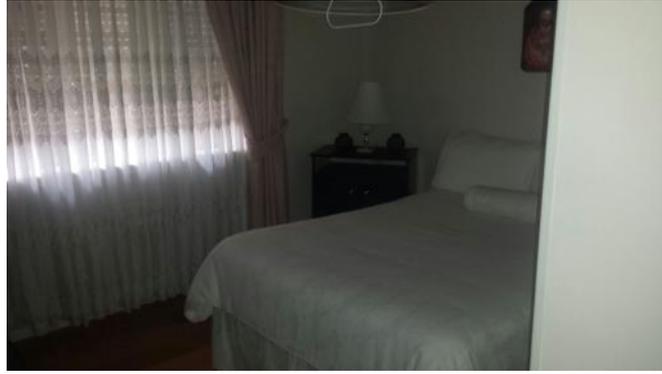
### Door

Striker plate needs adjusting.

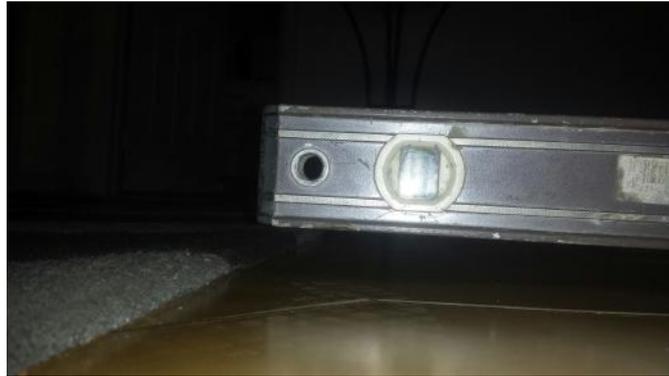
## Flooring

Unevenness visible in floor.

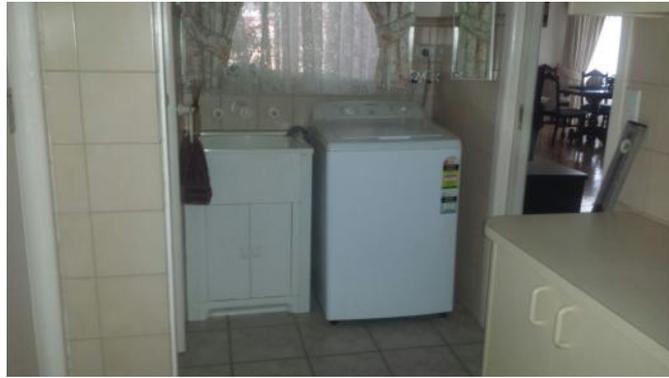
#### Walls

Kitchen is a converted garage. There are high moisture readings on wall. This is common due to type of construction.

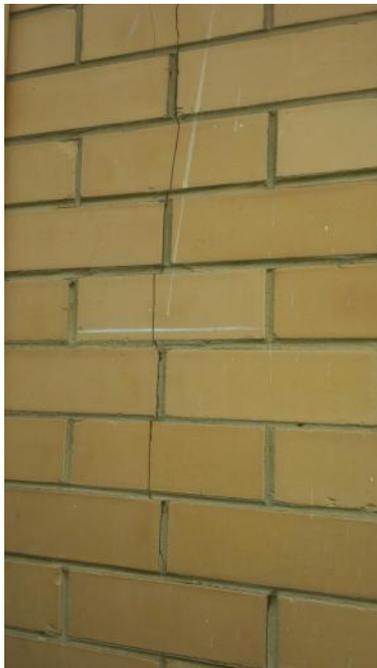
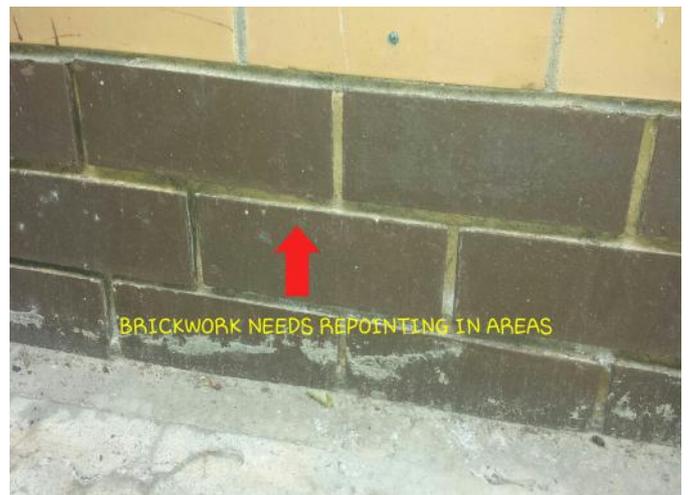
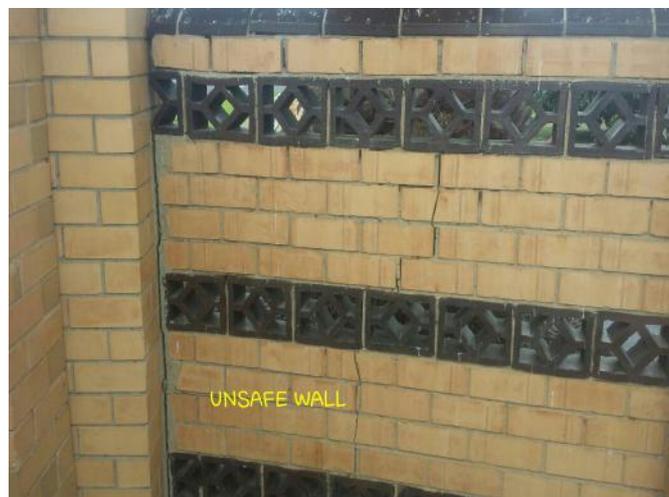
On visual inspection, the general condition of the exterior walls is serviceable for the age. Cracks noted. Possible causes may be foundation movement. Support structure deflection. Thermal movement and moisture uptake or loss, failure under external loads. These are not a concern. Cracks need to be sealed with silastic and monitored over the next 12 to 24 months. If cracks appear to be worse a structural engineer should be consulted for further evaluation and advice.

Mortar erosion between the brickwork is eroded. Contact a licensed bricklayer for repairs.

Wall is a safety hazard and will need the attention of a qualified bricklayer

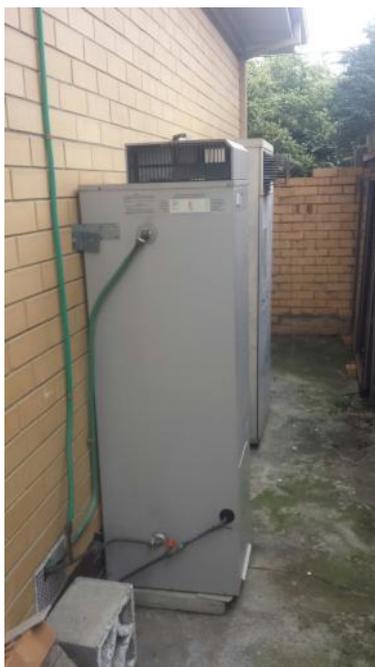
The hot water overflow requires diverting to a drain or further from the dwellings wall or footings. Excess water ponding alongside walls and into perimeter footings has the potential to cause rising damp, differential settlement and wall cracks over time. It is also conducive to termite infestation.

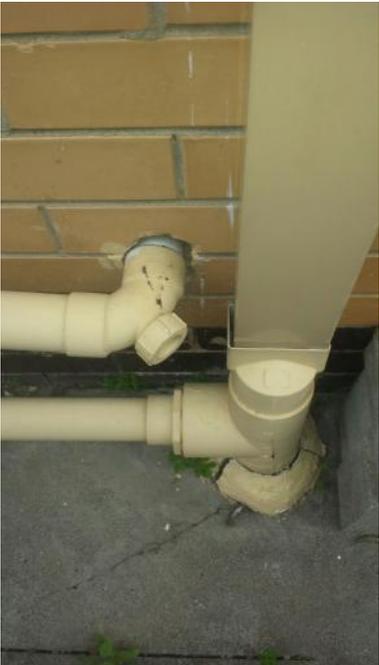
Penetration openings- as per the guide to standards & tolerances 2007 - Clause 7.08 - Pipe penetrations through external walls and inside cupboards - Plumbing holes are defective if they are not properly grouted; or in the case of cabinet work, fitted through neat minimum size penetrations, or fitted with tight fitting cover plates or collars with penetrations kept to the smallest size practicable.

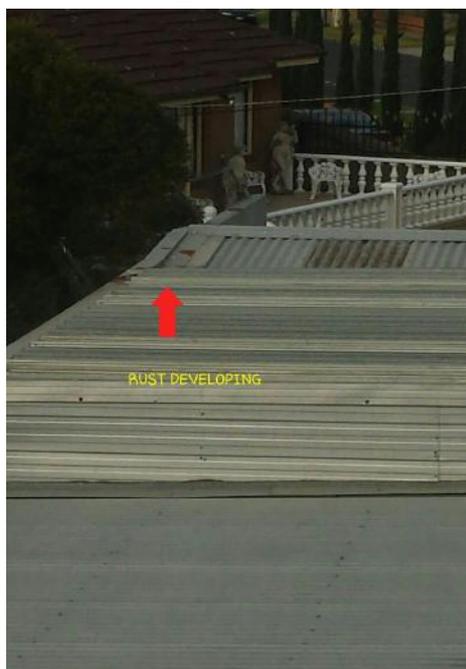
### Roof And Gutter

Rust on roof sheeting. Recommend treating with rust inhibitor.

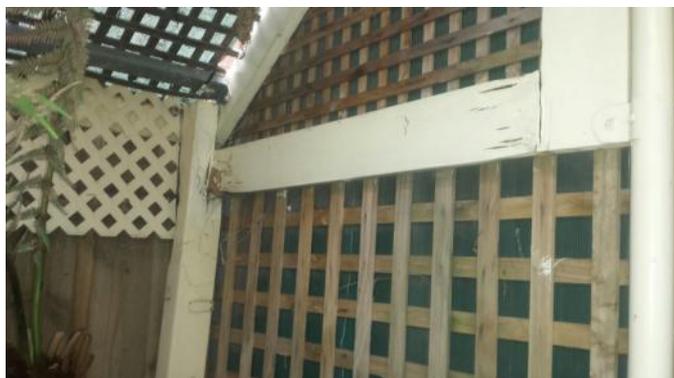
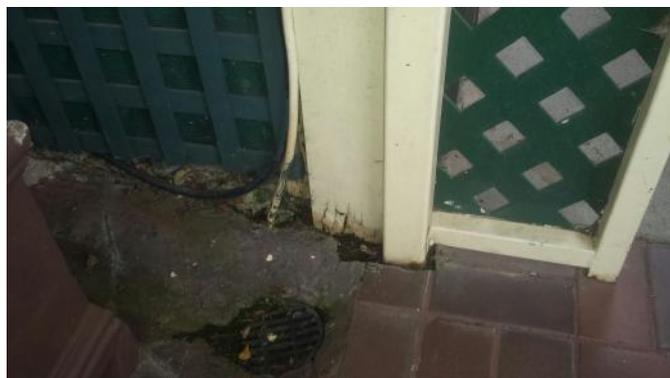
### Pergola Framework

Timber fungal decay in the framework is visible. Recommendations: A qualified tradesman needs to repair or replace affected areas.

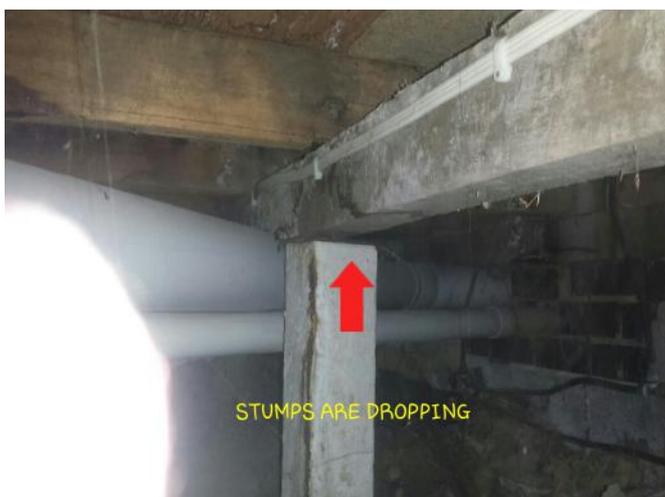
### Piers And Foundation Walls

Excessive or inadequate packing of stump footings between bearers and stumps - If the sub floor is kept dry this should not be too much of an issue, however packing is defective if it is compressible e.G. Timber packing. Recommendations: A qualified re-stumping contractor should be engaged for advice and recommendations.
