PADinspections

Report/Agreement #	11011611561
Inspection Date	11 Jan 2016
Inspection Time	11:30 am

Building Inspection

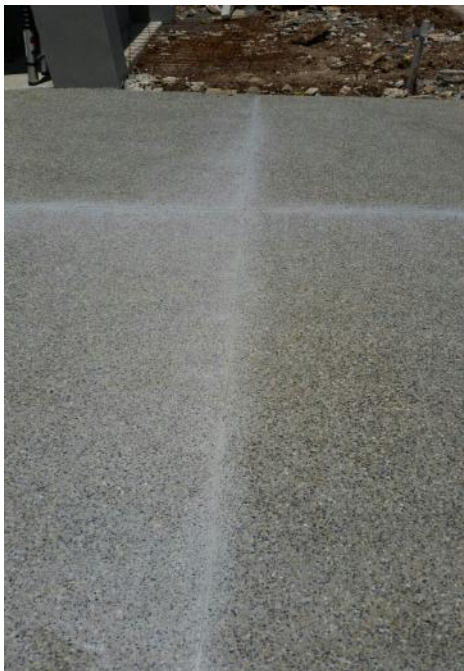
The expansion joints have not been cut parallel to anything. It is running off at an angle.

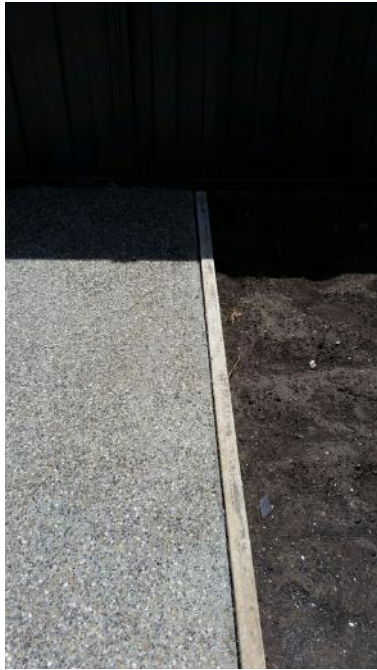
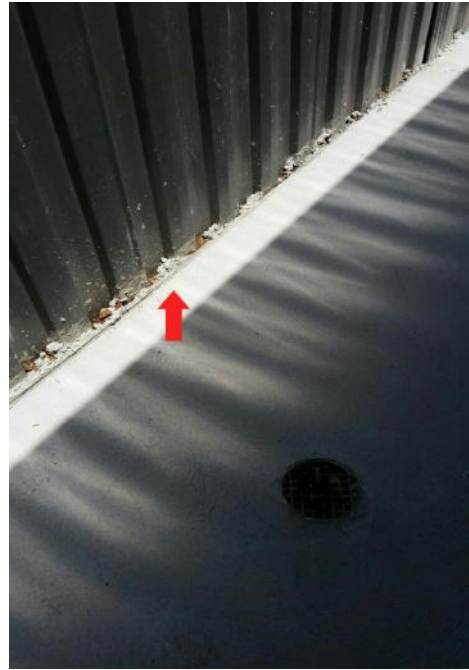
Expansion joints appear to have been cut free hand. A straight edge should have been used to keep everything looking neat.

Star pickets sticking out of the ground at meter box. These will need to be removed.

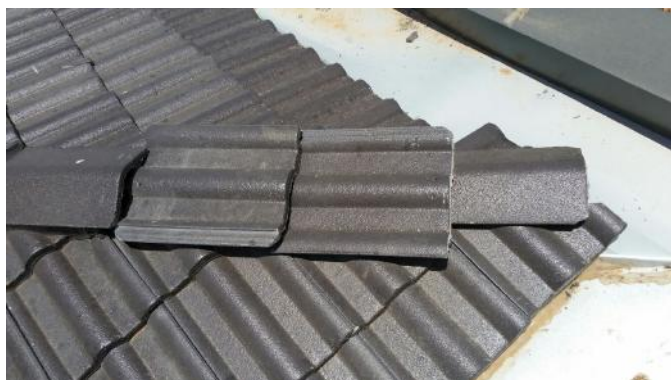
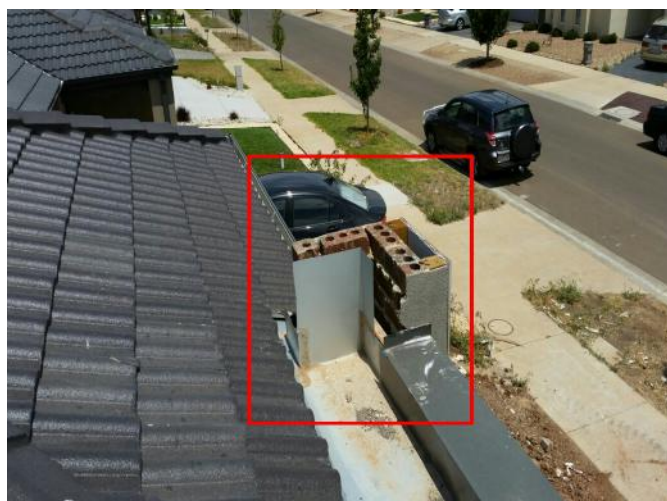
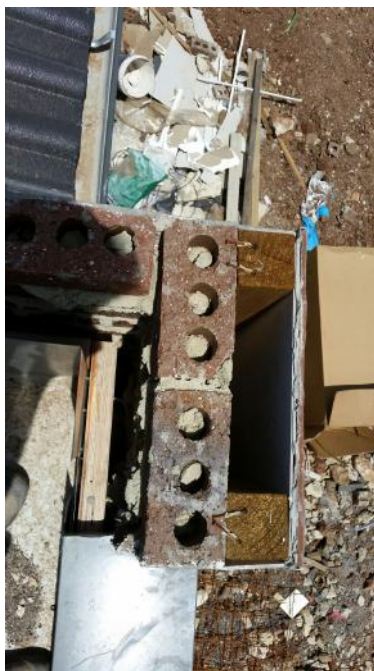
Cracked tiles visible - Recommendations: Contact a roof tiler for repairs. This has potential to become a serious issue if repairs aren't carried out due to water ingress into the roof cavity

Ridge capping missing. Contact a roof tiler for repairs. This has potential to become a serious issue if repairs aren't carried out immediately due to water ingress into the roof cavity

Cracked tile ends visible - Recommendations: A qualified roof tiling contractor should be engaged for advice and recommendations. Considered a minor defect but has the potential to become a Major defect if repairs aren't carried out immediately due to water ingress into the roof cavity

Unfinished capping/rendering above entry porch. This is a major concern as the house is open to the elements.

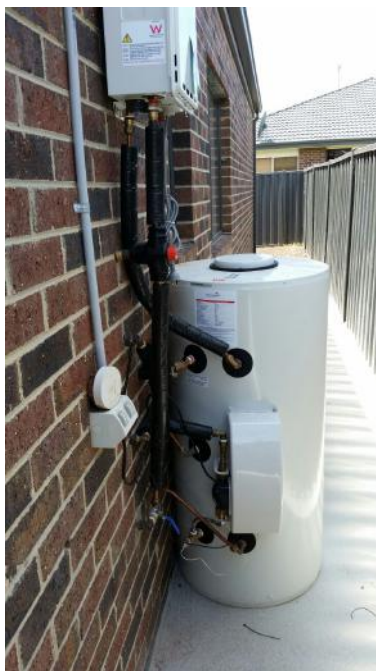
System has been installed but not functional at time of inspection.

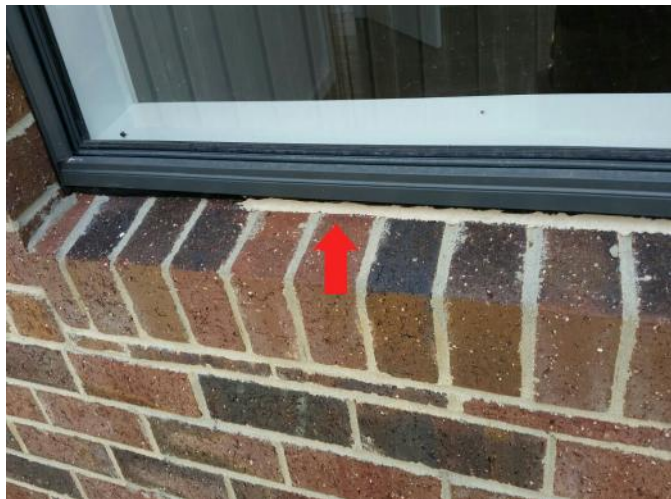
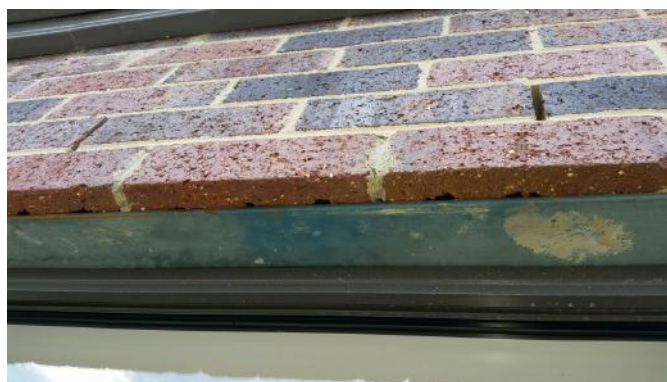
Silicone has been added to a window sill on the south side of the house. In order to keep things consistent black silicone should have been used and also have been across the whole window.

Recommend having silicone removed and reinstalled.

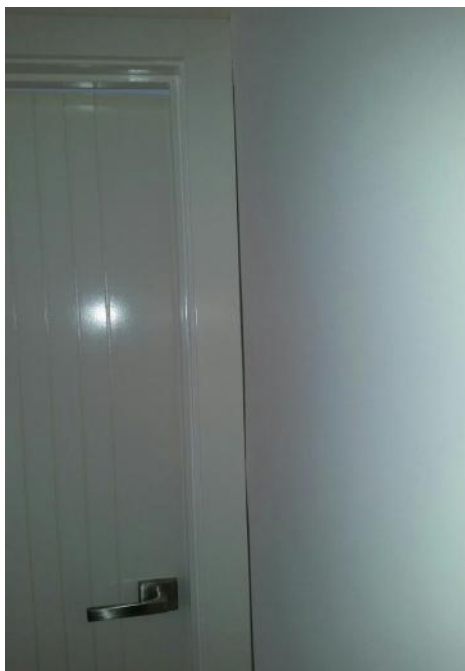
Gaps along door frames in rear hallway need to be sealed or trim added. They are out of plumb and look unfinished.

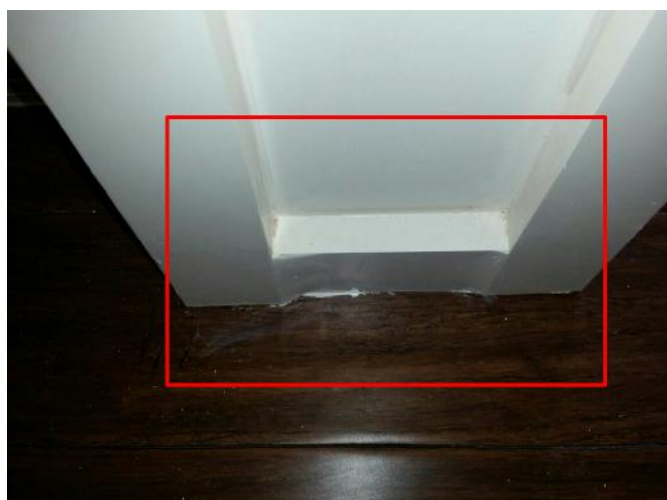
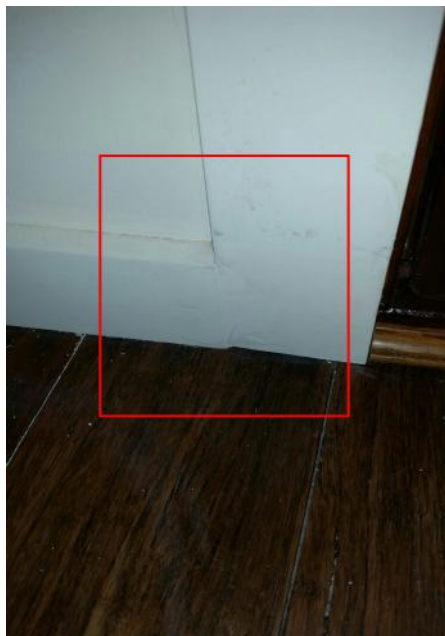
Excess architrave paint needs to be removed from wall at garage door.

Untradesman like finish on skirting boards.

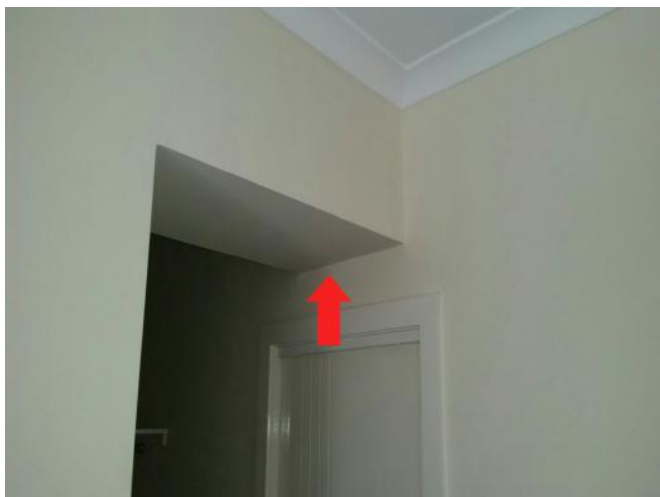
Impact damage noted. Contact a licensed plasterer for repairs.

Walk in wardrobe shelving is already showing signs of sagging these will need to be sufficiently supported. Shelving was installed poorly large gaps around notches.

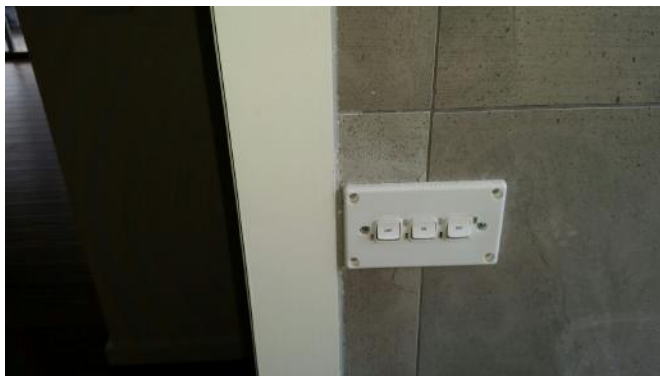
Paint needs to be removed from wall tiles.

It appears that light switch has been installed too close to door frame. This is why the cover has not been installed.

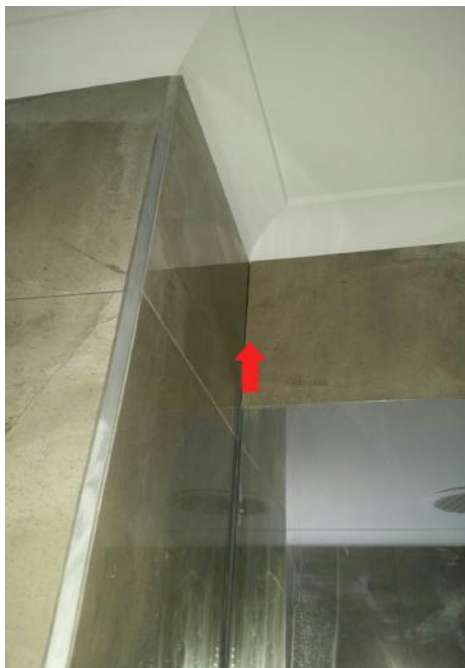
Silicone seal along door and wall tile junction is not consistent colour or neatly installed.

Unfinished grouting on wall junction.

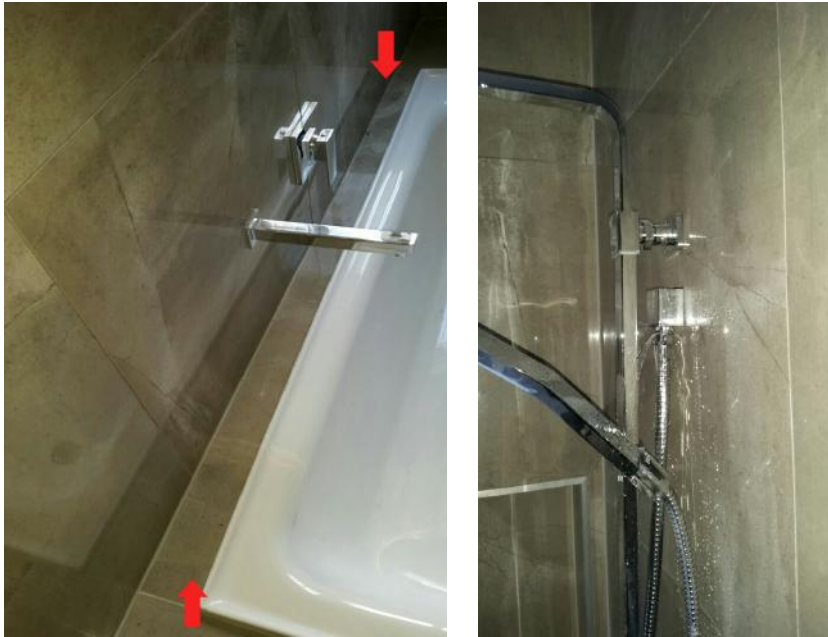
Shower head is leaking. A qualified plumber should be engaged for advice and recommendations.

The bath has been installed incorrectly. It is not parallel to the walls. There is over a 20 millimetre difference from one end to the other. The builder will need to rectify this.

Shower trap needs cleaning out.

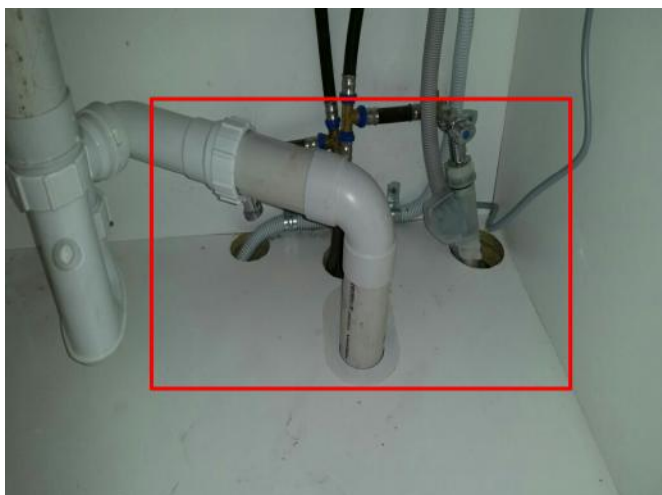
Penetration openings - As per the guide to standards & tolerances 2007 - Clause 7.08 - Pipe penetrations through external walls and inside cupboards - Plumbing holes are defective if they are not properly grouted; or in the case of cabinet work, fitted through neat minimum size penetrations, or fitted with tight fitting cover plates or collars with penetrations kept to the smallest size practicable. Recommendations: Engage a plumber to assess.

Bench top and splash back junction sealing deteriorated - Recommendations: Re-sealing by a plumber or general maintenance contractor is recommended to prevent water access behind the bench.

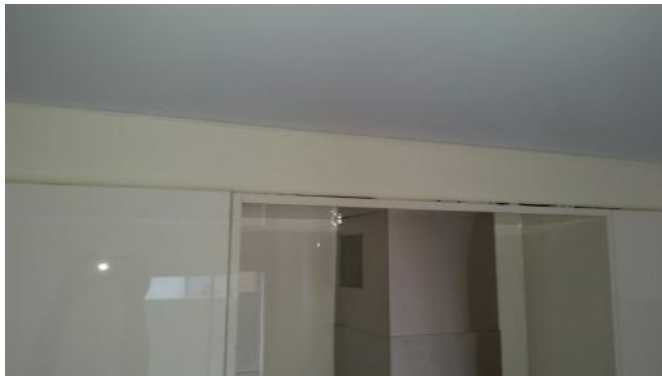
Pantry shelves are not sufficiently supported. They are already showing signs of sagging.

Kick boards have not been installed.

Gap between cupboard and bulk head need to be sealed and painted.
