Inspection Report

PADinspections Pty Ltd

Inspection Address
Albert Park, Victoria, 3206

Pest And Building Inspection

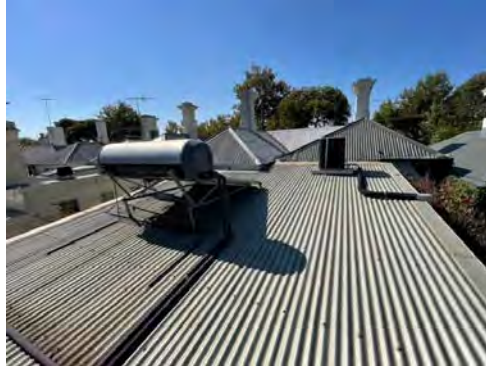
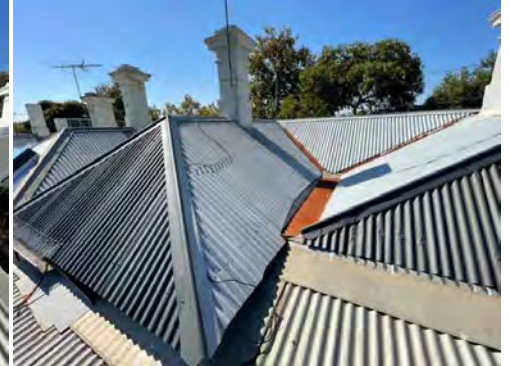
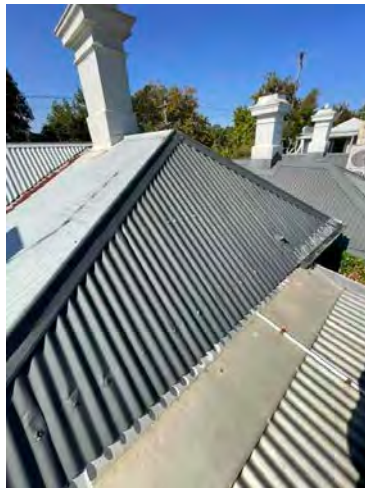
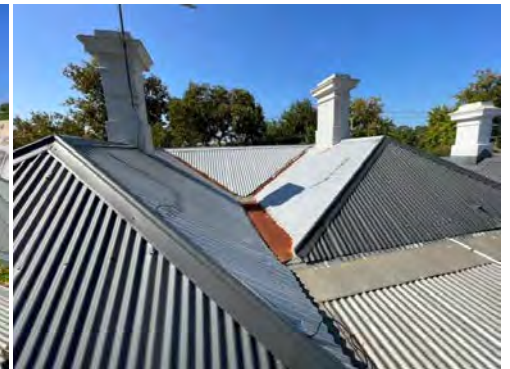
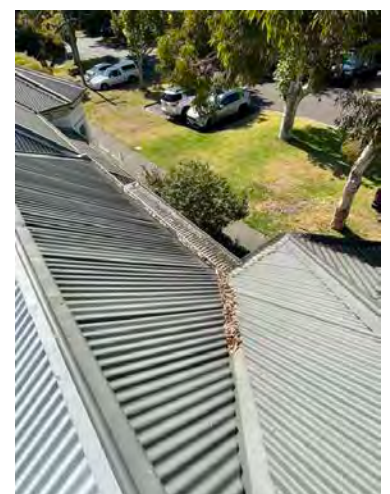
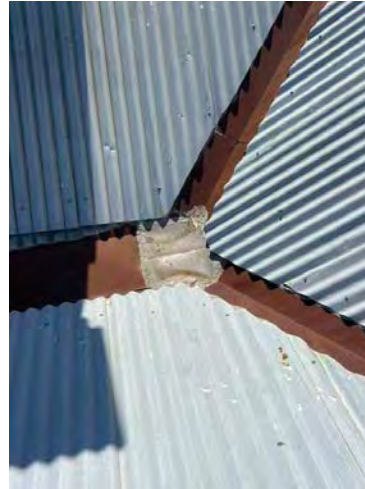
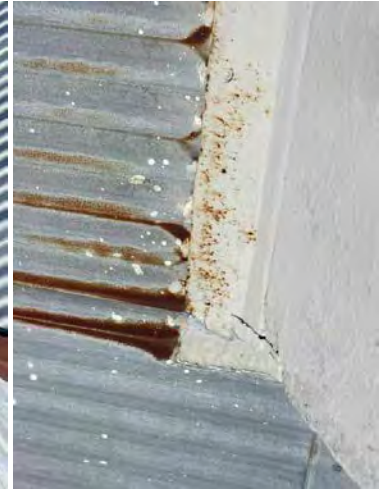
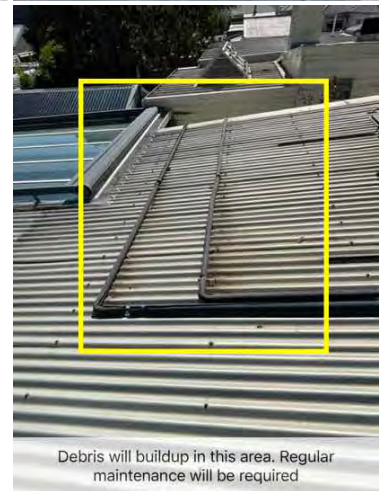
Roof Clad Condition

Metal roof is rusting and requires repairs or replacement as they may lead to water ingress into the roof cavity. Sections have been painted but it appears that these are the areas visible from the ground. The flashings around the chimney's will need replacing. Contact a qualified roofing contractor for immediate repairs.

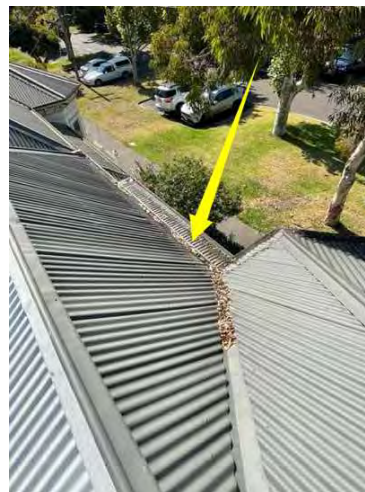
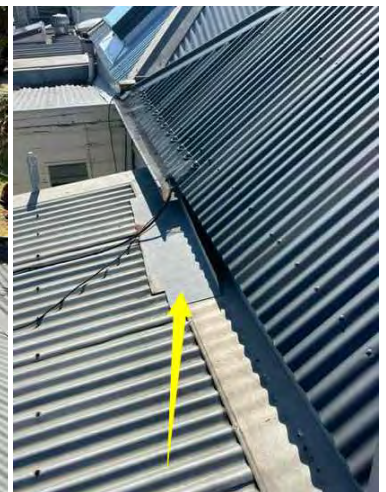
Gutter Findings

Debris in guttering areas- this requires cleaning out to prevent blocking of downpipes and leaking into eaves and fascia. Have gutters cleaned and assessed by a plumber for adequate fall. Regularly clean to prevent ponding. Ponding water will contribute to rust. The gutter flashing at the back of the house is poorly fixed. A qualified roof plumber should be engaged for repairs and recommendations for more permanent solution.

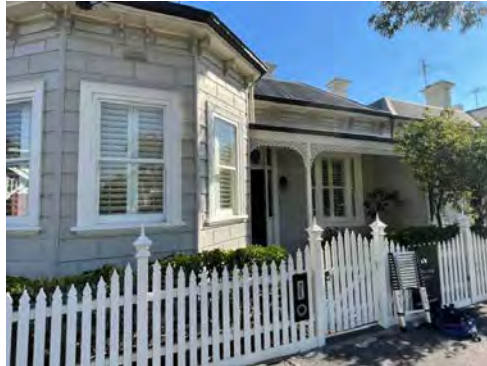
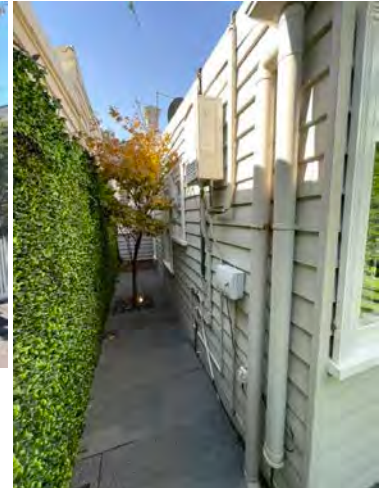
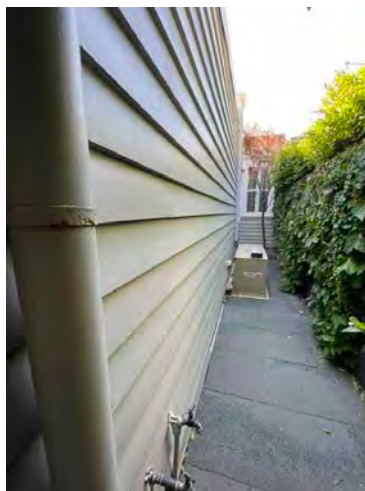
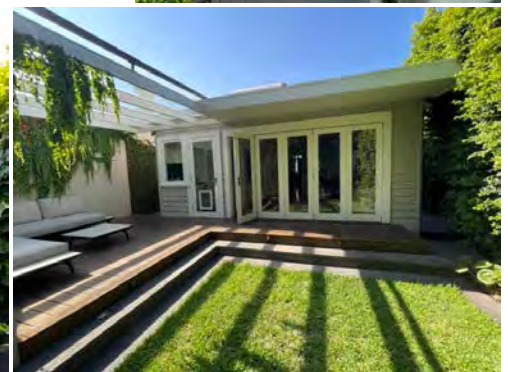
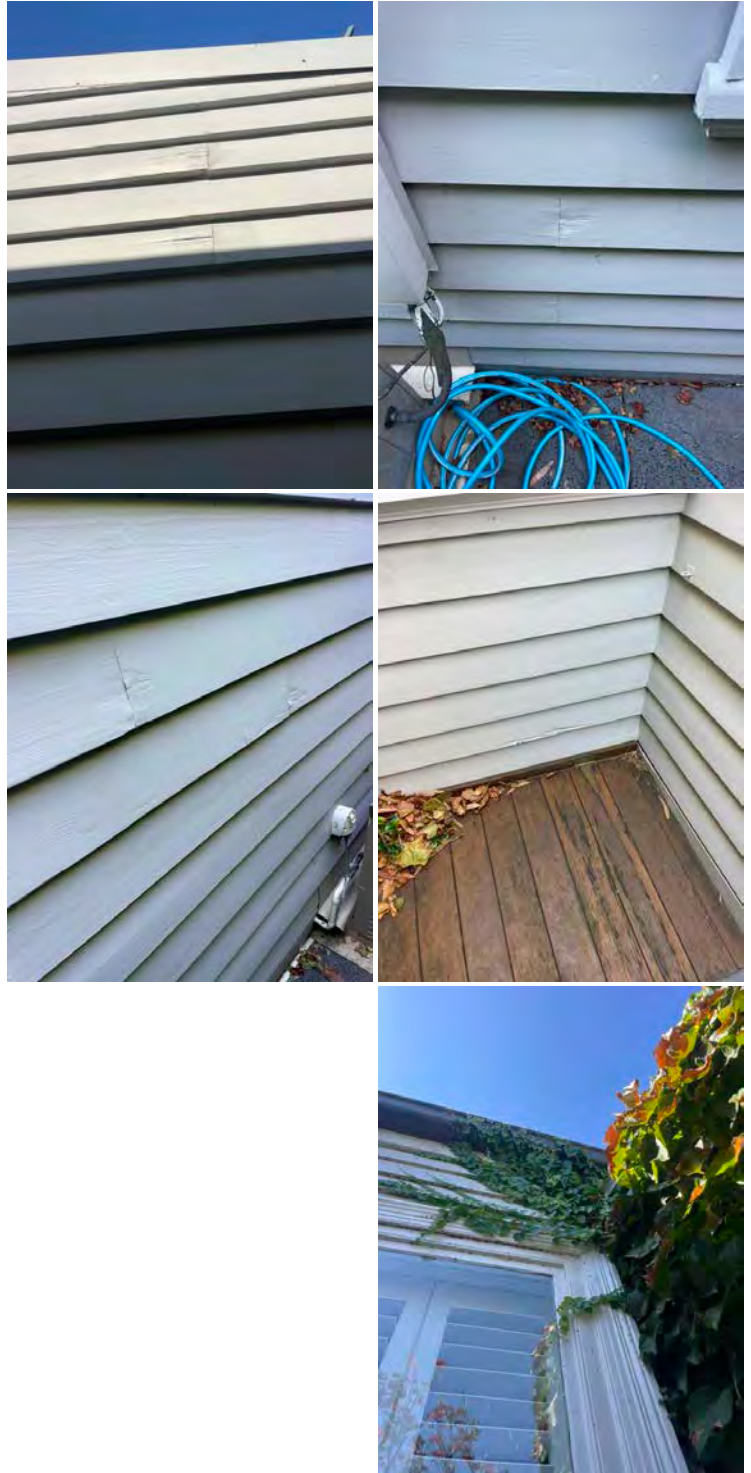
Condition

Minor decay was noted to the external wall lining. We recommend replacement of all affected timbers. The vines will contribute to the decay. Regular maintenance will be required with this weatherboard home as there is overshadowing on both sides of the house.

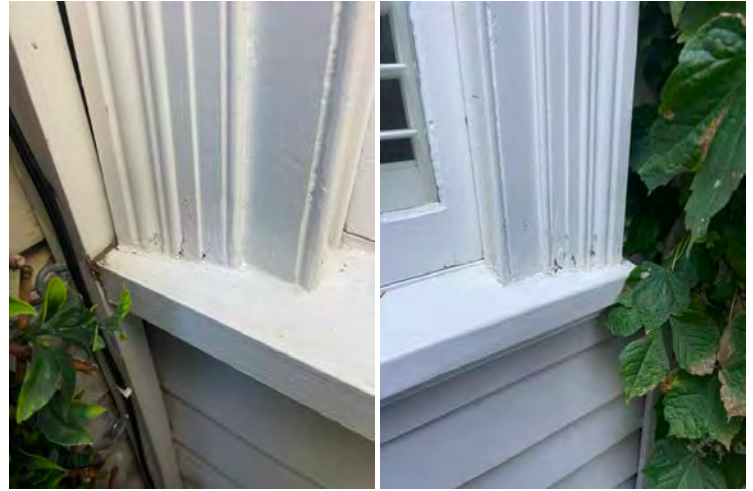
Sections of the external windows have paint deterioration. Engage a qualified painter for repairs.

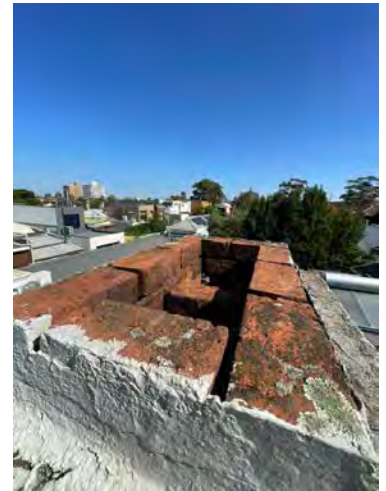
Condition

Upon visual inspection, the chimney lacks a cowl, which can lead to water ingress and blockages. It is recommended to install a chimney cowl to prevent debris and rain from entering, ensuring proper ventilation and reducing potential damage. A suitably licensed or qualified tradesperson should be engaged to perform the installation to ensure compliance with safety standards and optimal functionality.

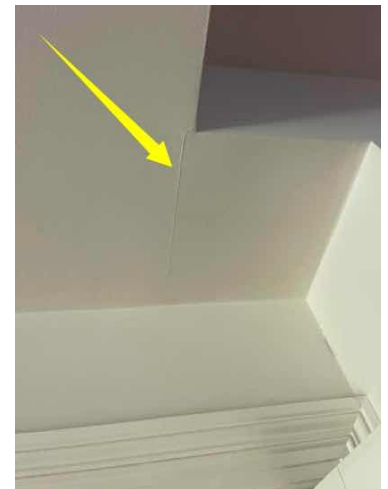
Ceiling

Settlement Cracks Noted. These are typical and generally patch and paint will suffice, however monitoring these cracks is advised for 12 months and if they become worse, further investigation by a suitably qualified professional is advised.

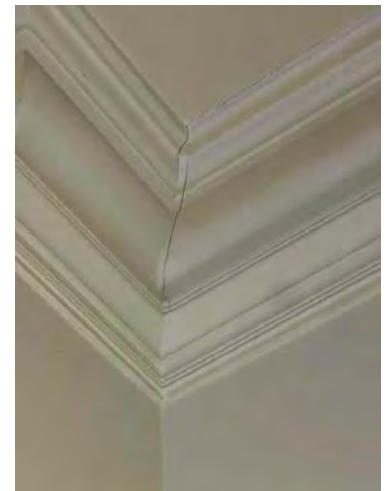
Ceiling

General ageing and/or denting and the like is evident on ceiling linings -
Recommendations: A qualified painter should be engaged to assess and repair as required.

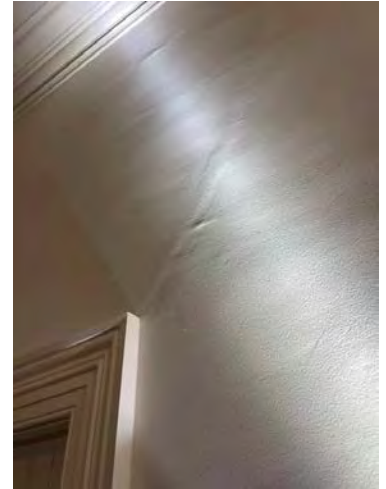
Walls

Patched wall cracks visible - Recommendations: I am unable to guarantee that these patched areas will not re-open in the future. If further opening occurs the affected areas may require re-assessment by a suitably qualified plasterer.

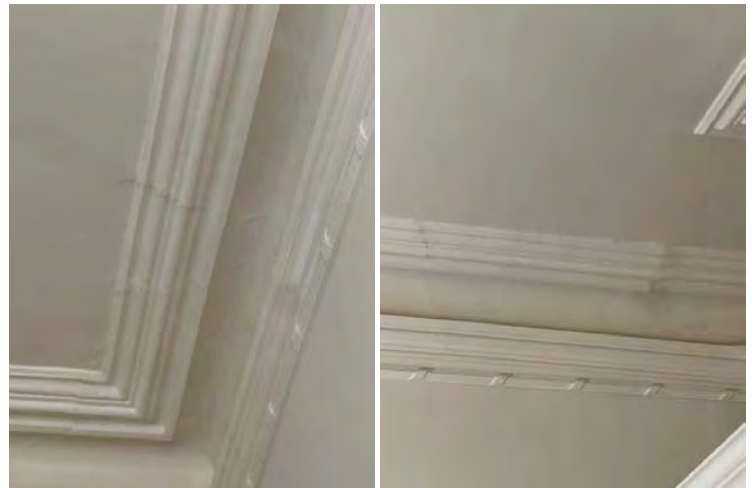
Ceiling

General ageing and/or denting and the like is evident on ceiling linings - Recommendations: A qualified painter should be engaged to assess and repair as required.

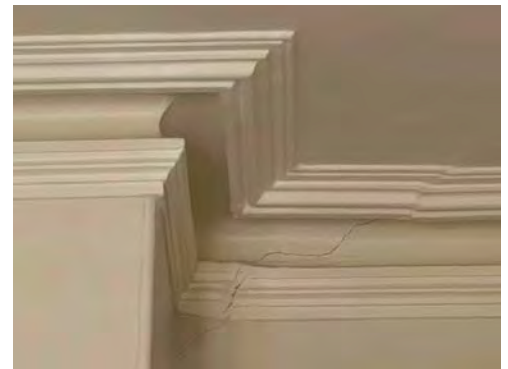
Ceiling

General ageing and/or denting and the like is evident on ceiling linings -
Recommendations: A qualified painter should be engaged to assess and repair as required.

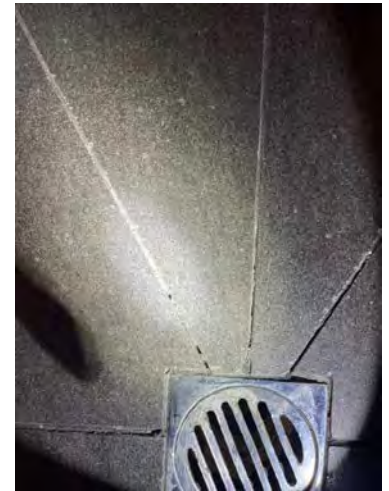
Shower And Bath

Tile grout deterioration to tiles to the shower area. Re-grout / seal. A qualified tiler should be engaged recommendations and repairs as water may seep in causing rot and creating conducive conditions termites.

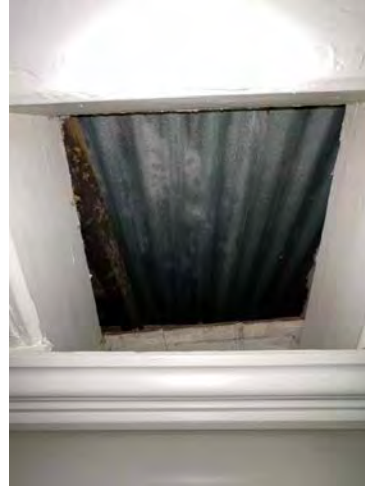
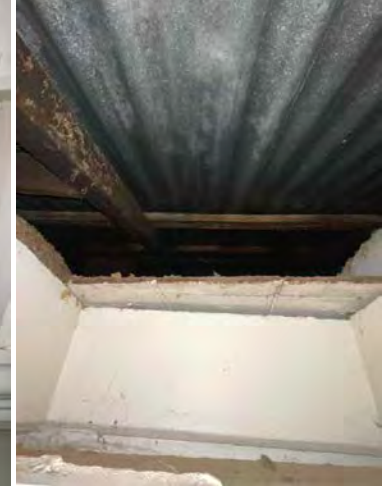
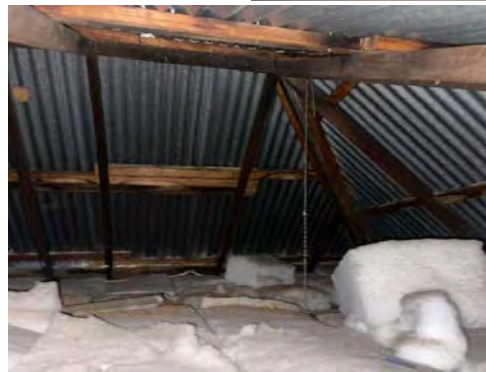
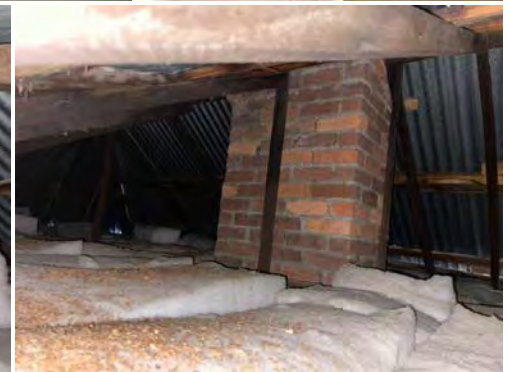
Restricted Areas

The manhole was too small to allow full body access. The roof void was not entered. We recommend installing a 500 x 500 mm manhole at a minimum to allow further investigation of the roof void as defects may still exist

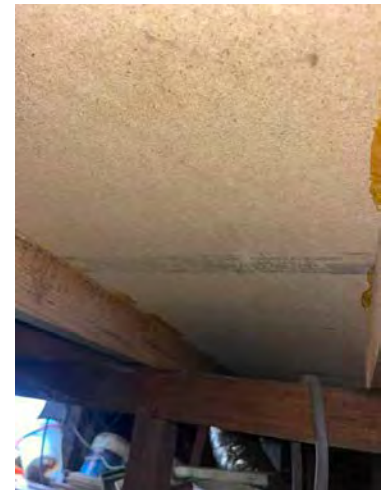
Joists

Some of the joists appear to have been replaced as a result of a timber pest attack.

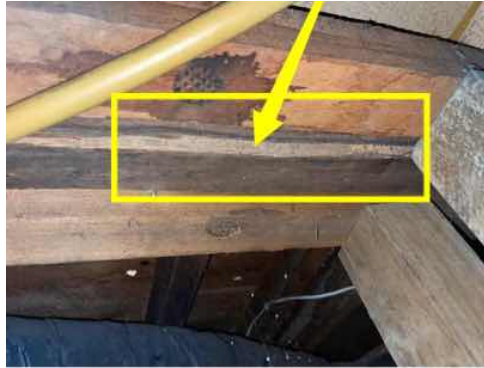
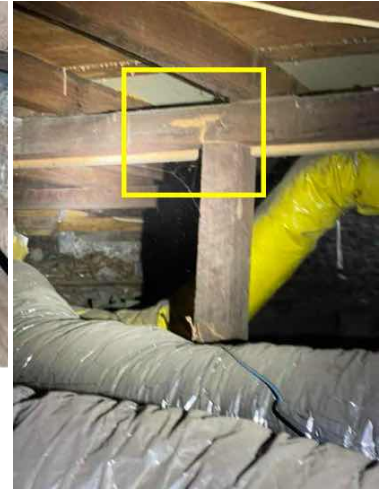
Bearers

Timber pest attack noted. The affected areas have been reinforced with additional bearers/joists. See a licensed pest technician and a licensed carpenter for further evaluation and advice. Please refer to the attached visual timber pest inspection report.

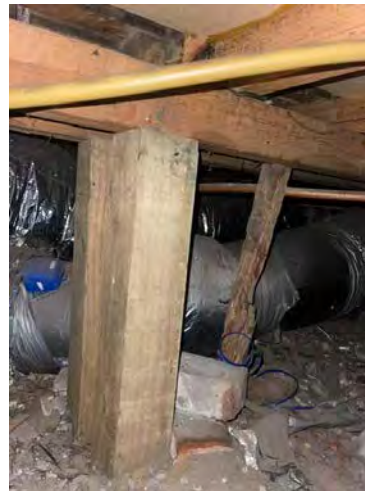
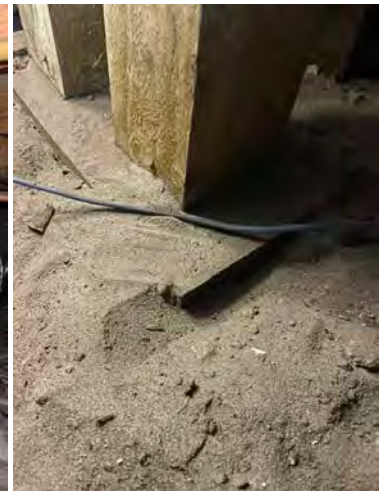
Piers And Foundation Walls

There are a number of timber posts used as floor supports/stumps in the subfloor and are only sitting on a timber pad as a base. These should be replaced with permanent concrete stumps or steel supports as there are conducive to termite entry and decay.

Without a concrete base, timber stumps can sink or move, leading to uneven floors, cracked walls, and other structural problems.

A qualified re-stumping contractor should be engaged for advice and recommendations.

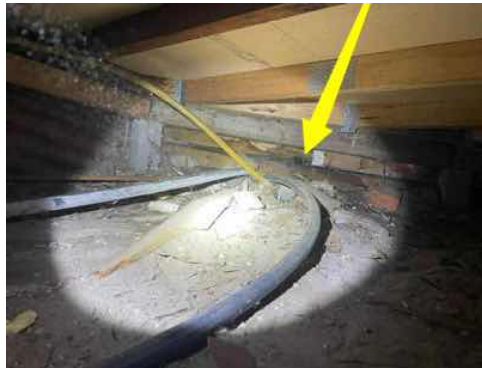
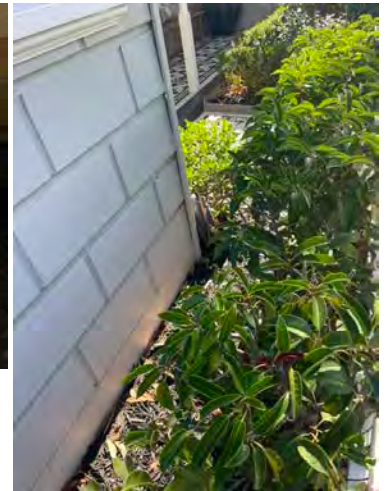
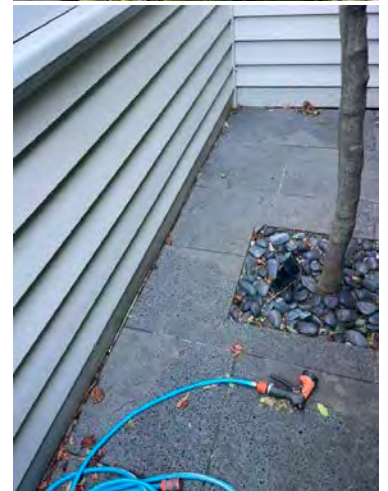
Dampness

The underside of the residence is lower than the external ground level. This situation may cause external stormwater runoff to enter the sub floor area. The sub floor area should be monitored in times of heavy rainfall. Additional site drainage may be required.

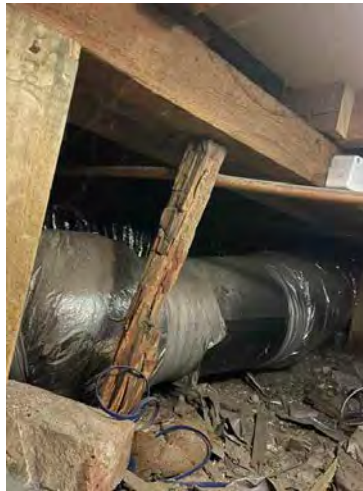
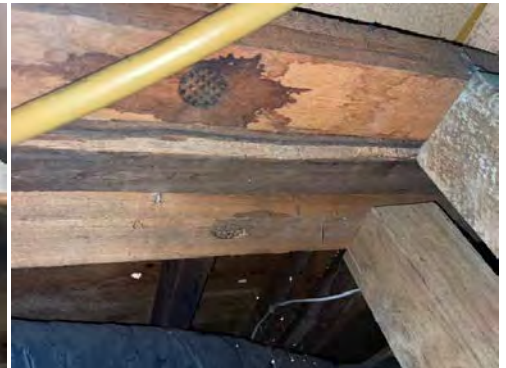
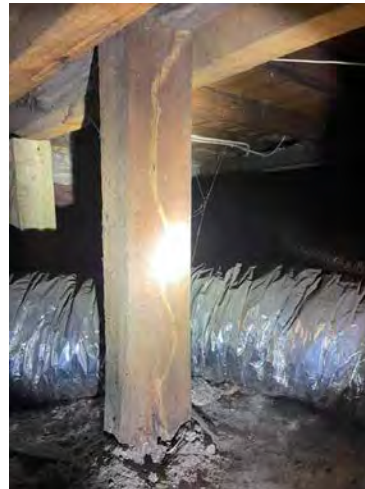
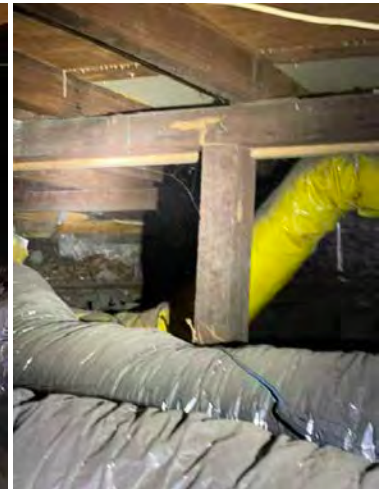
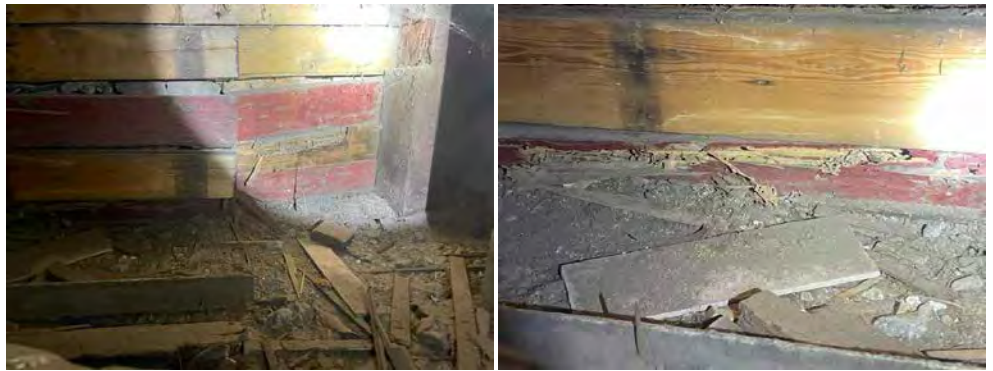
Yes, termite damage was located mainly but not limited to the following.

Where evidence of termite activity was found in the grounds then the risk to buildings is extremely high. A treatment to eradicate the termites and to protect the building(s) should be carried out in the first instance.

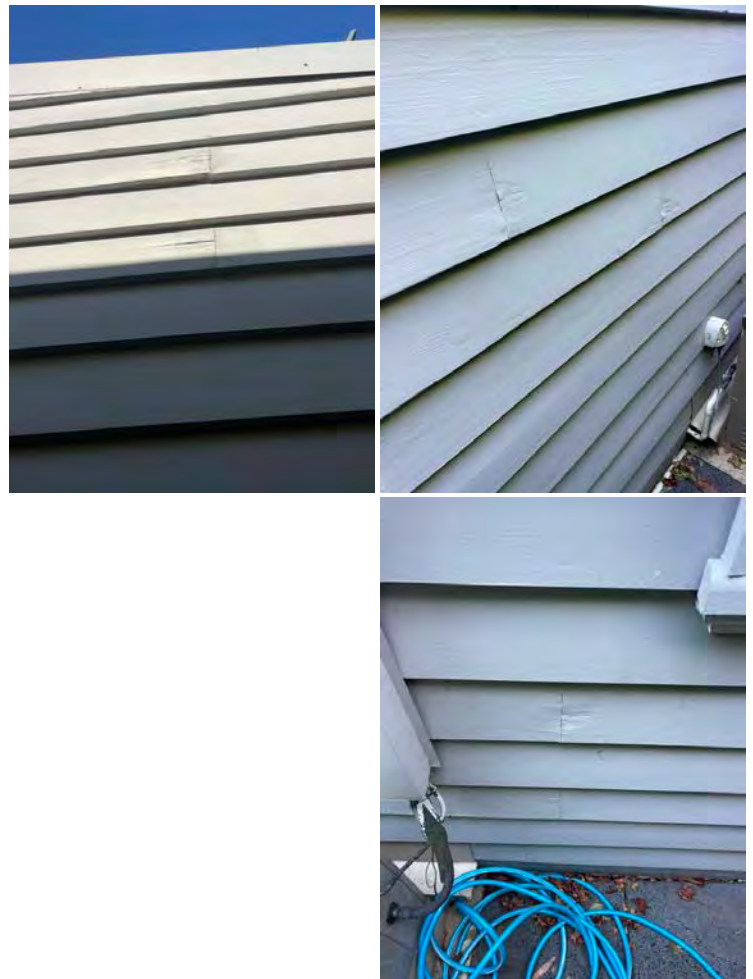
Yes, in the following areas ,
Exterior wall cladding.

The extent of rot damage is considered to be moderate.
