Inspection Report

PADinspections Pty Ltd

Thornbury, Victoria, 3071

TIMBER PEST INSPECTION

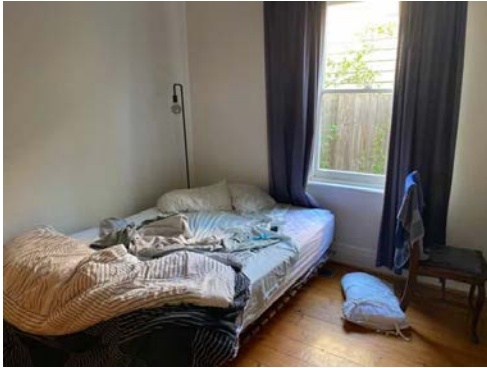
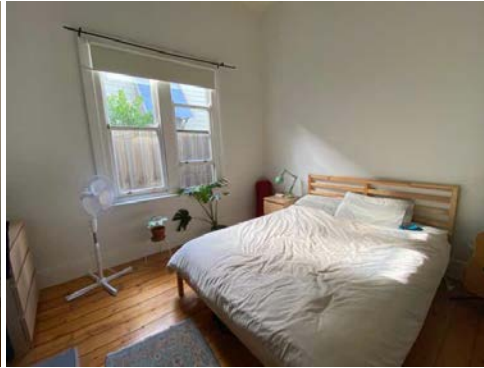
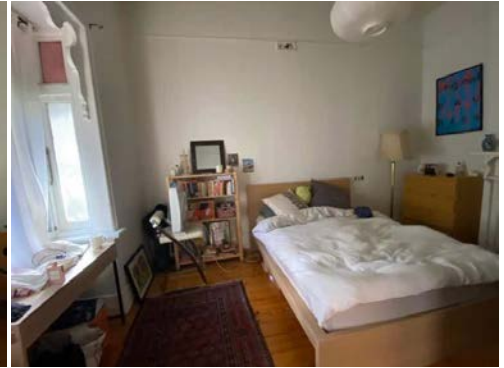
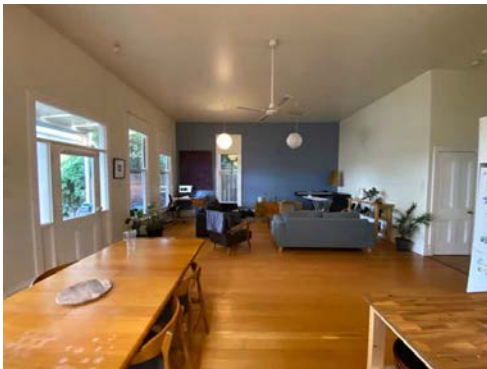
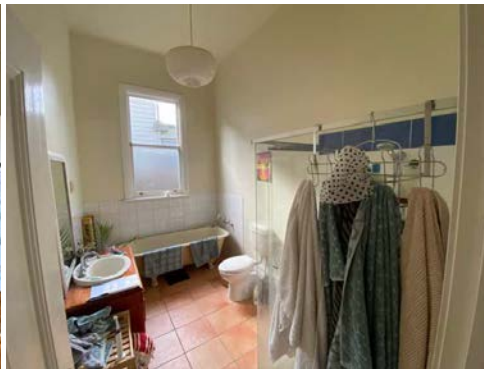
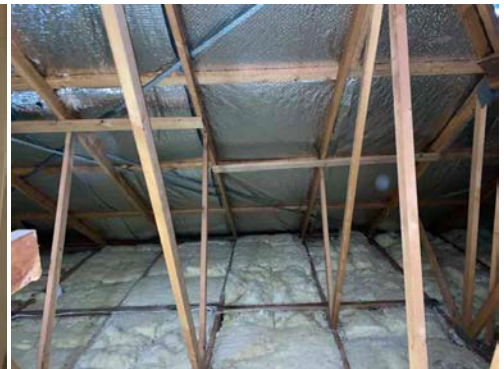
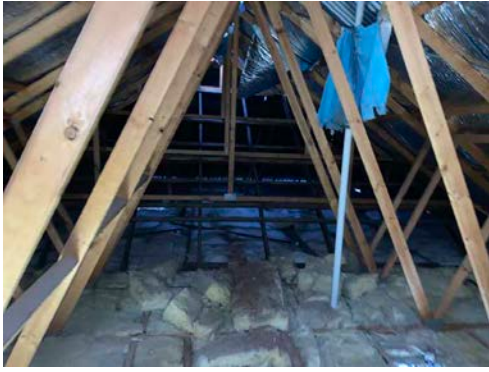
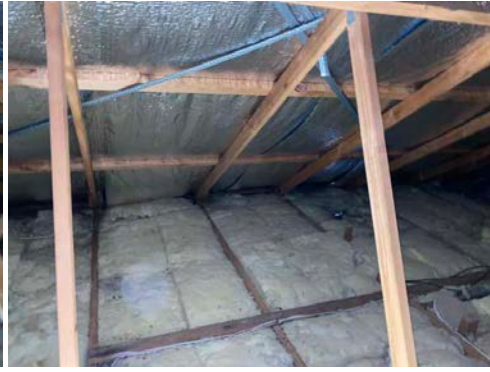
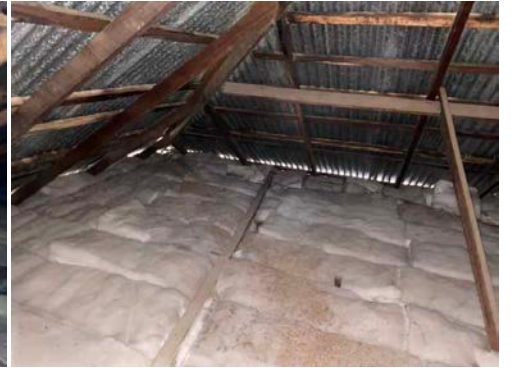
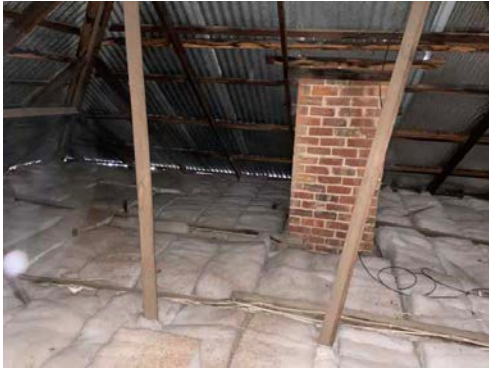
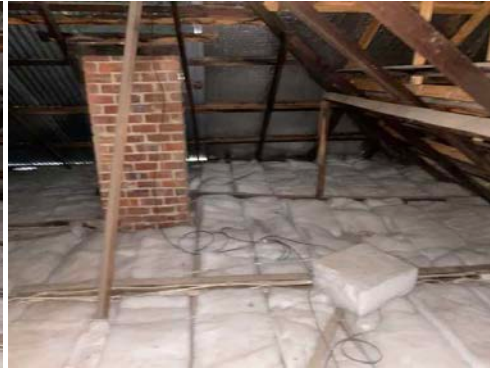
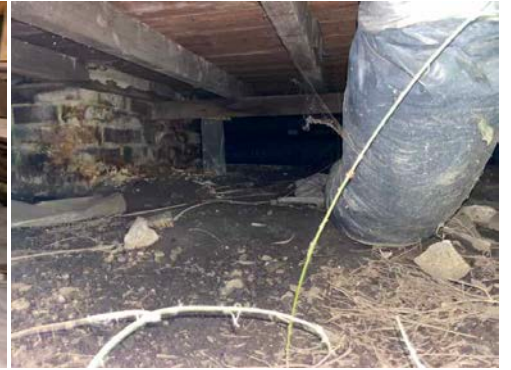
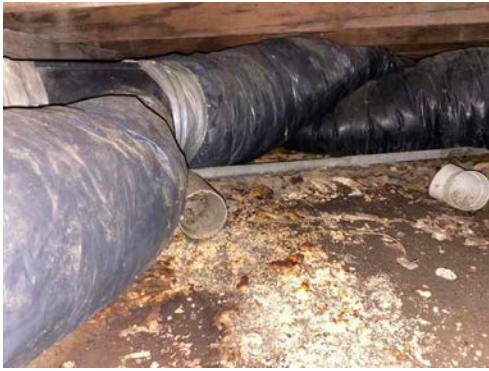
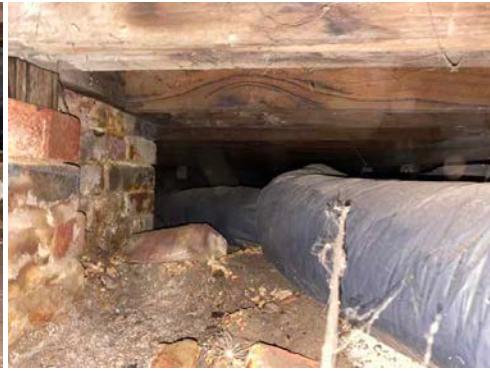
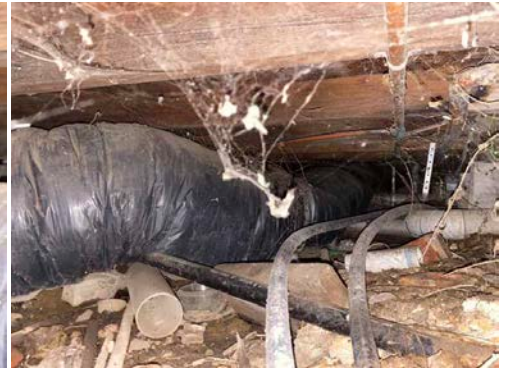
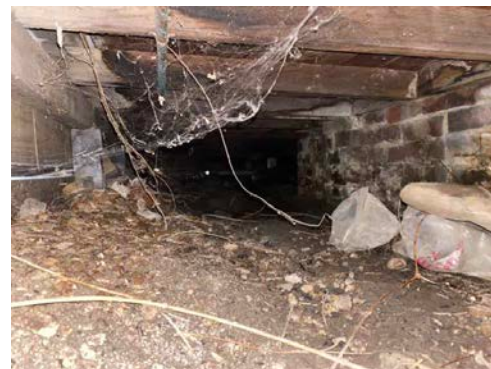
Where present carpet conceals damage to the underside, owners possessions, items in cupboards & furniture present throughout the building which is preventing a thorough inspection from being undertaken. You should be aware that furnishings and/or owners possessions may be concealing evidence of timber pests and defects, which may only be revealed when items are removed or moved. It is strongly recommended that full access be gained as it could be harbouring timber pest activity, pest damage or defects.

There is insulation, present in the roof space/void. This is preventing a full inspection from being undertaken. It is strongly recommended that full access be gained as it could be harbouring timber pest activity and/or damage. There is duct work present throughout the subfloor which is preventing a full/thorough visual inspection taking place. It is strongly recommended that full access be granted to enable a thorough inspection to take place as it could be harbouring timber pest activity and/or damage.

There is low clearance in areas present throughout the subfloor which is preventing a full/thorough visual inspection taking place. It is strongly recommended that full access be granted to enable a thorough inspection to take place as it could be harbouring timber pest activity and/or damage.

Please note since a complete inspection of the above areas was not possible, timber pest activity and/or damage may exist in these areas.

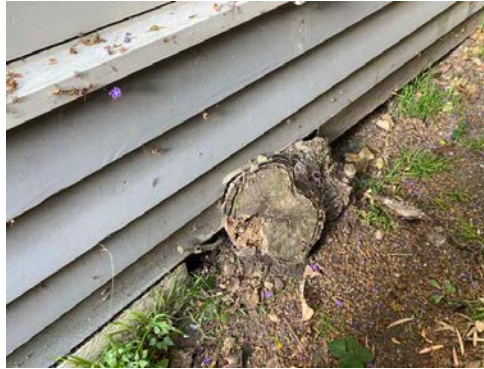
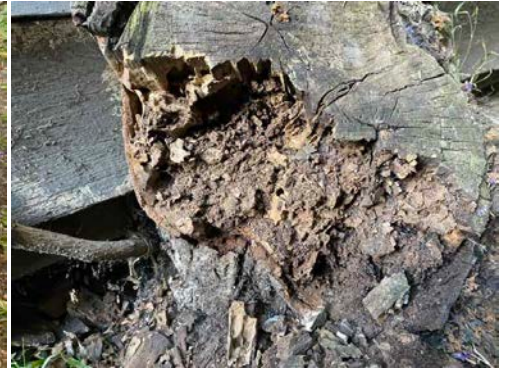
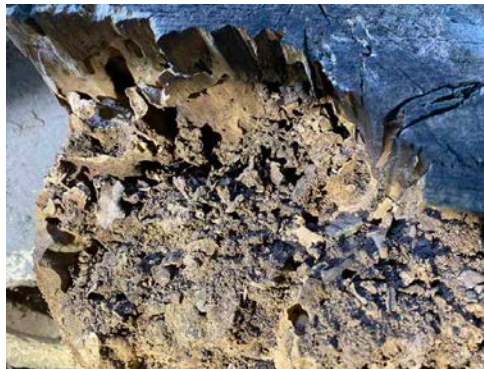
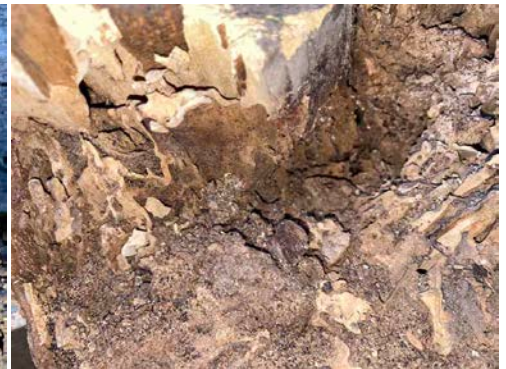
Were Active or Live Termites Visible

Yes there were visible termites found at the time of the inspection.

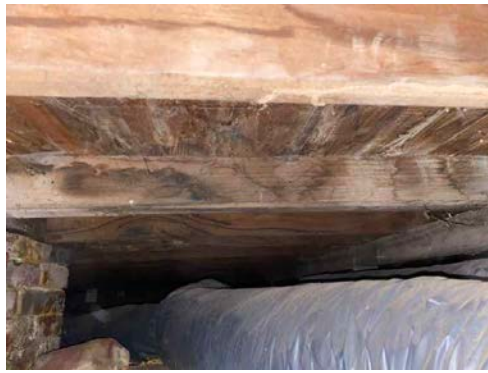
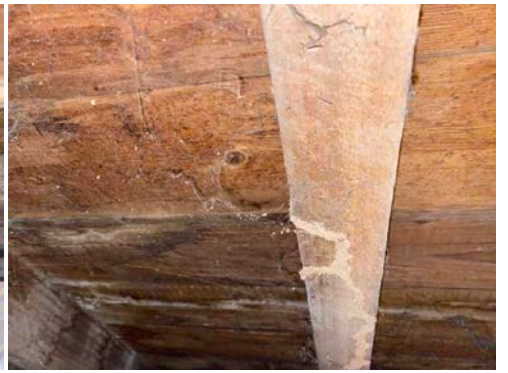
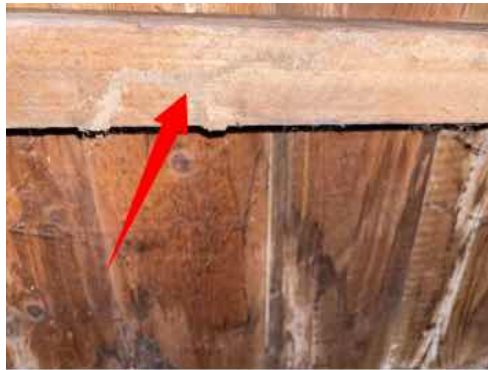
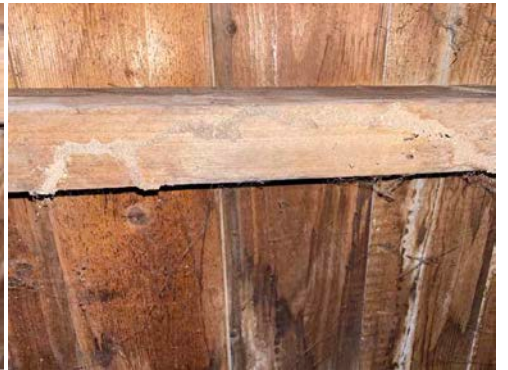
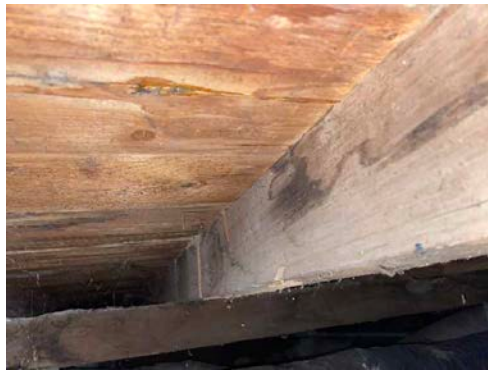
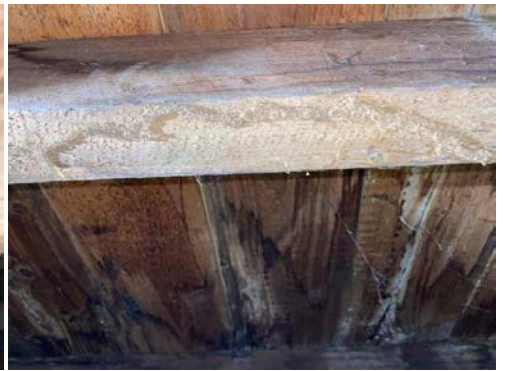
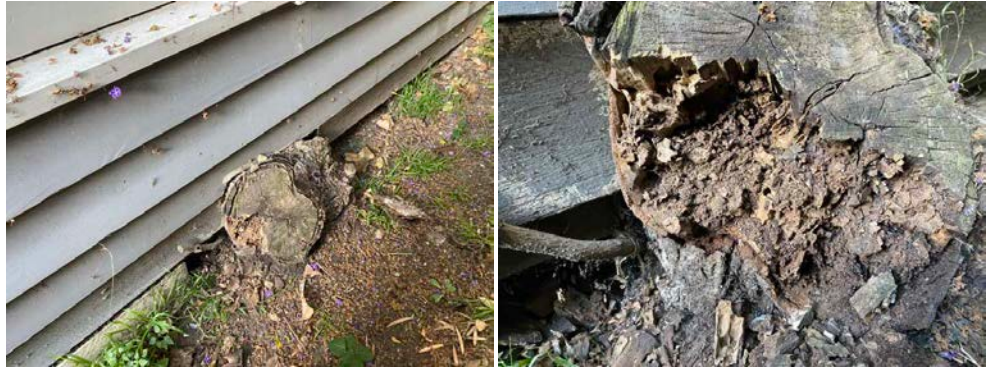
3.2 Subterranean Termite Damage or workings

Any workings or damage found

Yes, termite damage was found in the following
 Sub floor timbers
 Tree stumps

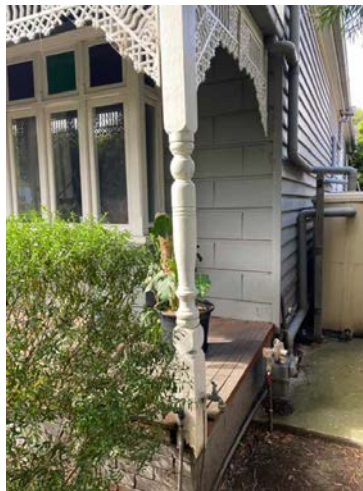
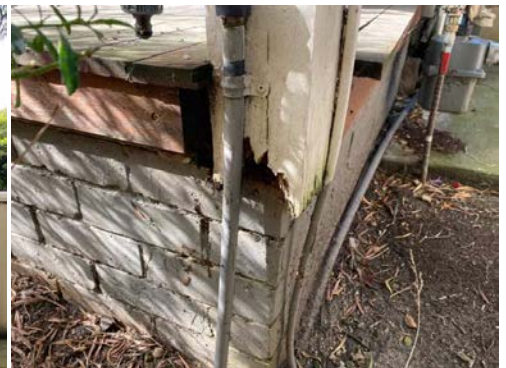
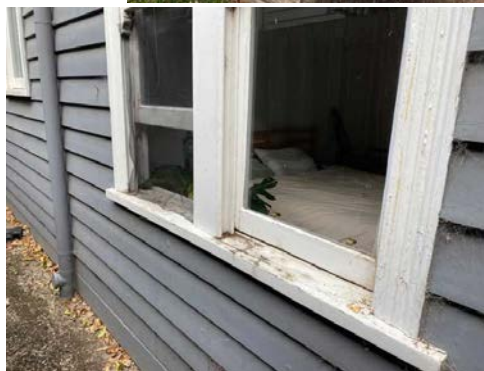
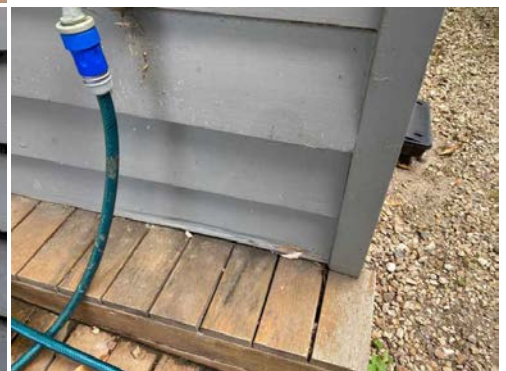
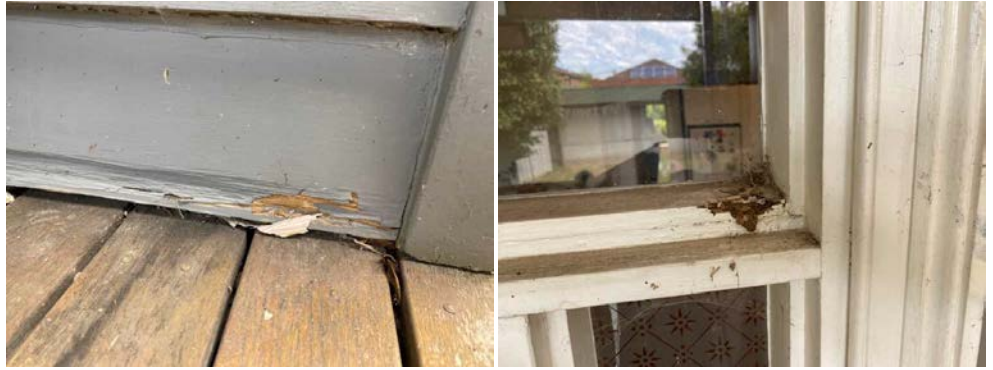
3.5 Timber Fungal Decay - Rot

Evidence of Wood Decay Fungi -Rot

Yes, in the following areas ,
Entry porch,
Window frame/s ,
Exterior Wall Clad
Door frames

Moderate Damage

If any evidence of fungal decay or damage is reported you should consult a building expert determine the full extent of damage and the estimated cost of repairs or timber replacement (see terms & limitations).

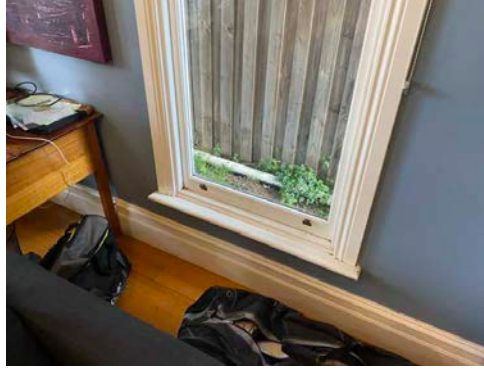
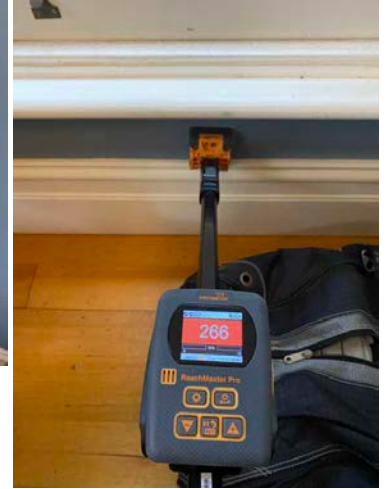
4.2 Moisture Readings

Was there any Excessive Moisture Readings

At the time of the inspection moisture readings were high

If high moisture was reported then you must have a building expert investigate the moisture and its cause and determine the full extent of damage and the estimated cost of repairs.

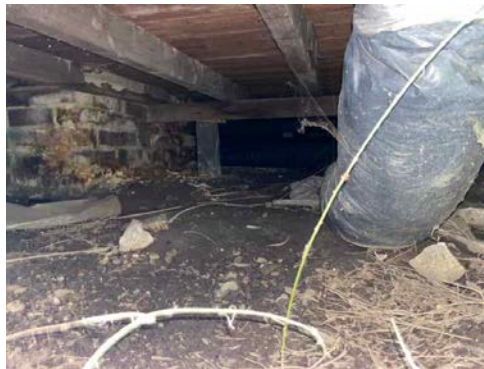
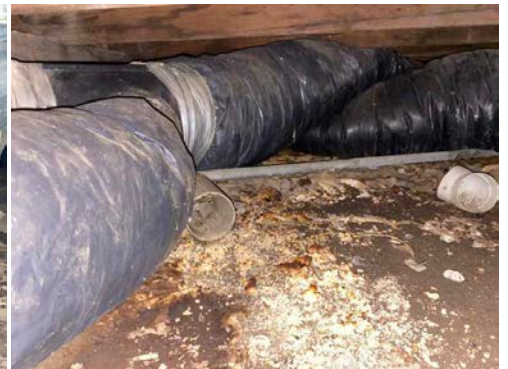
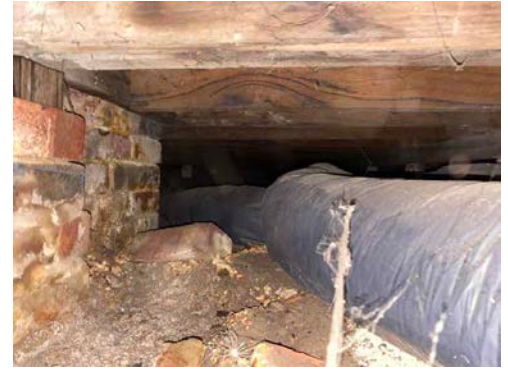
Sub Floor Ventilation is Generally

The ventilation isn't adequate in the subfloor. This needs to be improved by either clearing/exposing all air vents to enable sufficient airflow or potentially installing further vents in the external walls. This lack of good ventilation is a conducive condition for termites.
