**PADinspections**

**Inspection Address**

Report/Agreement # 18032214293223

### Building And Pest Inspection

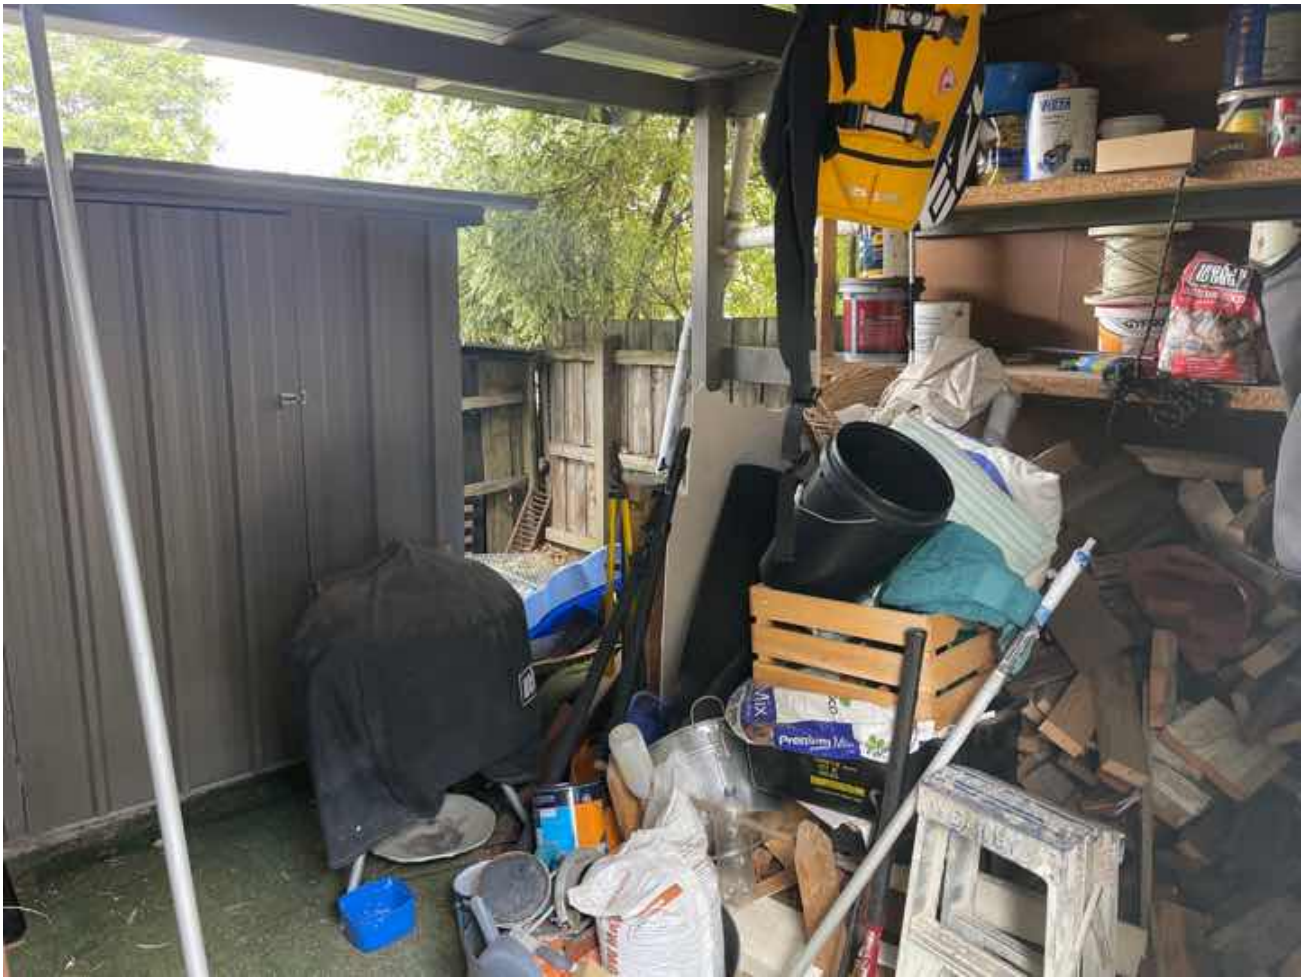
The shed is in fair usable condition.

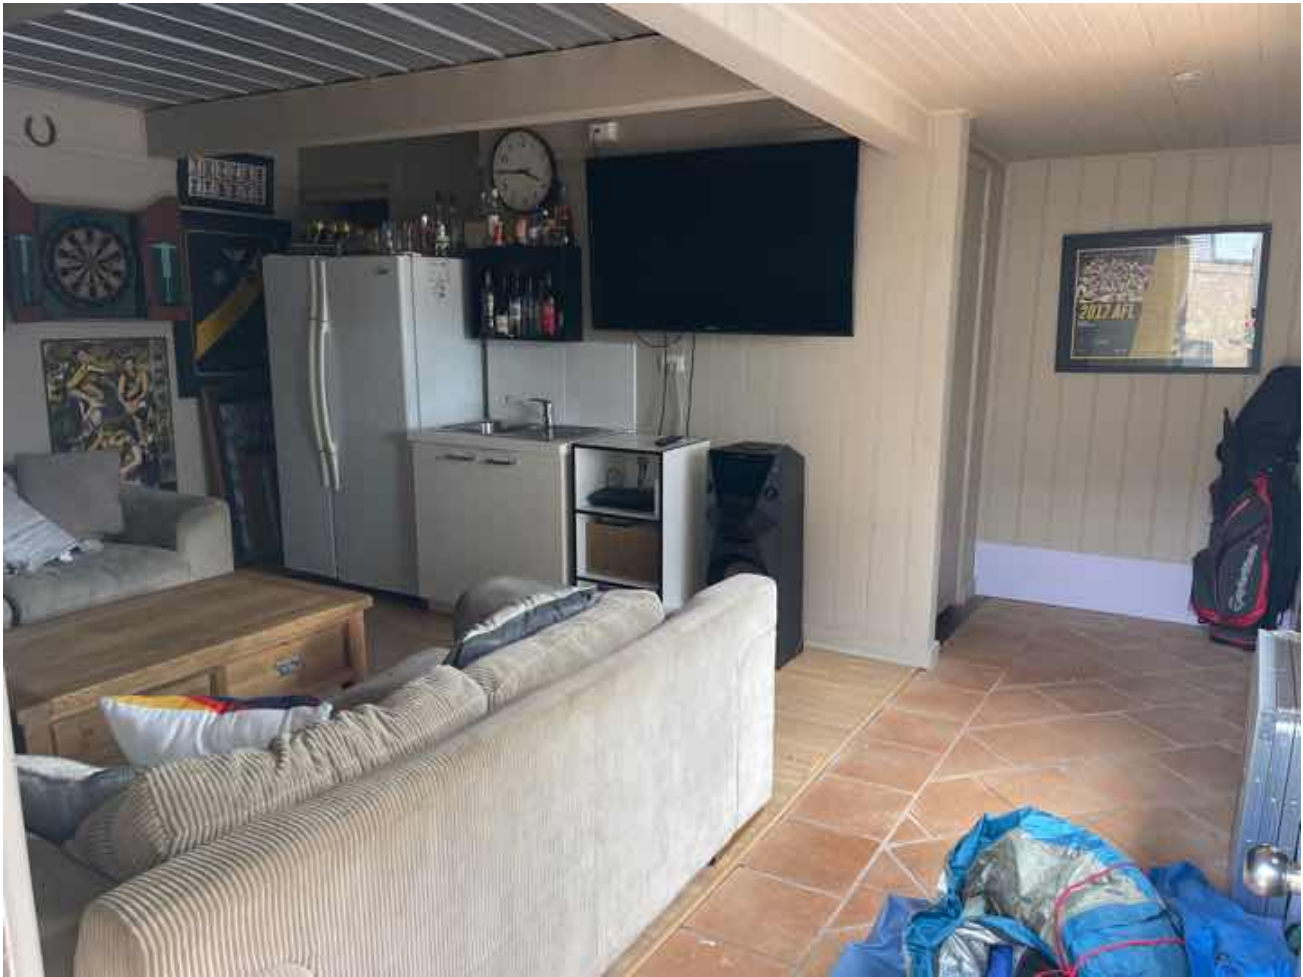
**Shed Condition(1)**

The shed is in fair usable condition.

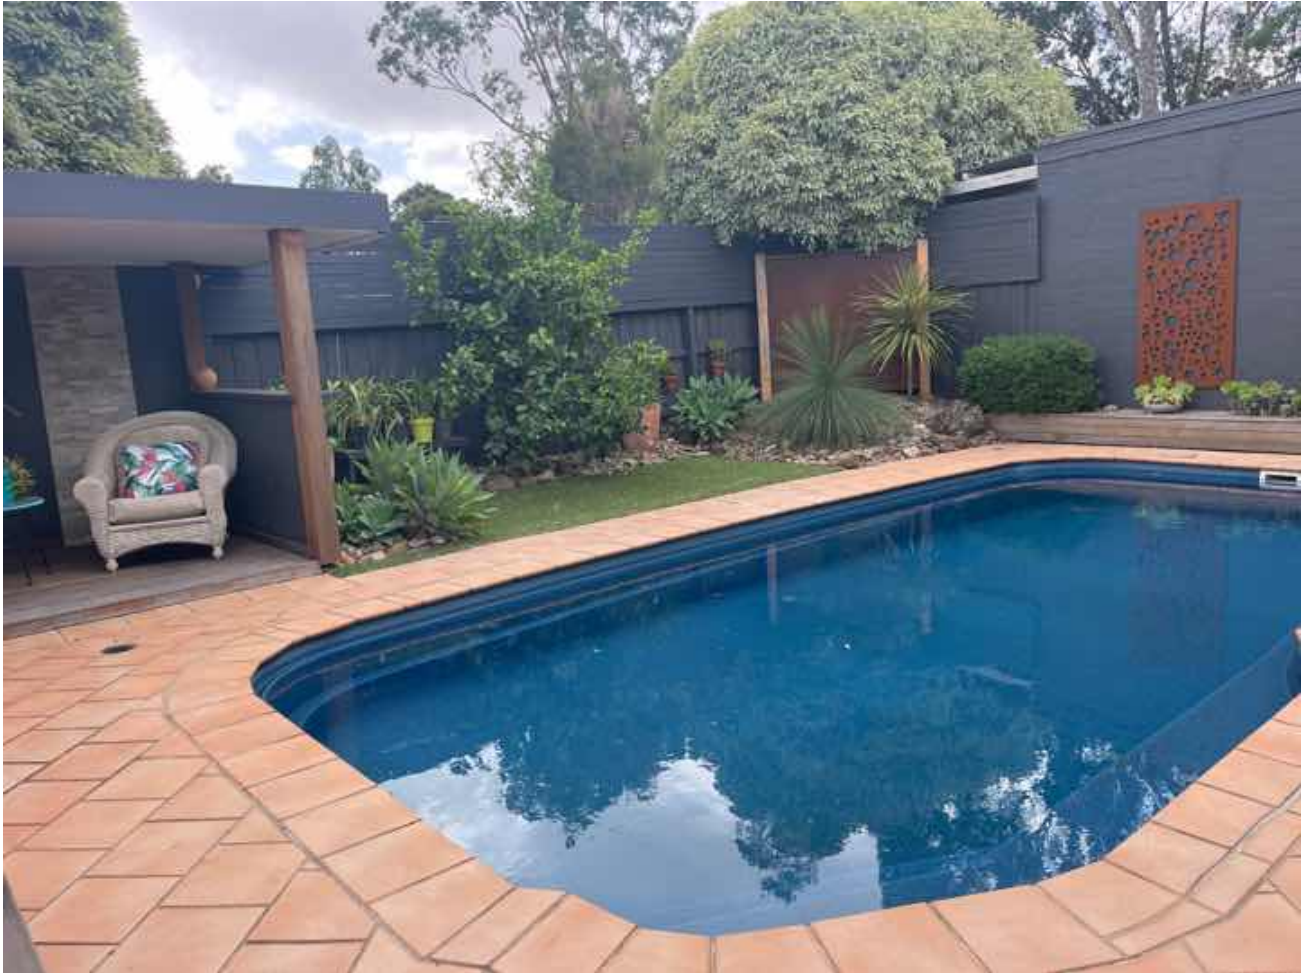
A pool fence was sighted.

**If a compliance report is required, please contact our office to have one organised.**

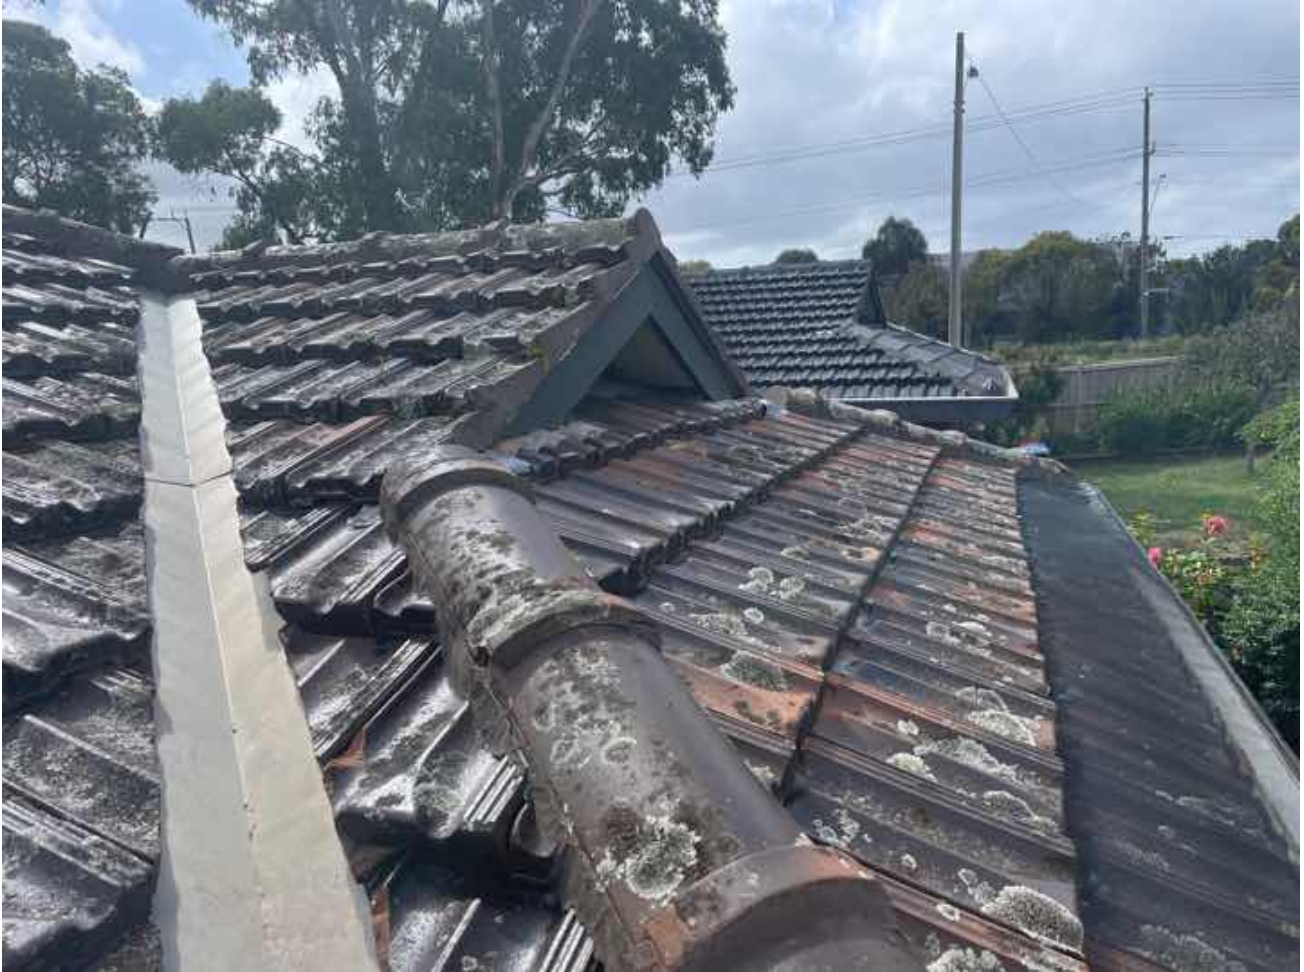
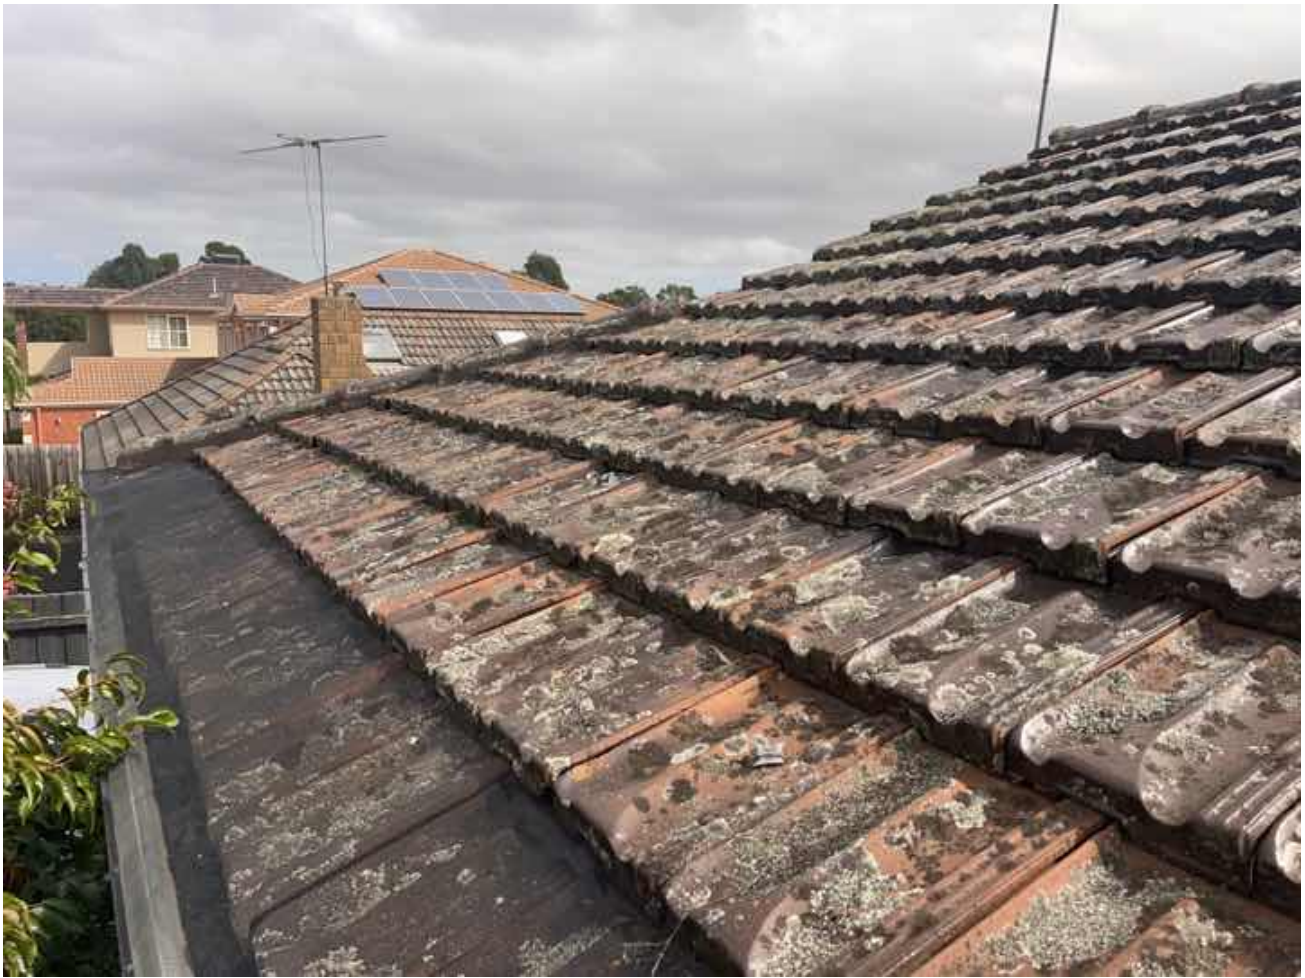
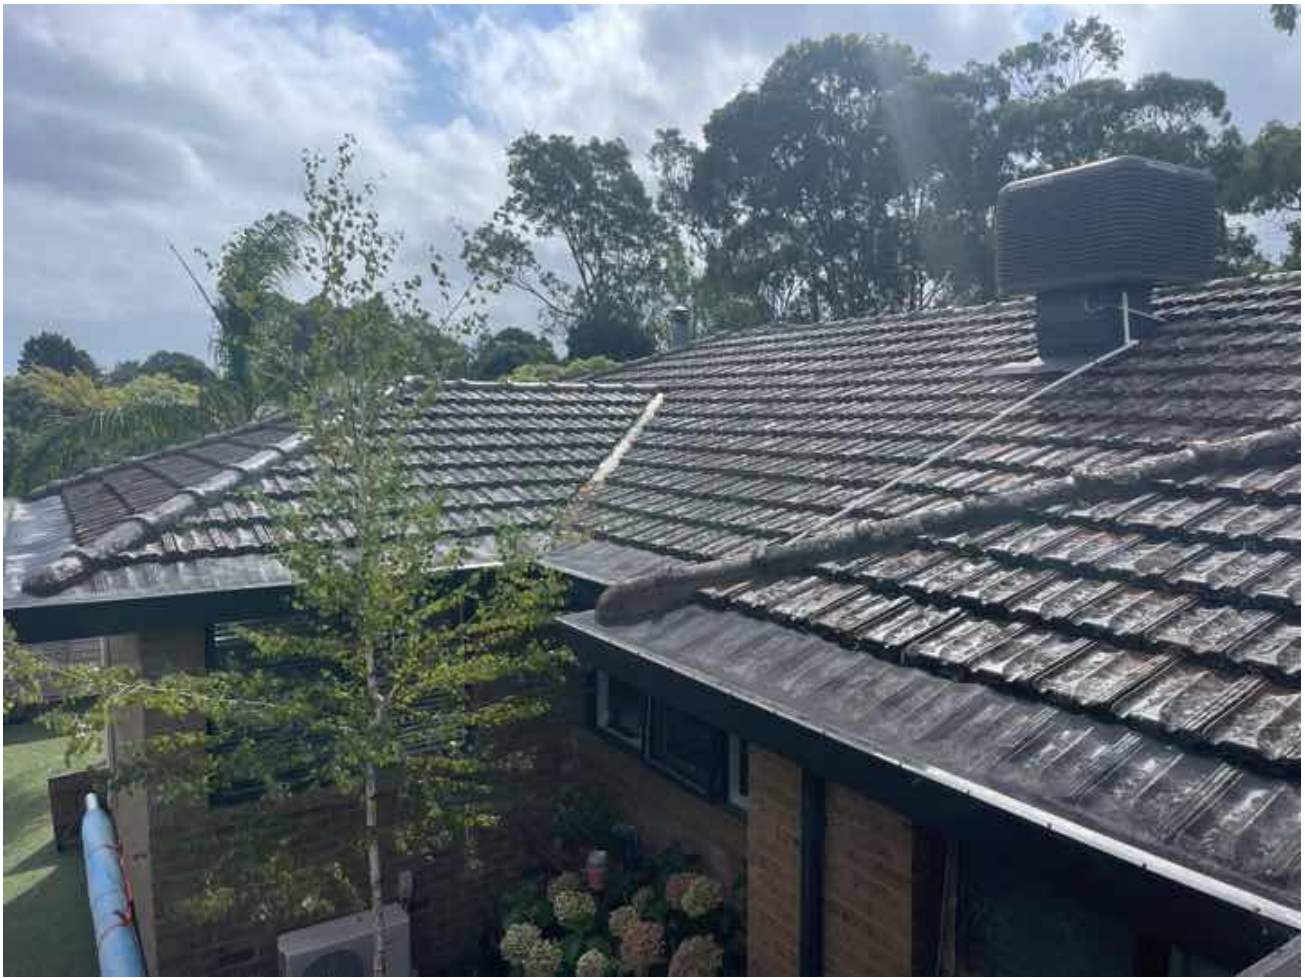
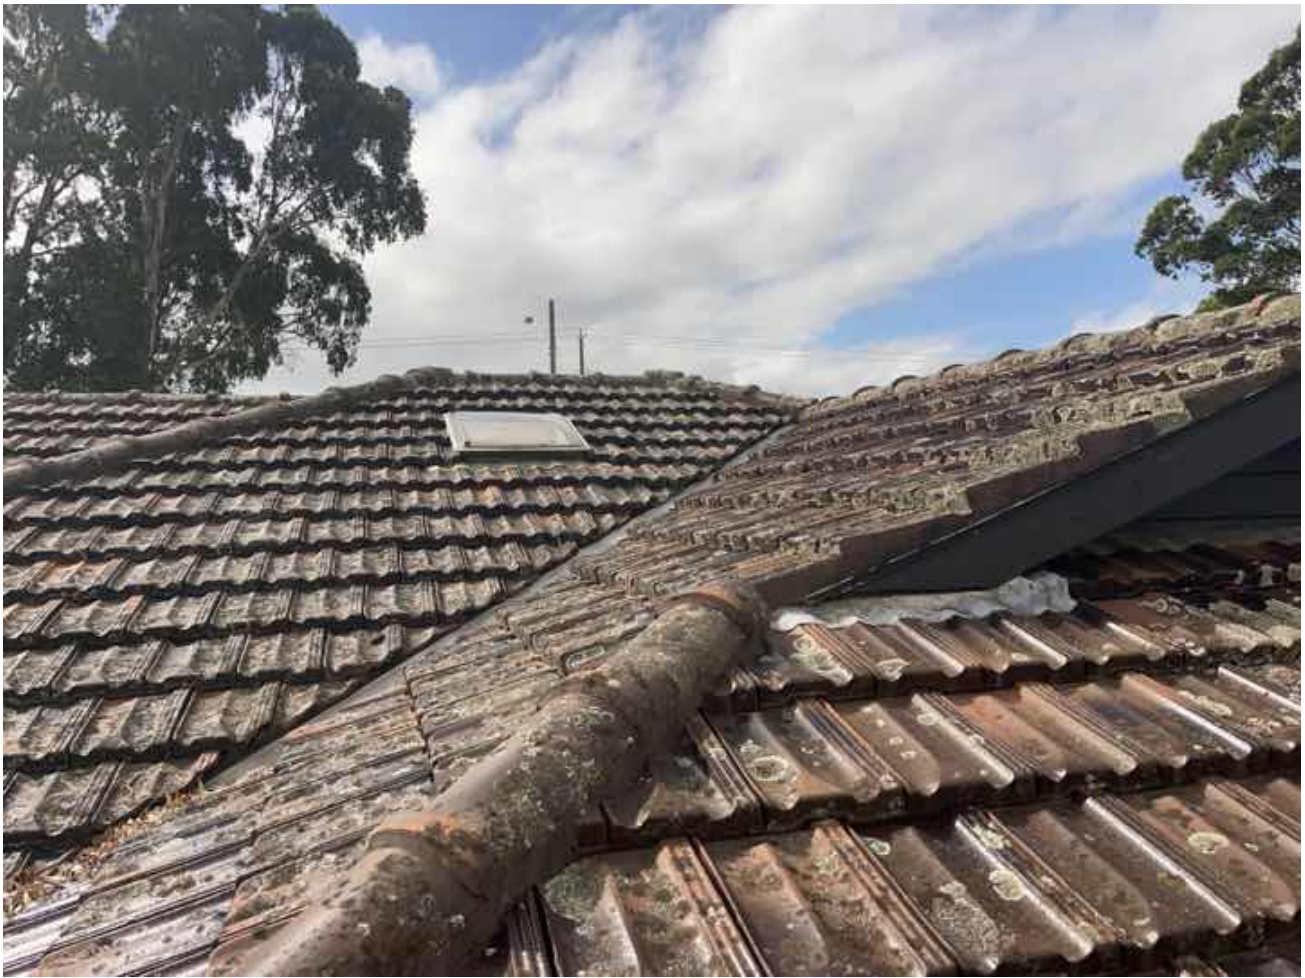
On inspection, defects were noted that may require further assessment and recommendations by licensed roofer.

Mortar cracks visible. We recommend having these repaired by a licensed roofer as they contribute to water ingress. Whilst common on properties of this age we recommend repair it may result in water ingress into the roof cavity

Moss has built up on the tiles over time. It is preferable to have the moss and debris from the surrounding trees removed / cleaned to prevent deterioration. Recommendations: A qualified roof restoration contractor should be engaged for advice and recommendations.

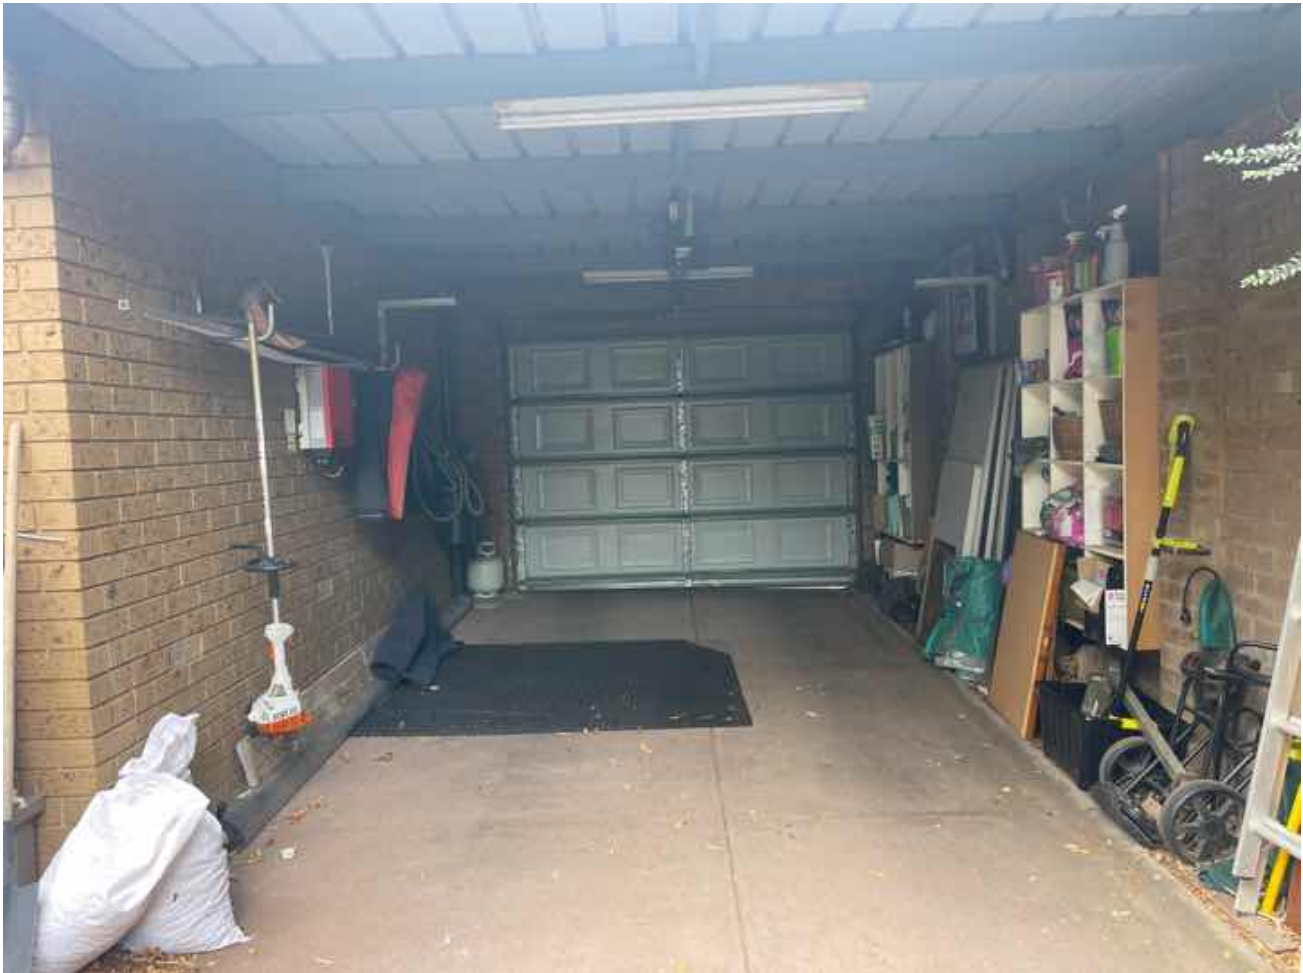
From the visible and accessible areas, the garage appears to be in a serviceable condition for the age of the property with no notable structural defects sighted.

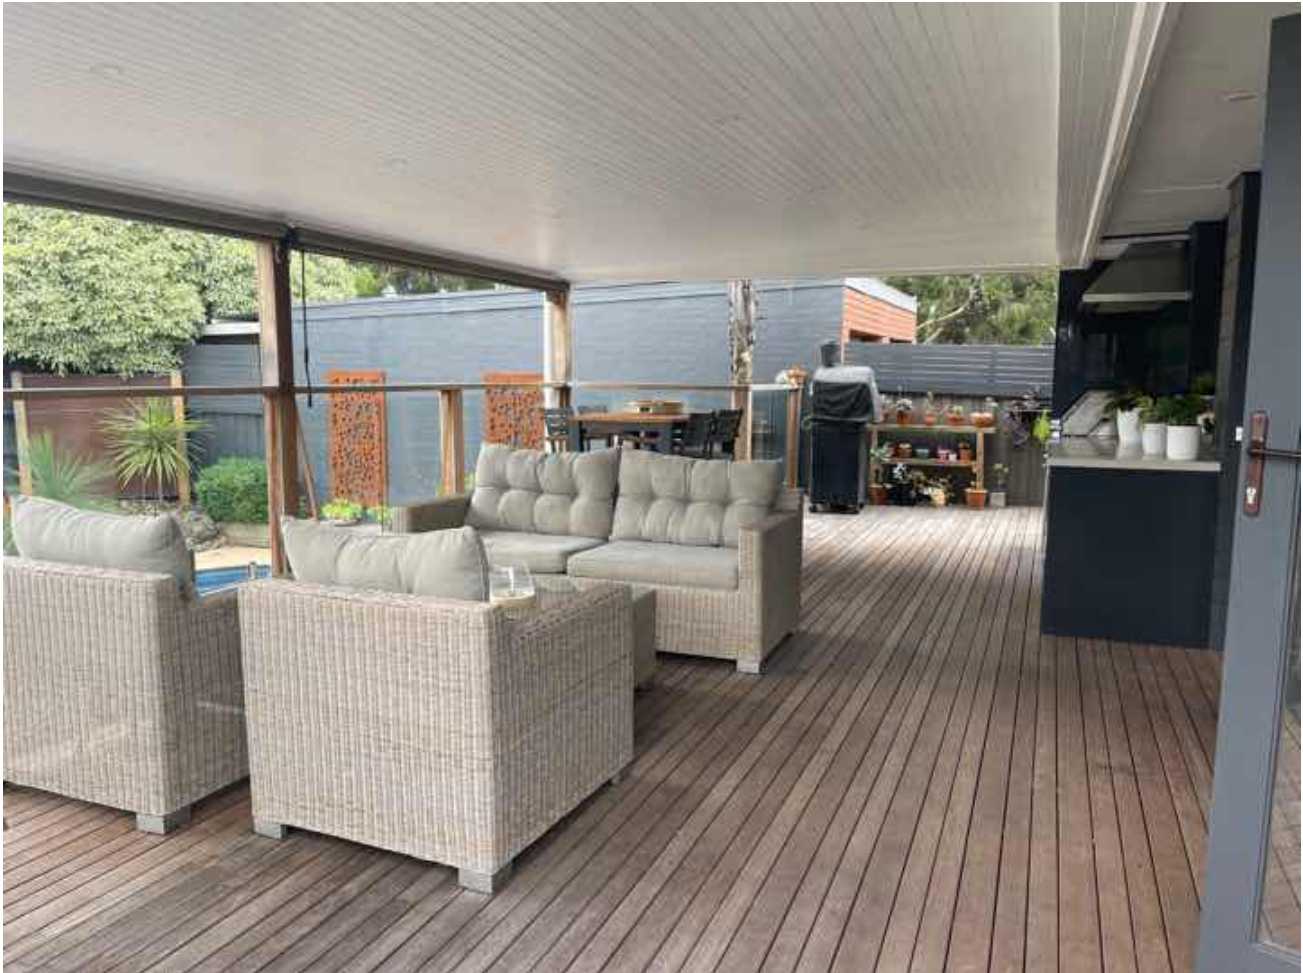
Though we are not structural engineers the verandah/s appear to be in a serviceable condition.

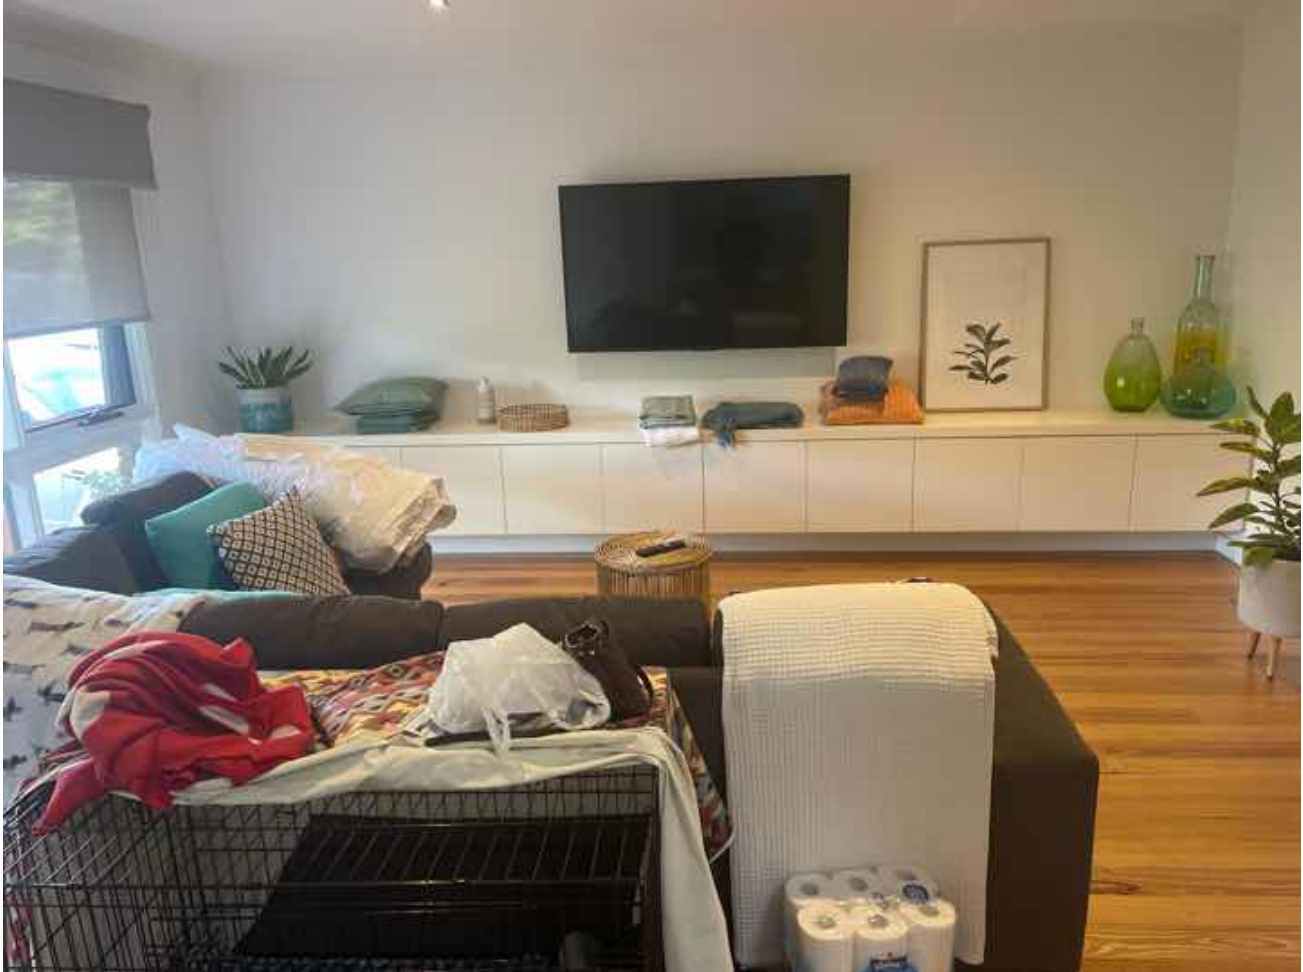
From the visible and accessible areas, the lounge room appears to be in a serviceable condition for the age of the property with no notable structural defects sighted.

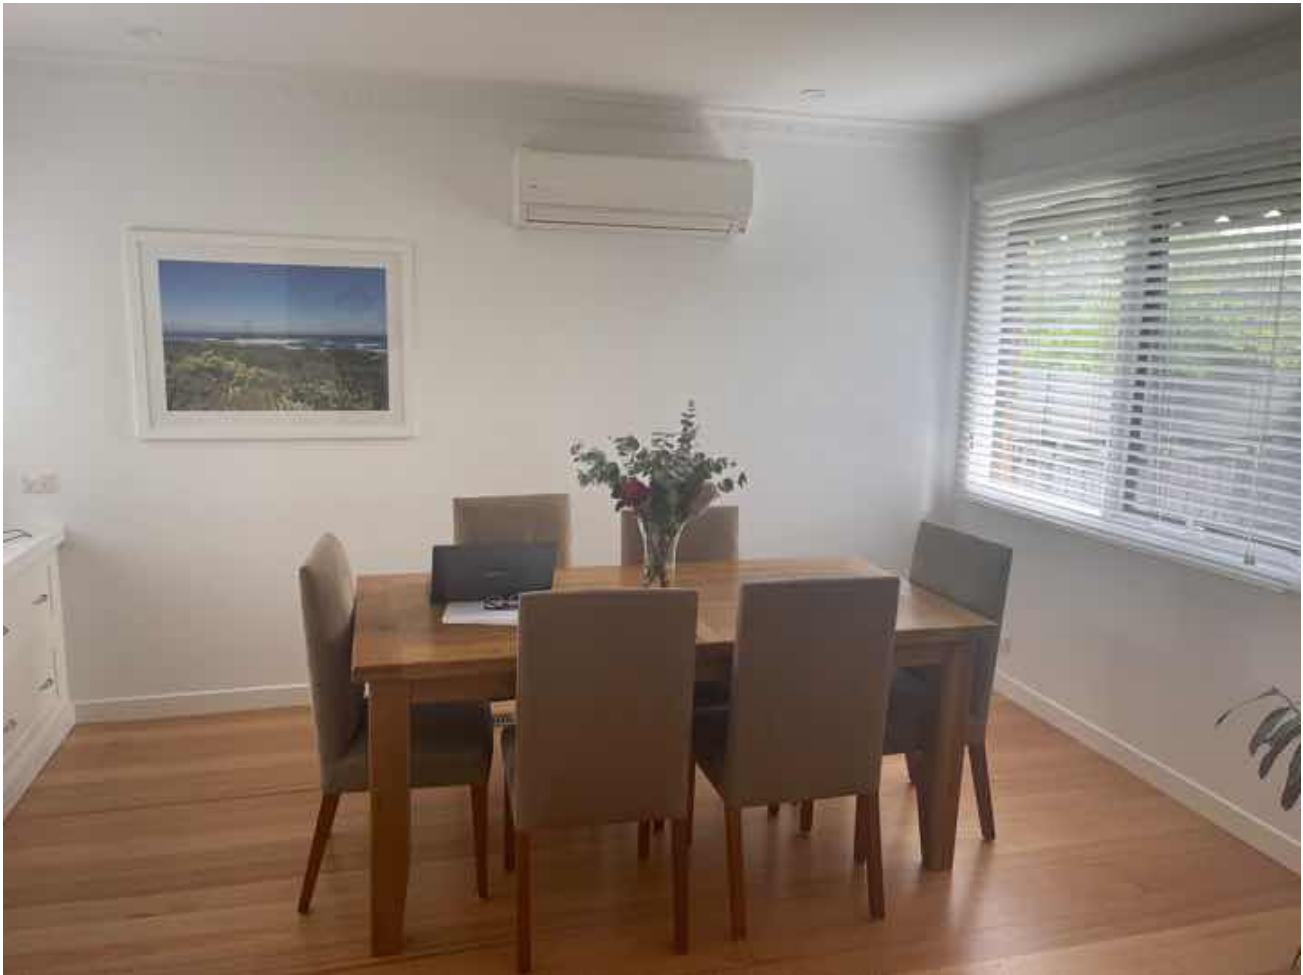
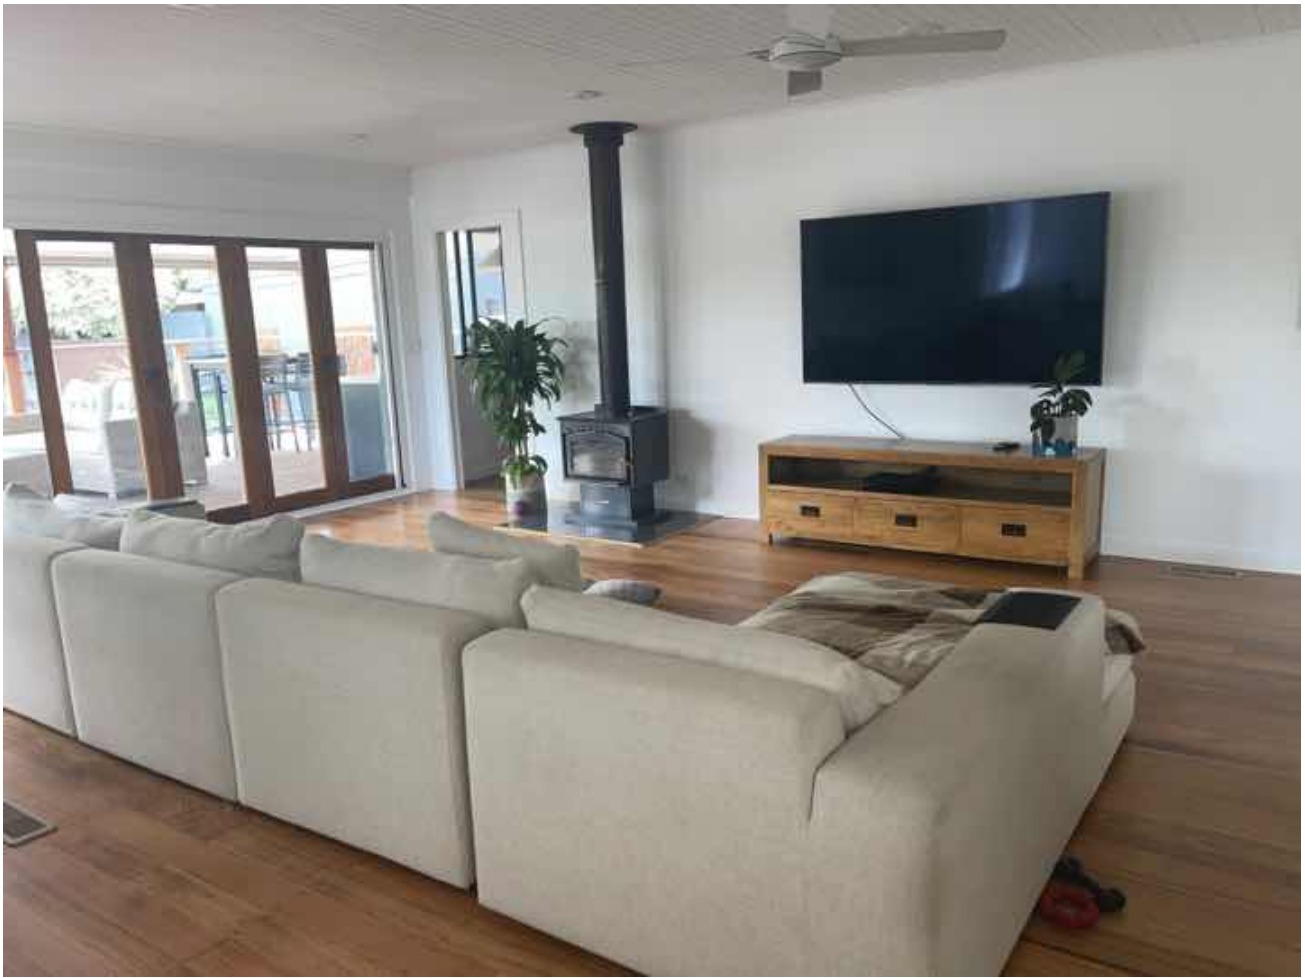
From the visible and accessible areas, the lounge/dining room appears to be in a serviceable condition for the age of the property with no notable structural defects sighted.

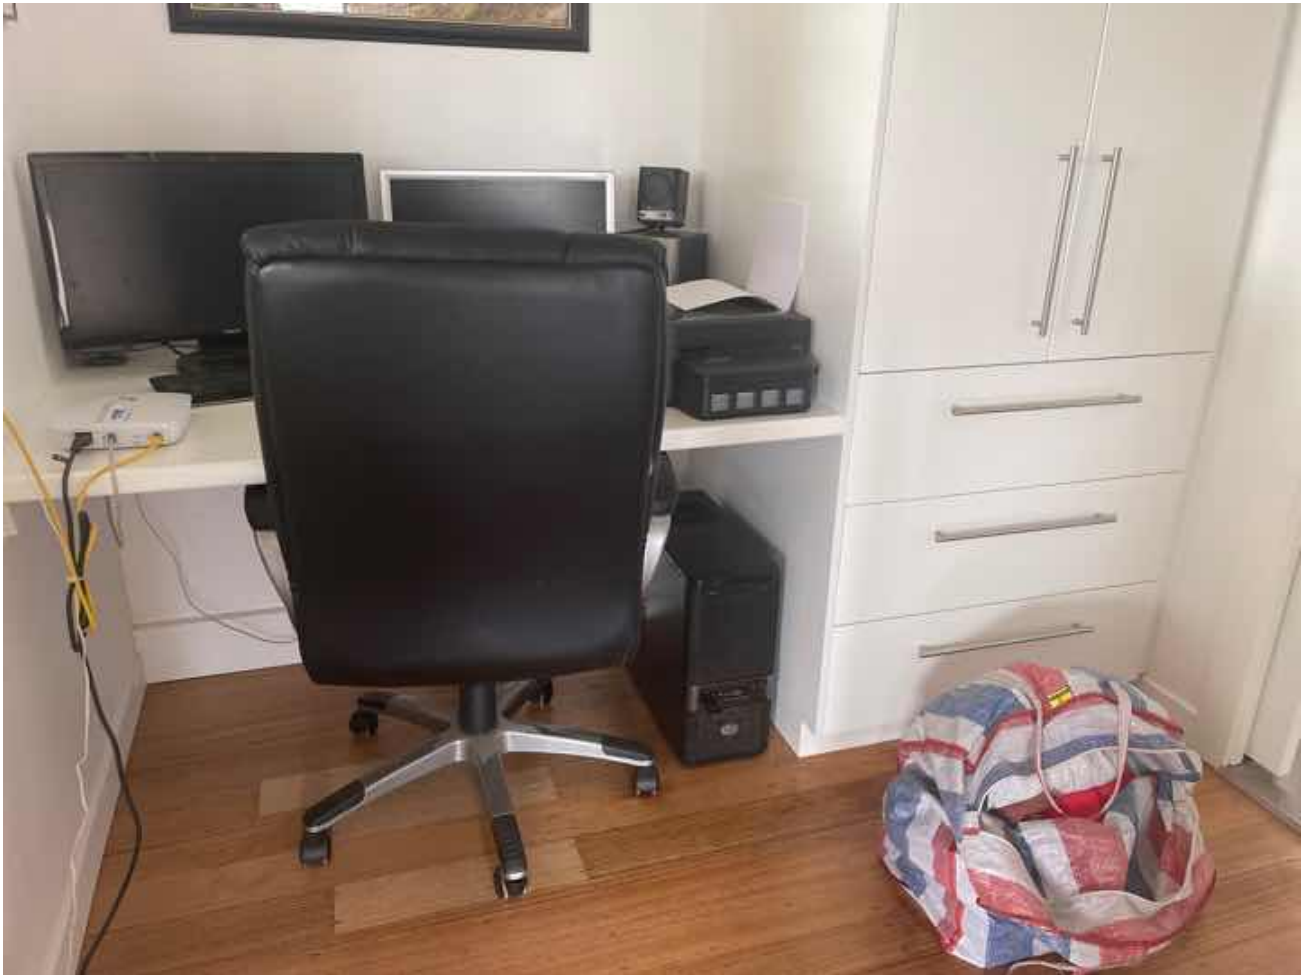
From the visible and accessible areas, the study nook appears to be in a serviceable condition for the age of the property with no notable structural defects sighted.

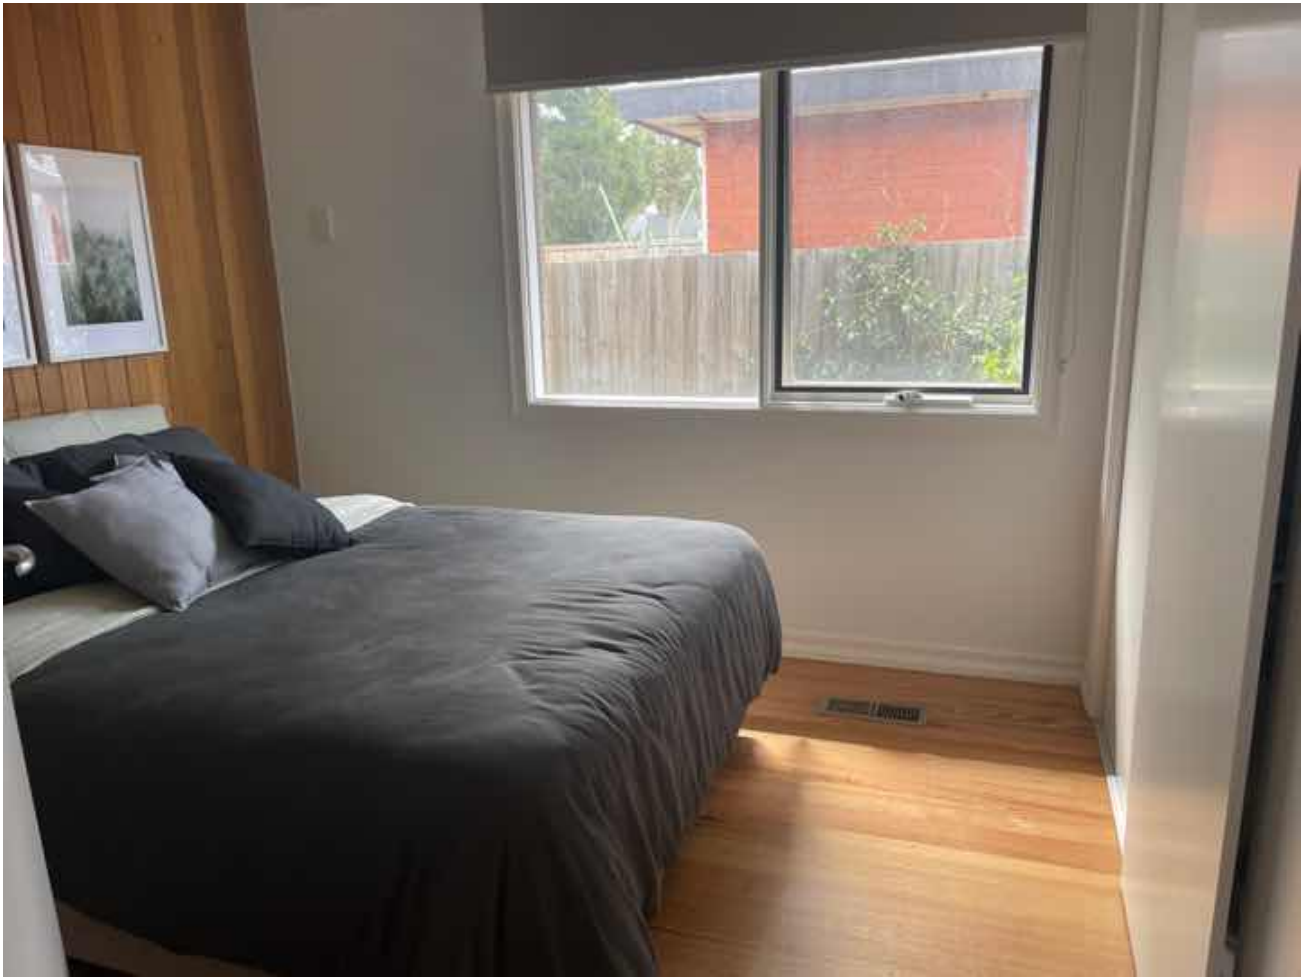
From the visible and accessible areas, the bedroom appears to be in a serviceable condition for the age of the property with no notable structural defects sighted.

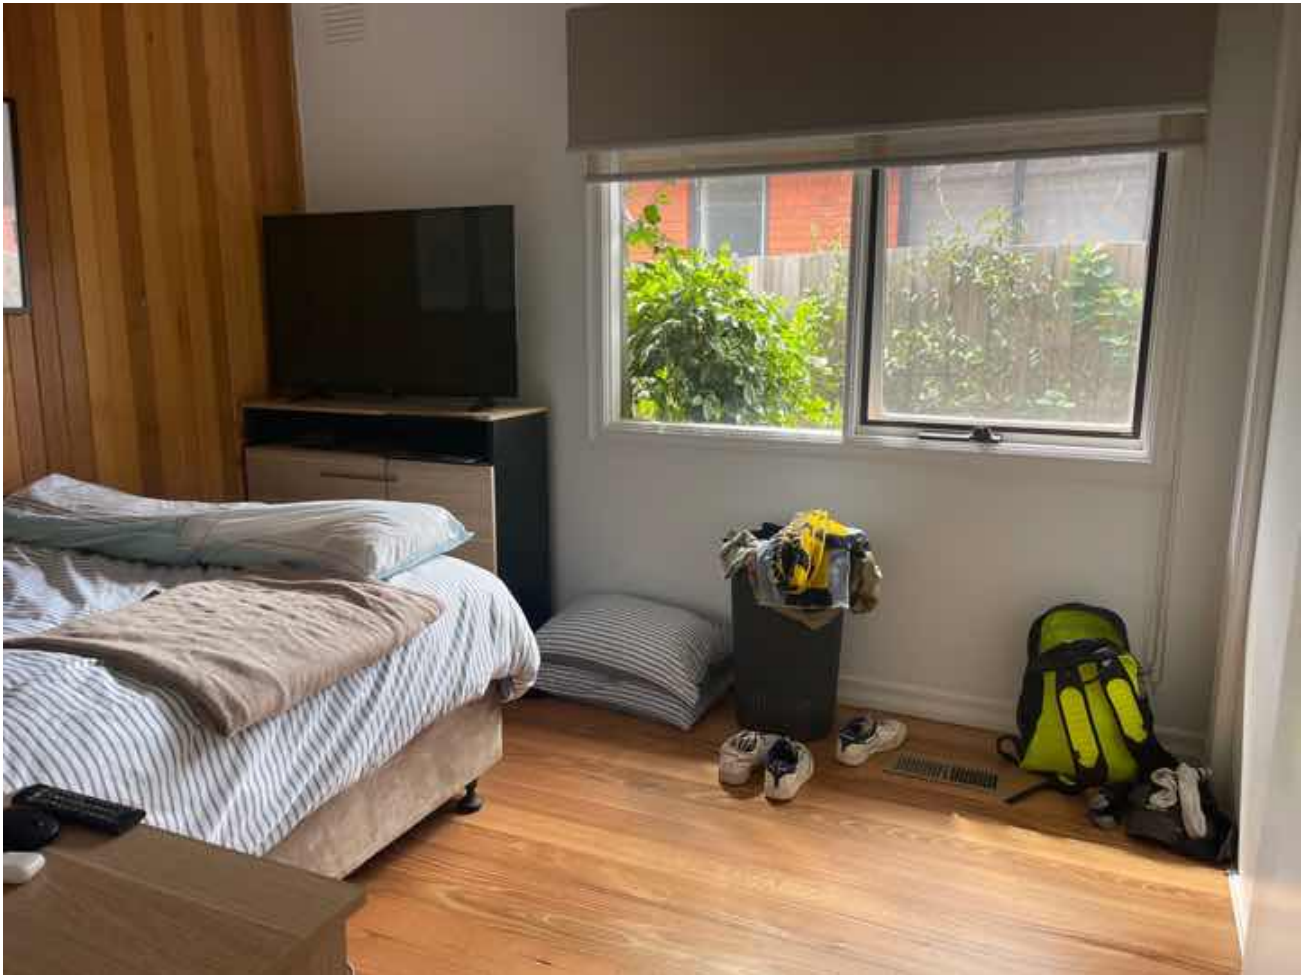
From the visible and accessible areas, the bedroom appears to be in a serviceable condition for the age of the property with no notable structural defects sighted.

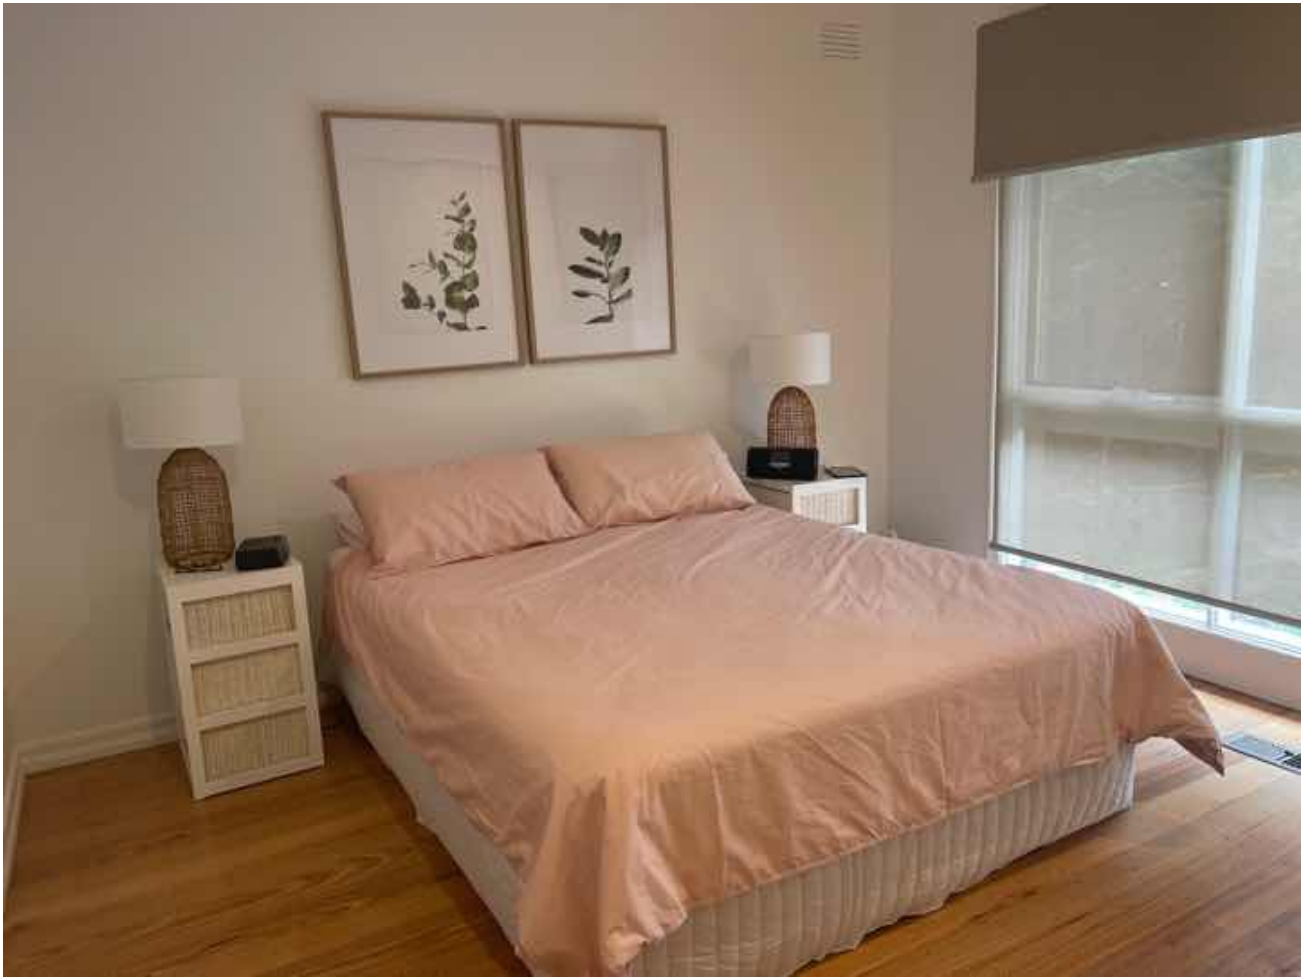
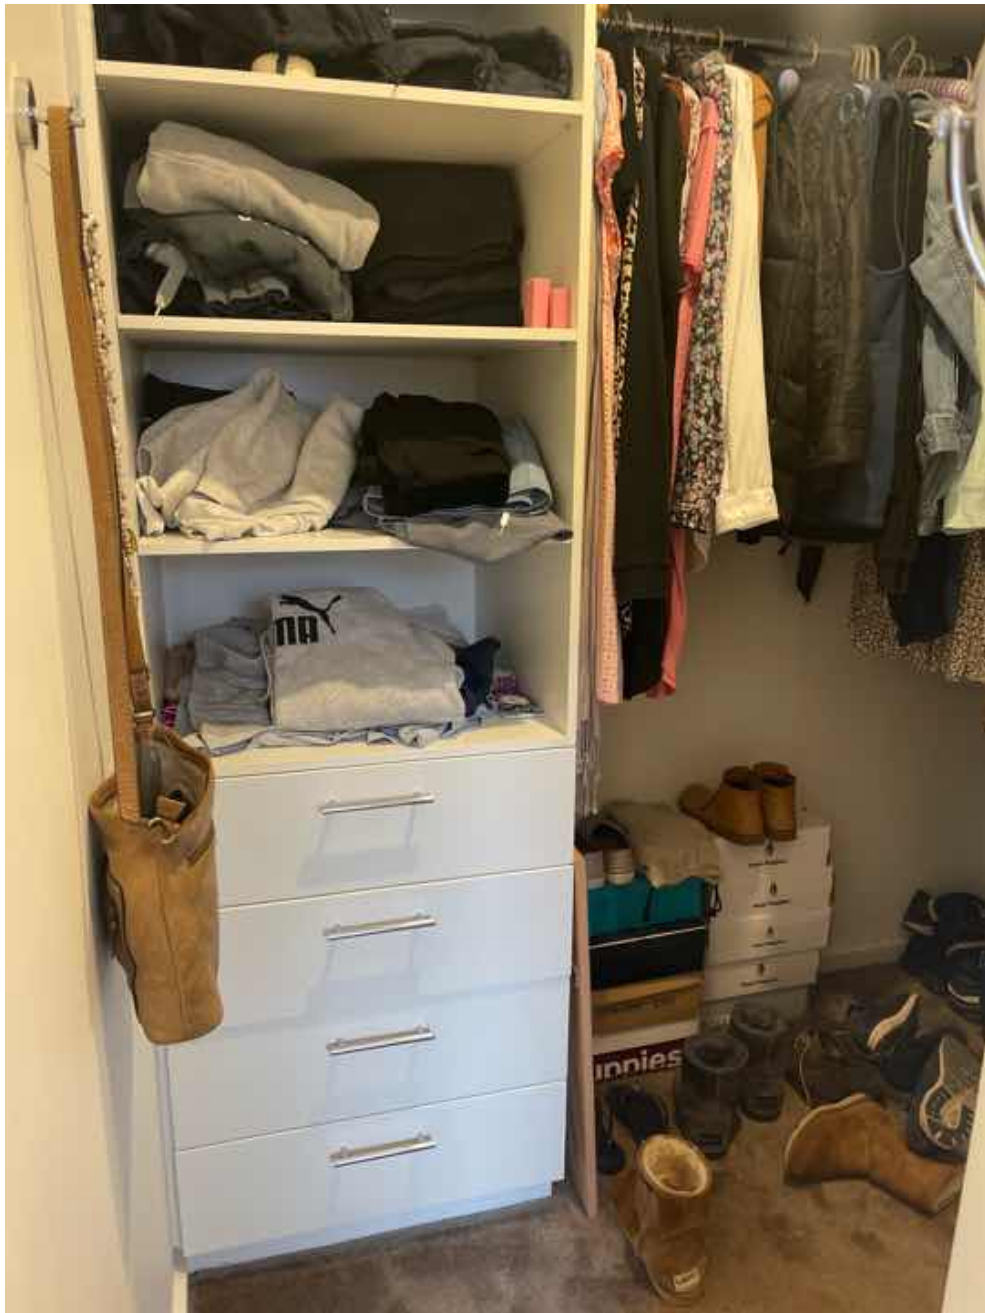
From the visible and accessible areas, the bedroom appears to be in a serviceable condition for the age of the property with no notable structural defects sighted.
