**PADinspections**

**Inspection Address**

Report/Agreement # 18032214293223

### Building And Pest Inspection

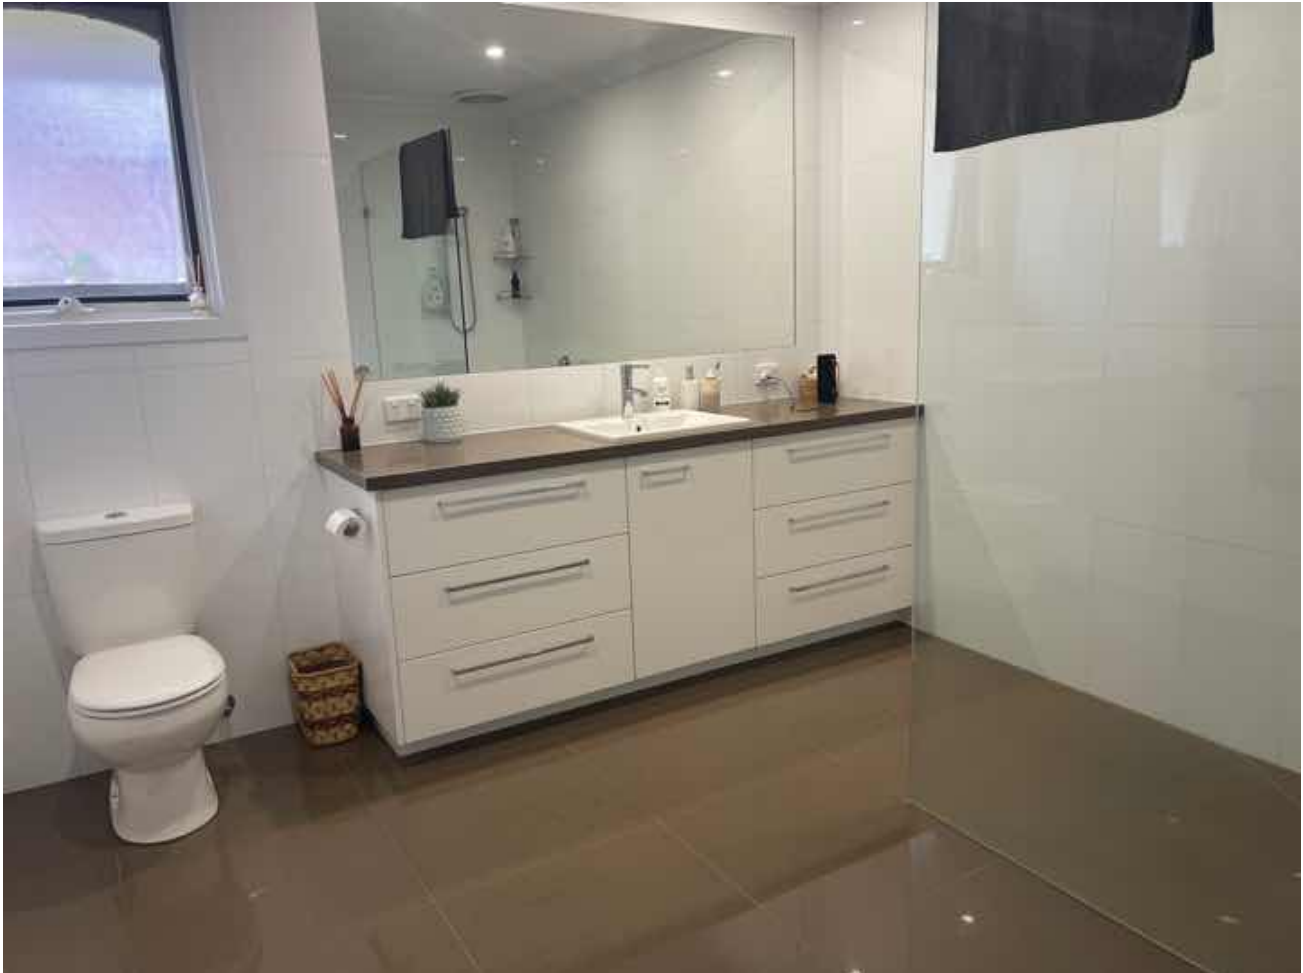
Of the visible areas, the general condition of this bathroom is serviceable or in reasonable condition for age of dwelling.

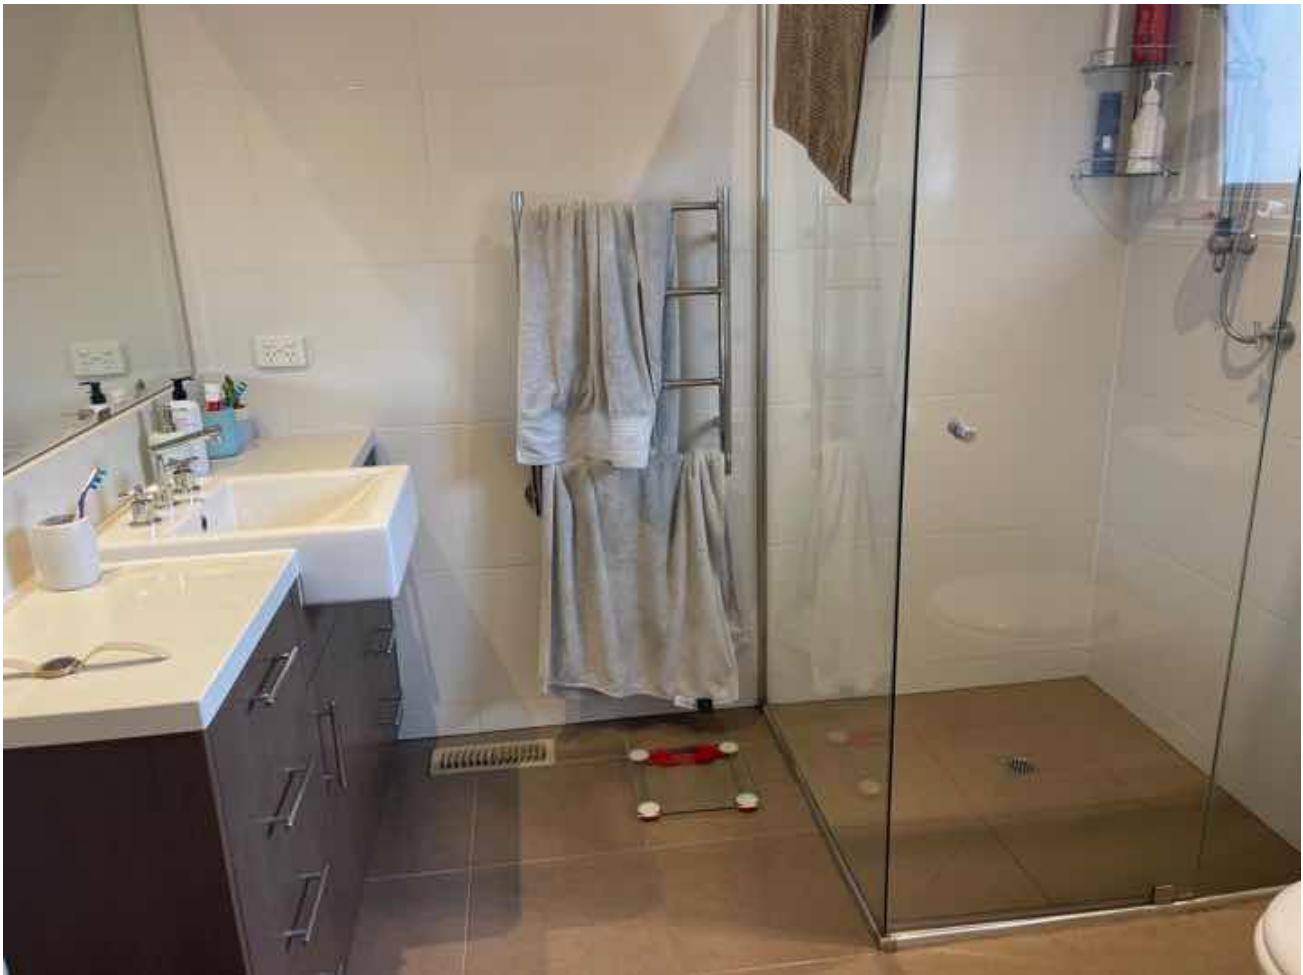
Of the visible areas, the general condition of this bathroom is serviceable or in reasonable condition for age of dwelling.

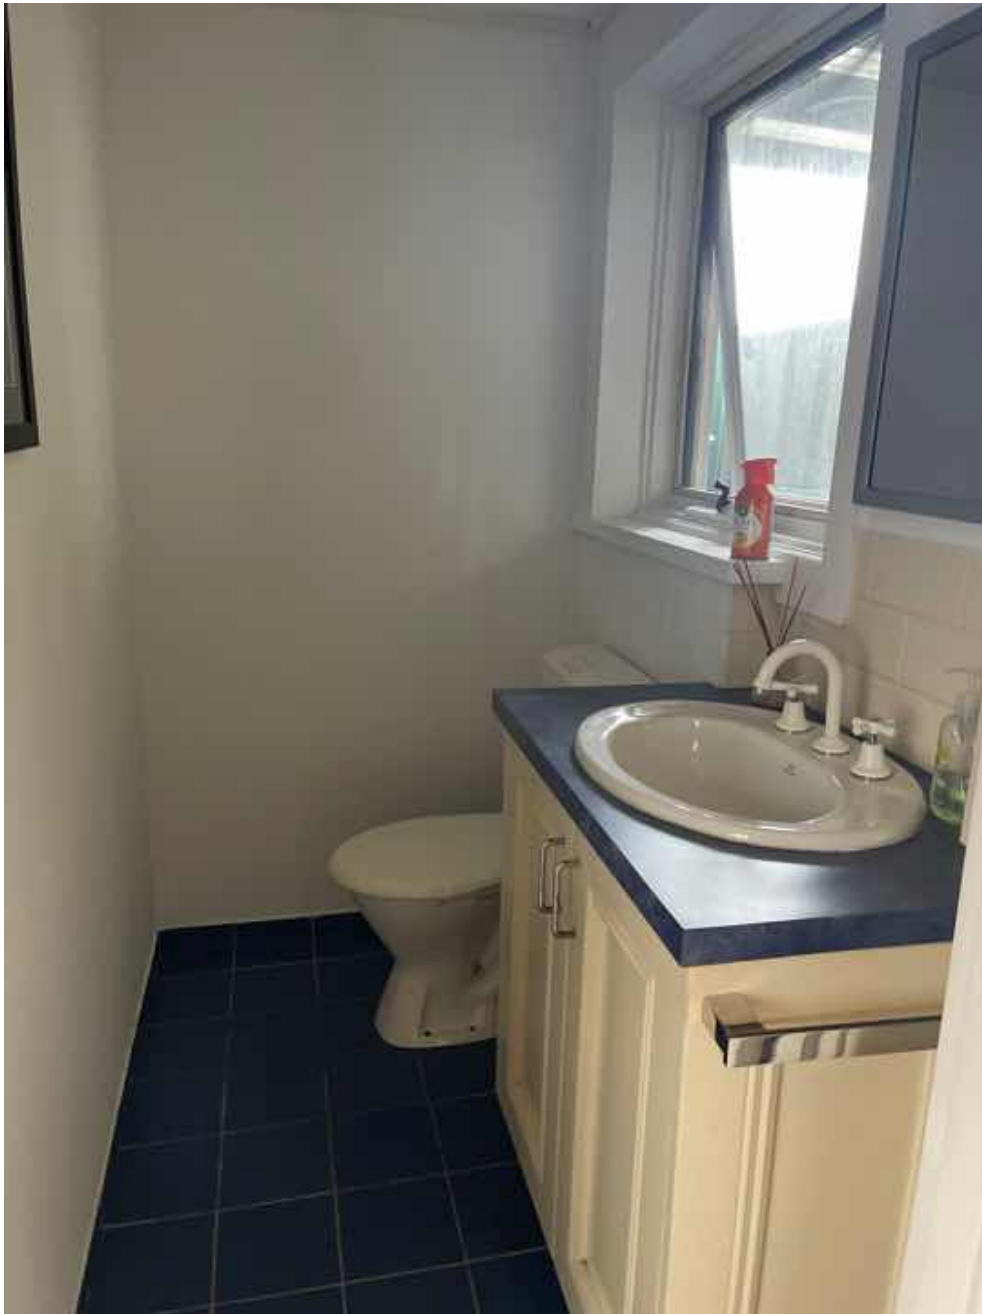
Of the visible areas, the general condition of this bathroom is serviceable or in reasonable condition for age of dwelling.

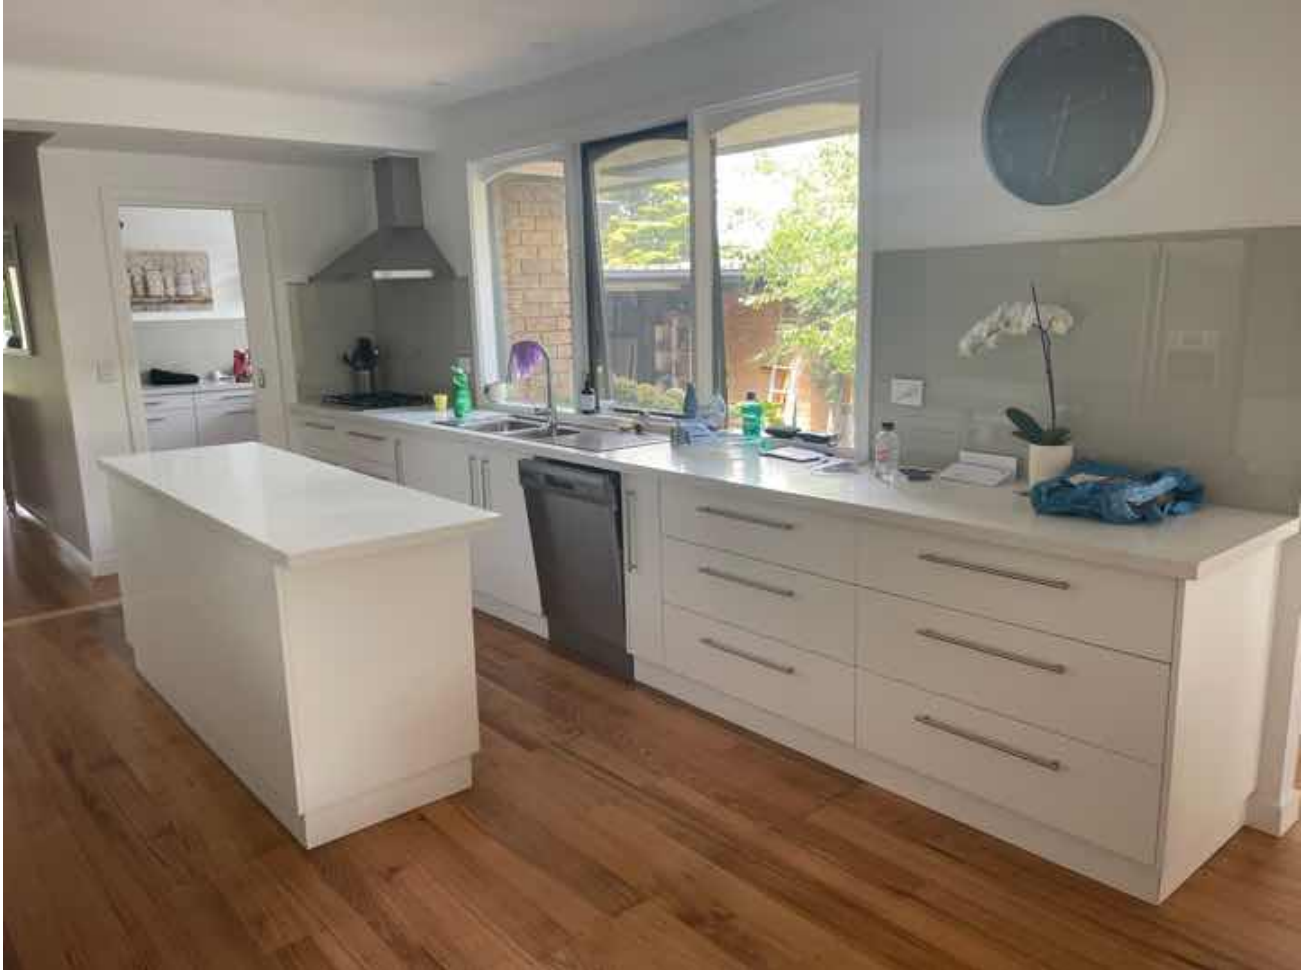
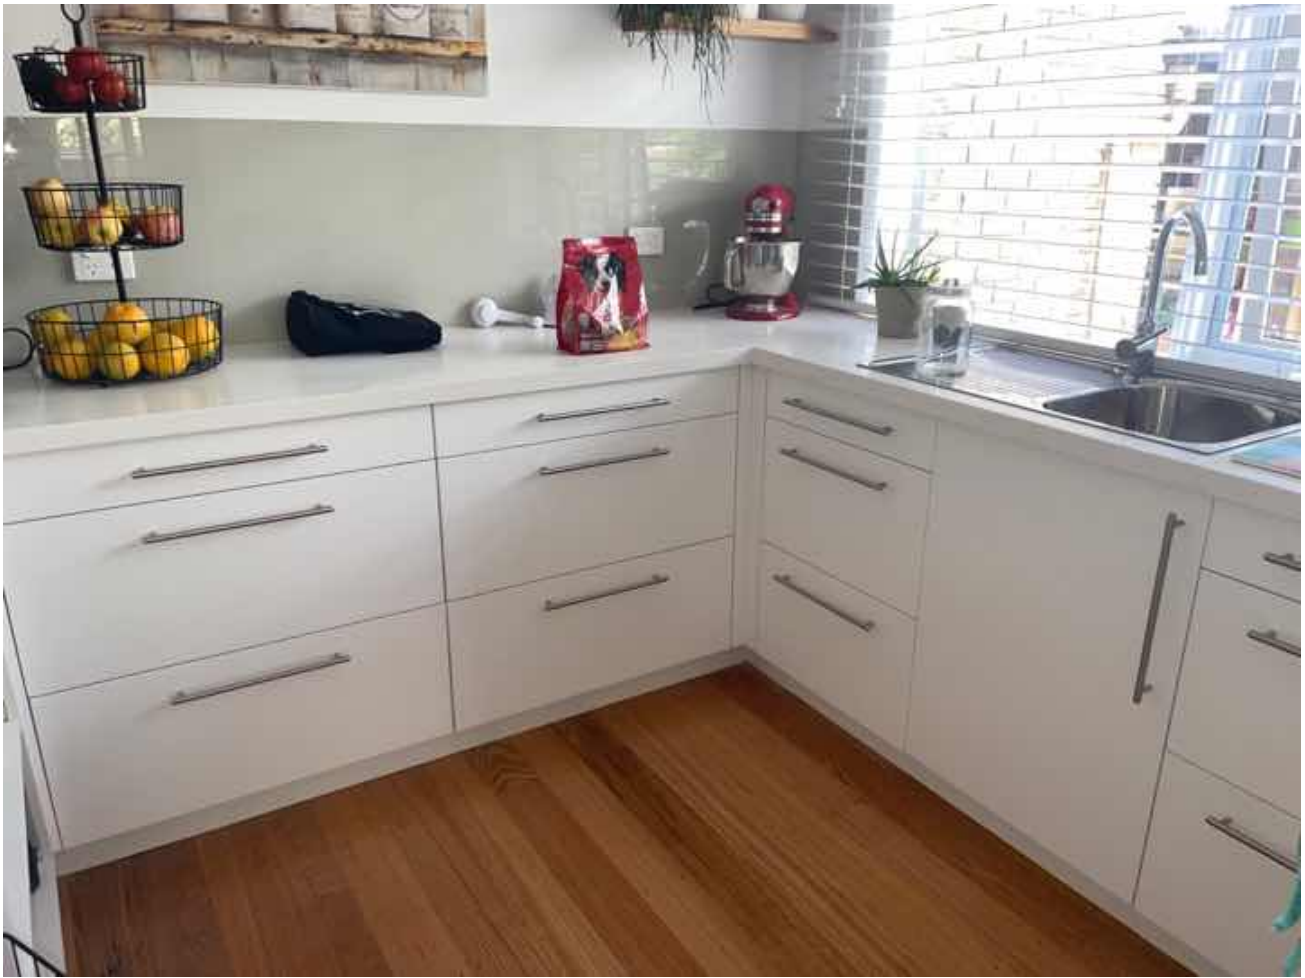
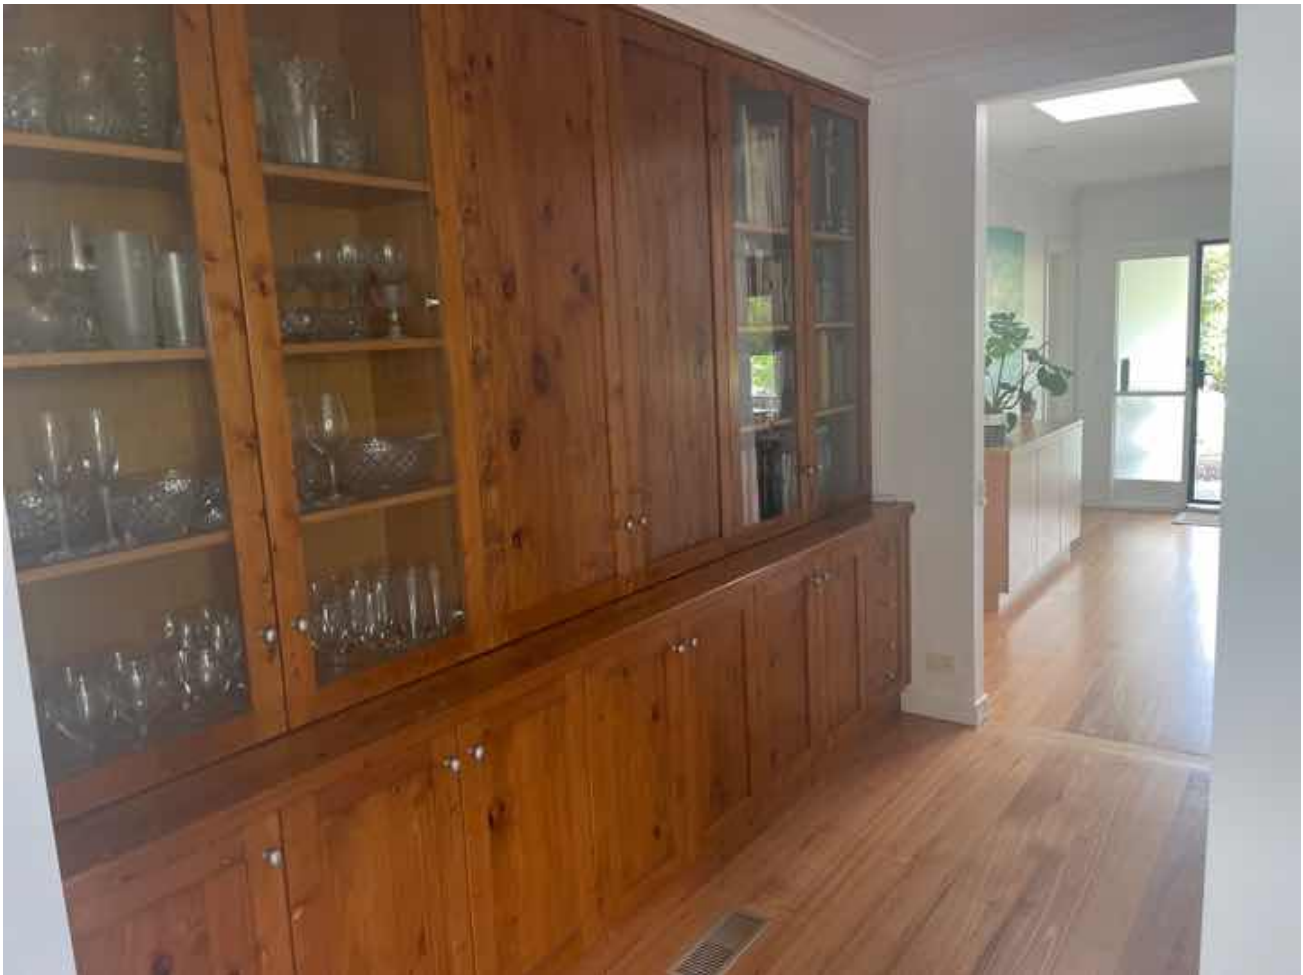
Of the visible areas, the general condition of the kitchen is serviceable or in reasonable condition for age of dwelling.

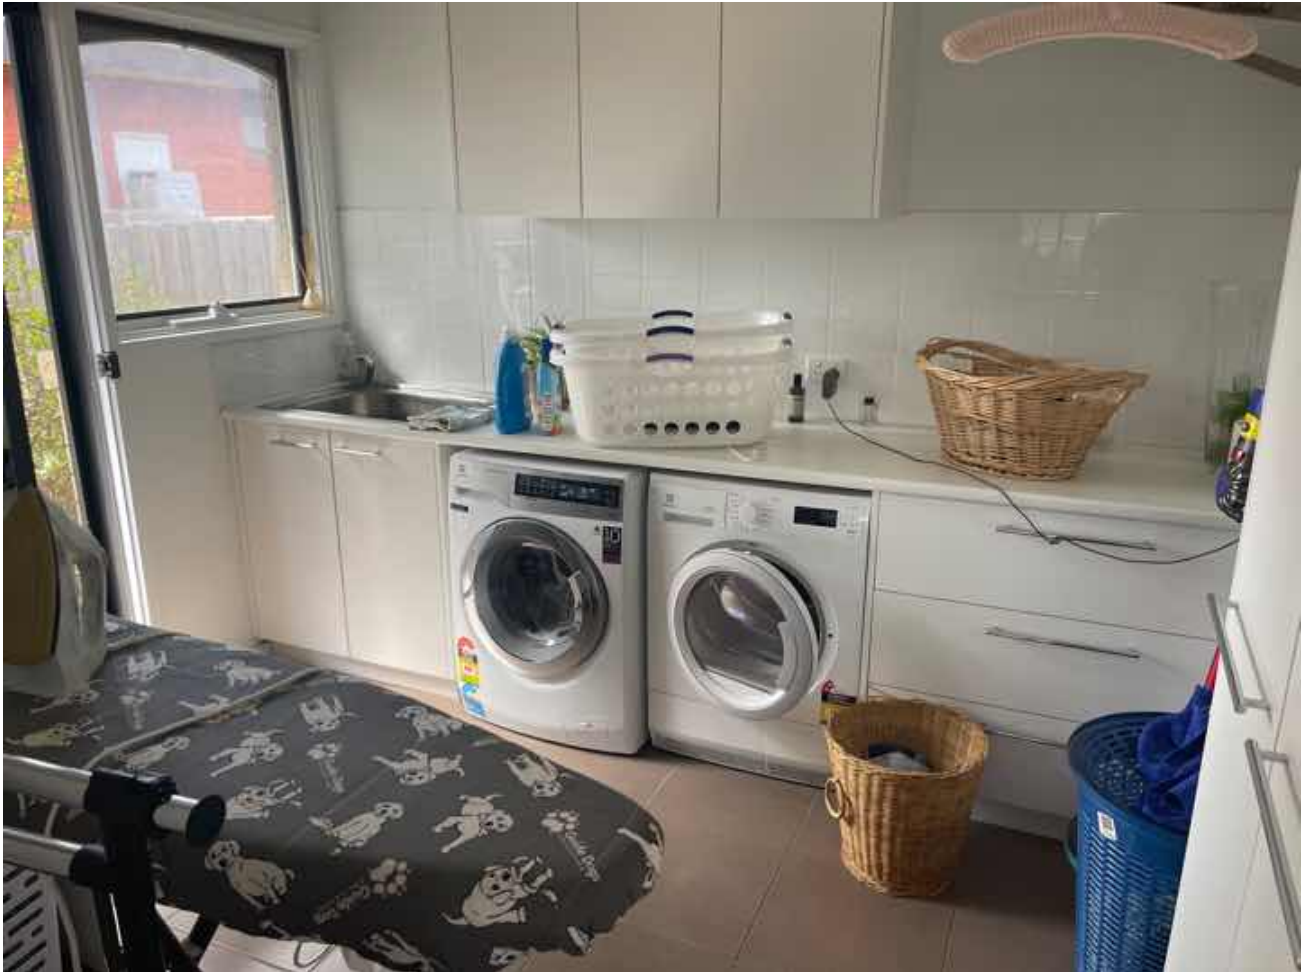
Appliances in the laundry restricted full and unobstructed view. Defects may exist behind same.

Of the visible areas, the general condition of the laundry is serviceable.

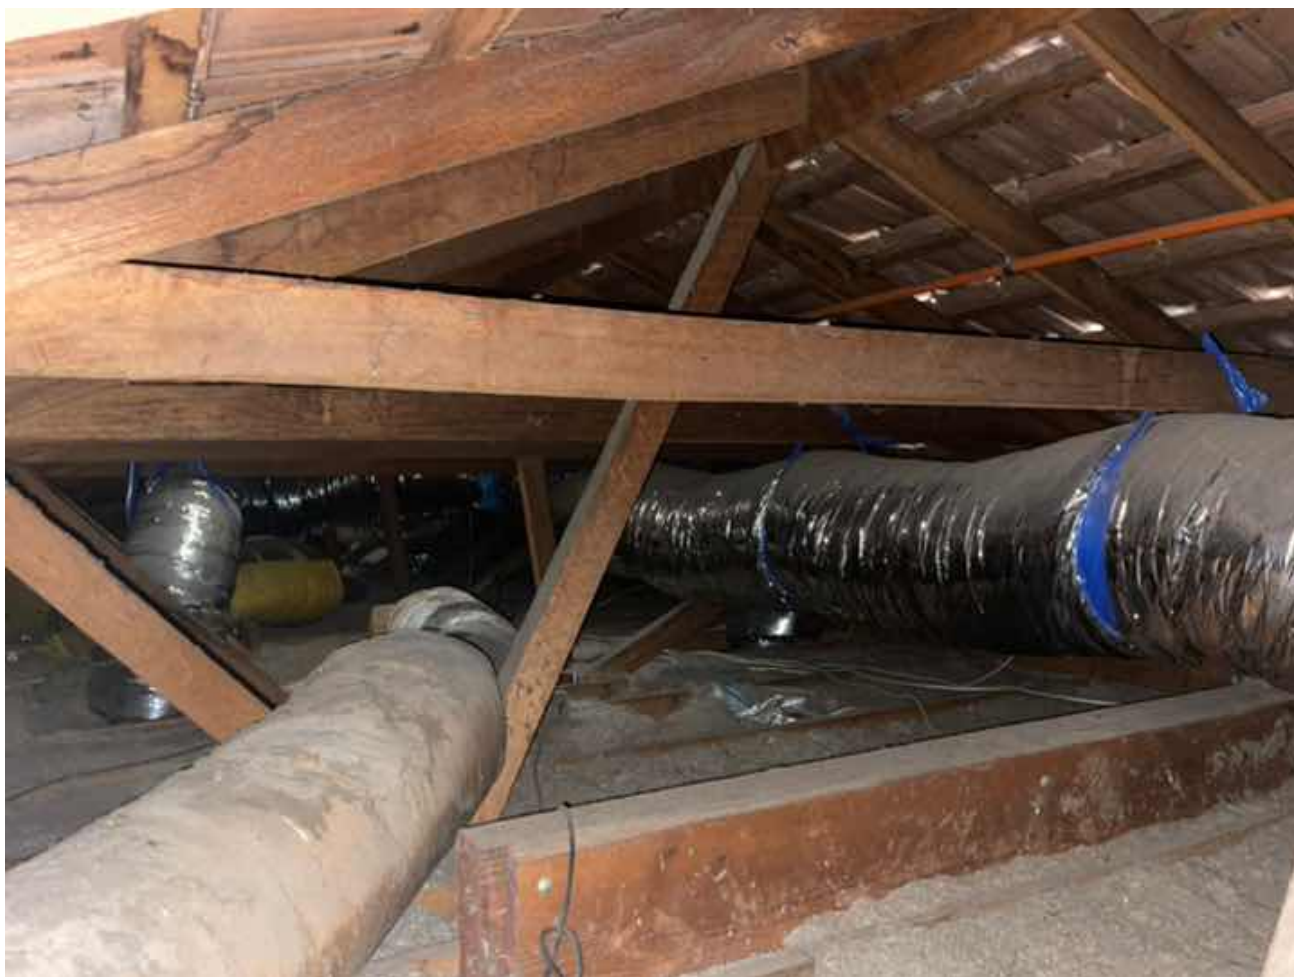
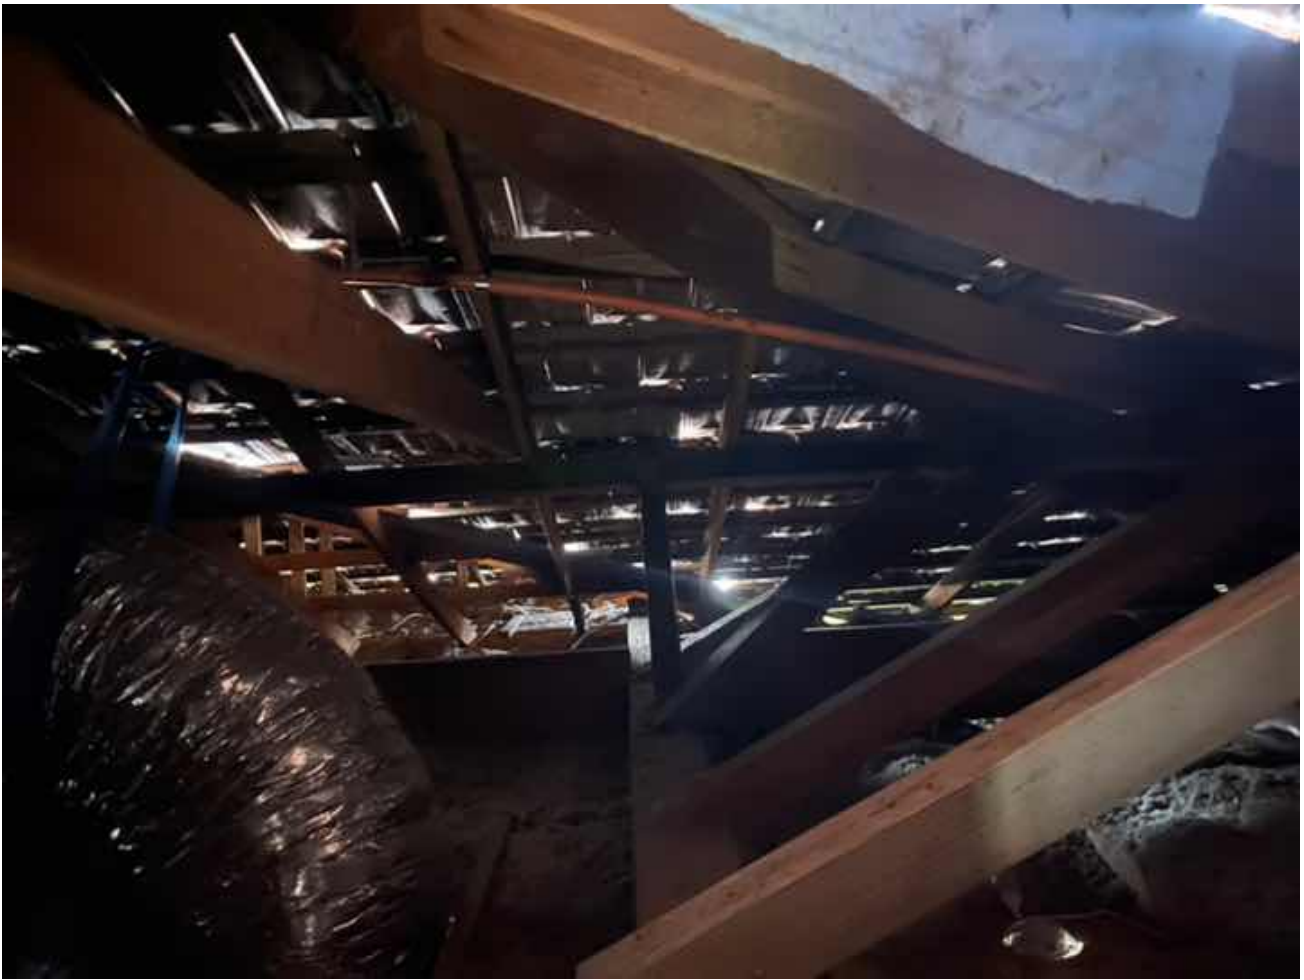
There is heating and/or cooling ducting present in the roof space/void. This is preventing a full inspection from being undertaken. It is strongly recommended that full access be gained as it could be harbouring timber pest activity, damage or defects.

There is insulation present in the roof space/void. This is preventing a full inspection of ceiling joists from being undertaken. It is strongly recommended that full access be gained as it could be harbouring timber pest activity, damage or defects.
