**padinspections**

**Marcia street, Sunshine West, VIC, Australia**

Report/Agreement #       0307151640104  
 Inspection Date           03 Jul 2015  
 Inspection Time           02:00 PM

### Building Inspection

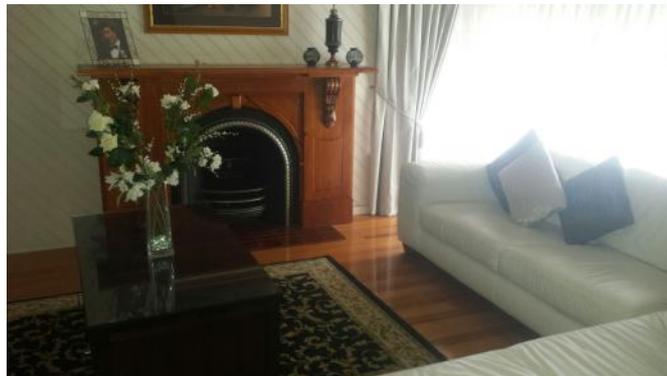
The lounge room is in serviceable condition with no notable structural defects sighted.

Settlement Cracks Noted . These are typical and generally patch and paint will suffice.

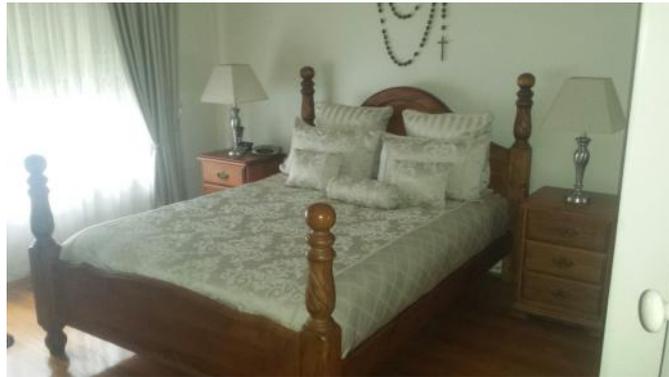
Bedroom 1 is in serviceable condition with no notable structural defects sighted.

Striker plate needs adjusting.

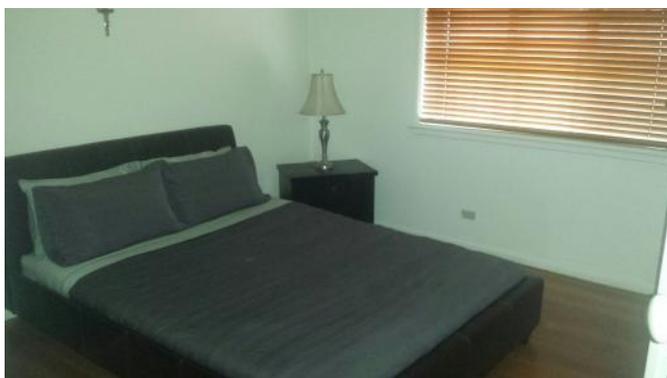
Bedroom 1 is in serviceable condition with no notable structural defects sighted.

Striker plate needs adjusting.

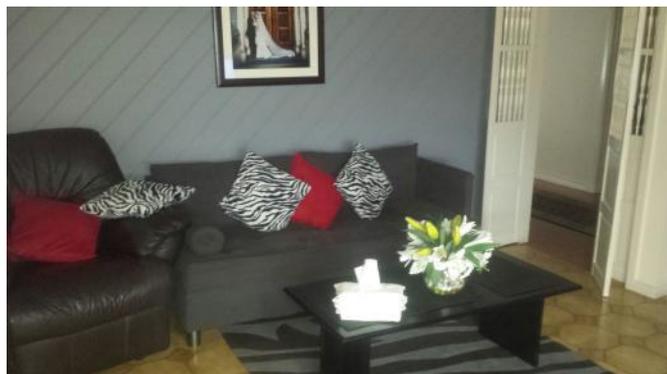
The lounge room is in serviceable condition with no notable structural defects sighted.

Settlement Cracks Noted . These are typical and generally patch and paint will suffice.

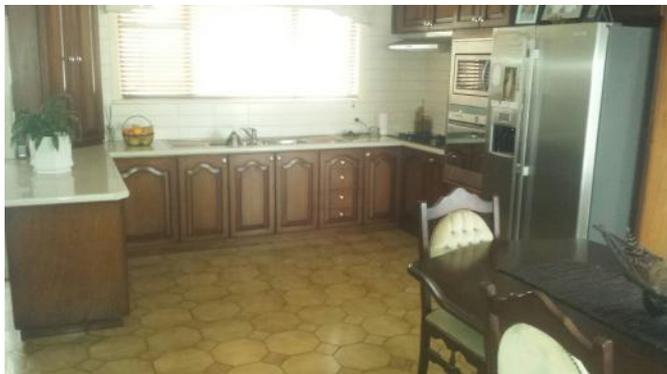
Of the visible areas, the general condition is serviceable or in reasonable condition for age of dwelling.

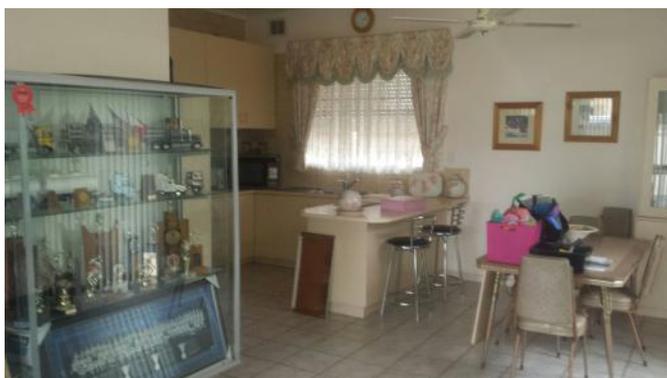
### Kitchen and Meals Area(Rear)

Of the visible areas, the general condition is serviceable or in reasonable condition for age of dwelling.

Kitchen is a converted garage. There are high moisture readings on wall. This is common due to type of construction.

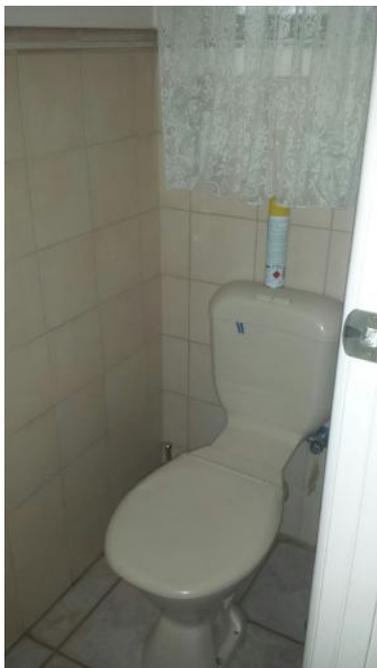
Of the visible areas, the general condition of the powder room is serviceable or in reasonable condition for age of dwelling.

Could not flush, check with owner as to why. You may need to contact a plumber for repairs

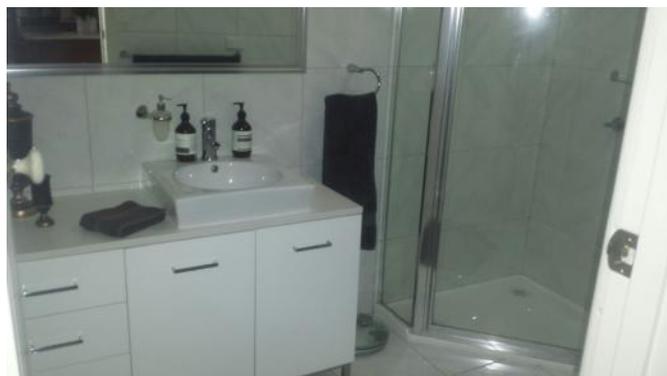
Family Room

Of the visible areas, the general condition of this bathroom is serviceable or in reasonable condition for age of dwelling.

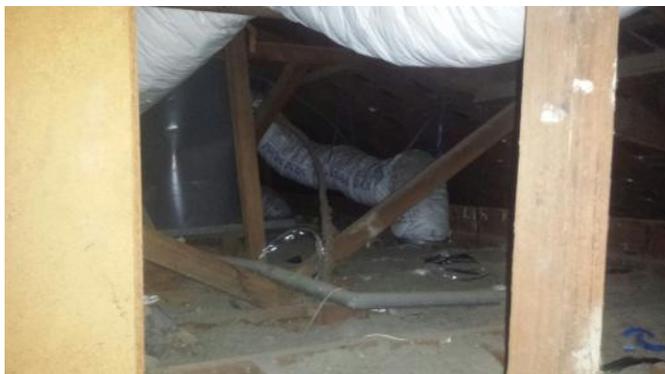
The roof frame is a conventional timber frame.

Visible sections of the roof void is in a serviceable condition for age of this dwelling.

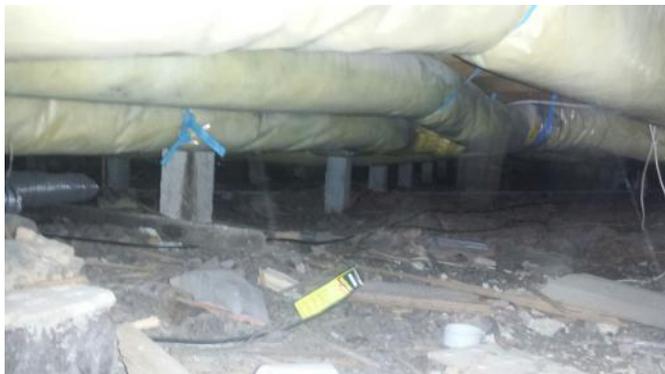
Of areas accessible and visible, the subfloor and components appeared to be in a serviceable condition.

Of the visible areas, no excess damp was visible.
