Inspection Report

PADinspections Pty Ltd

Inspection Address
Albert Park, Victoria, 3206

Pest And Building Inspection

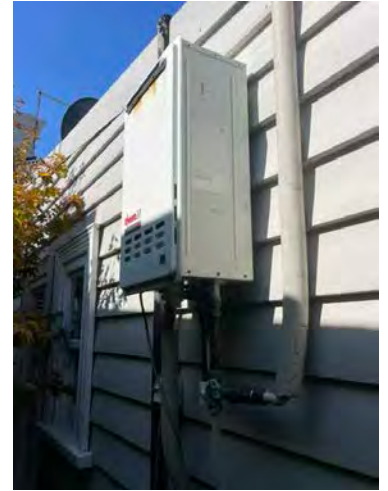
The hot water system appears to be in a serviceable condition. No specific tests other than running the hot water from a tap was carried out. No determination has been made as to the suitability or adequacy of the hot water system in relation to capacity or otherwise.

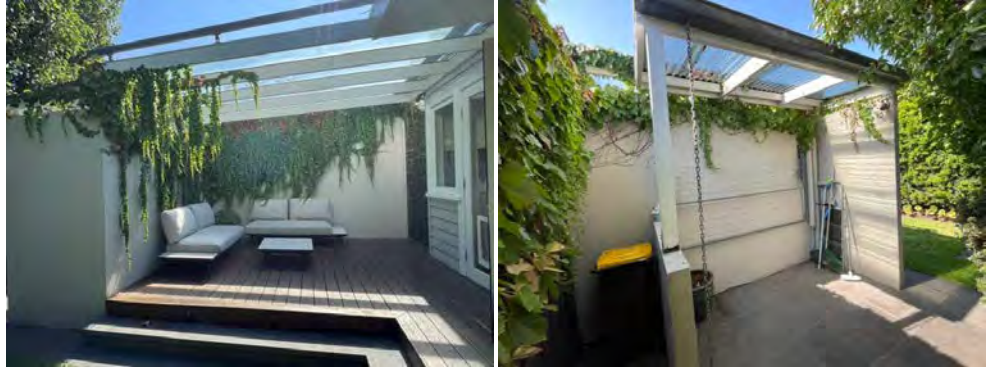
Though we are not structural engineers the veranda/s appear to be in a serviceable condition.

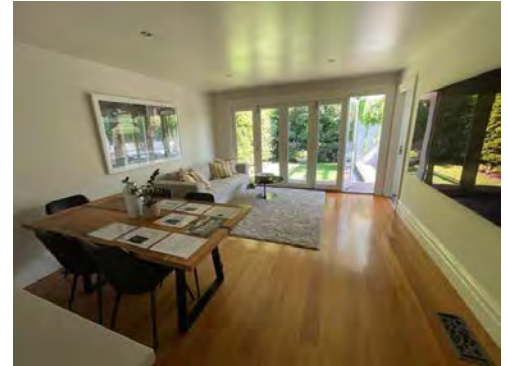
Ceiling

Settlement Cracks Noted. These are typical and generally patch and paint will suffice, however monitoring these cracks is advised for 12 months and if they become worse, further investigation by a suitably qualified professional is advised.

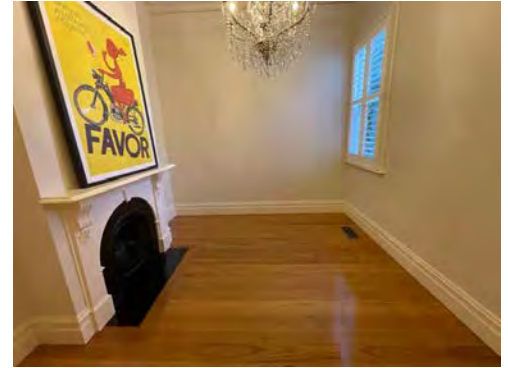
Ceiling

General ageing and/or denting and the like is evident on ceiling linings -
Recommendations: A qualified painter should be engaged to assess and repair as required.

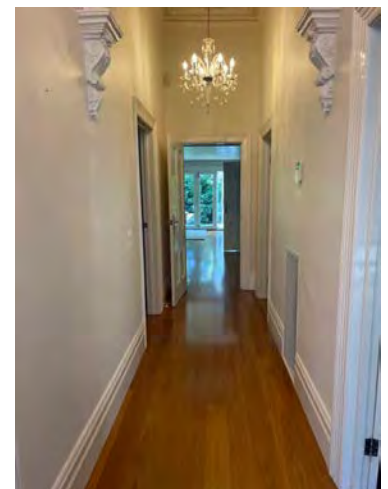
Walls

Patched wall cracks visible - Recommendations: I am unable to guarantee that these patched areas will not re-open in the future. If further opening occurs the affected areas may require re-assessment by a suitably qualified plasterer.

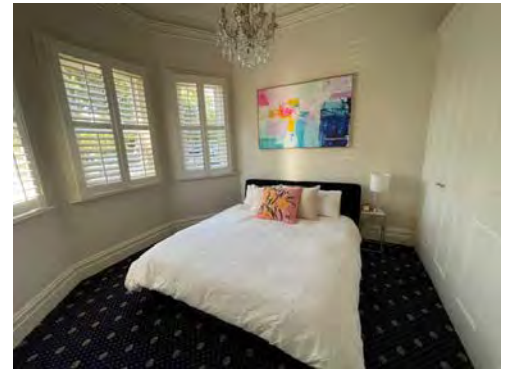
Ceiling

General ageing and/or denting and the like is evident on ceiling linings - Recommendations: A qualified painter should be engaged to assess and repair as required.

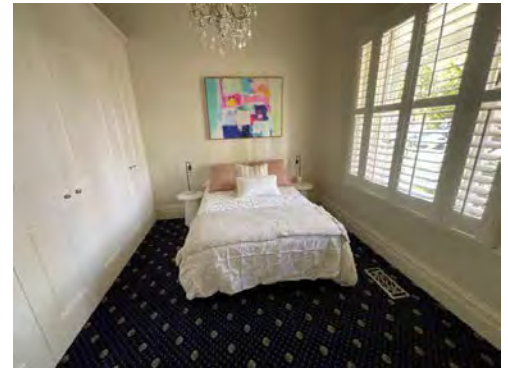
Ceiling

General ageing and/or denting and the like is evident on ceiling linings -
Recommendations: A qualified painter should be engaged to assess and repair as required.

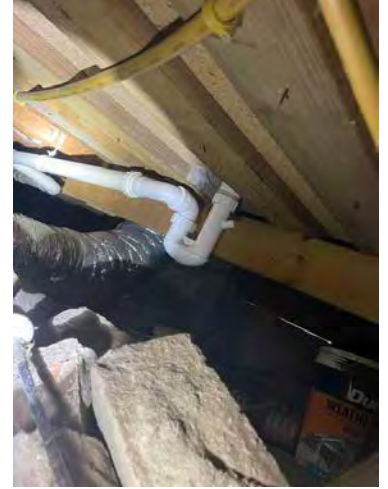
Dampness

The underside of the residence is lower than the external ground level. This situation may cause external stormwater runoff to enter the sub floor area. The sub floor area should be monitored in times of heavy rainfall. Additional site drainage may be required.
